**MIKE ASHEY PUBLISHING**  
**COMPREHENSIVE SERIES SCALE MODEL AIRCRAFT MANUAL**  
**NUMBER 5**  
**BUILDING AND DETAILING THE MONOGRAM/REVELL**  
**1/48 SCALE B-26 MARAUDER**

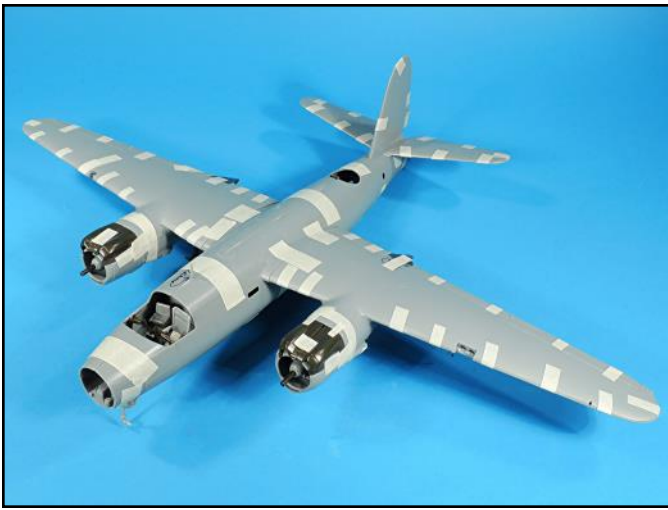
The fit check of all major parts is always the first step in building an aircraft model.

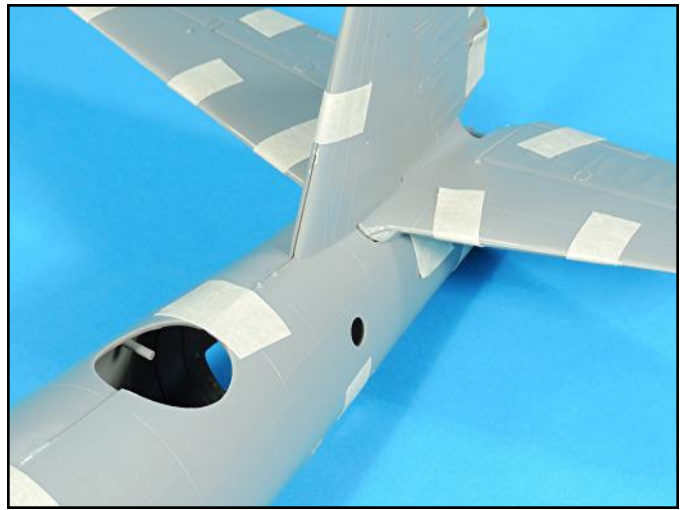
The elevator attachment to the fuselage is going to require some filling and sanding to get it contoured to the fuselage area.

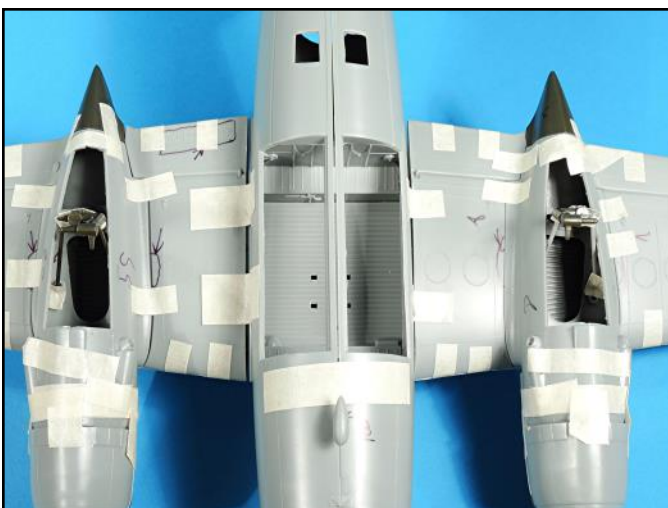
The underside attachment area between the wings and the fuselage are also going to be a challenge.

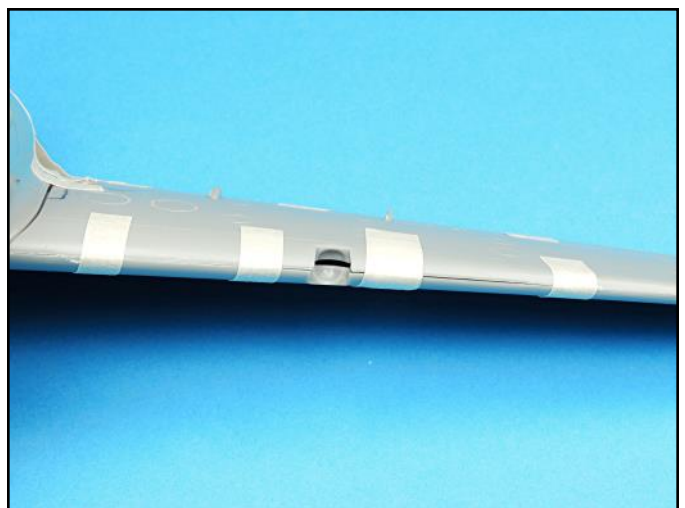
The leading edge lights on both wings have gaps, and the sides are misaligned.

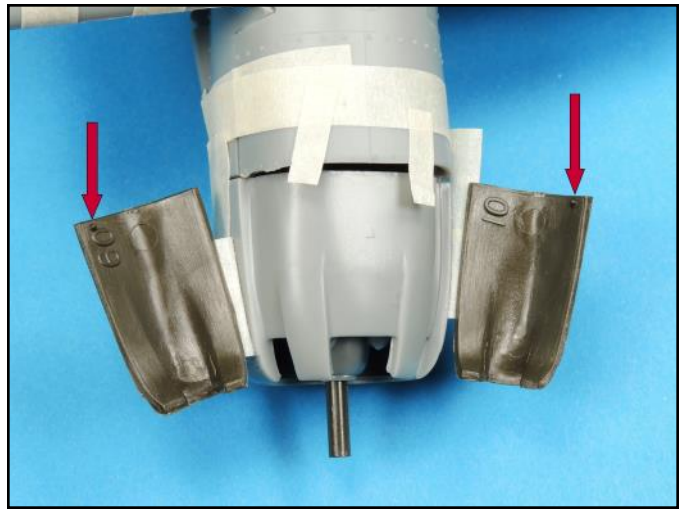
These small pins on the inside areas of the upper engine nacelle parts help level these parts against the upper aft nacelle areas.

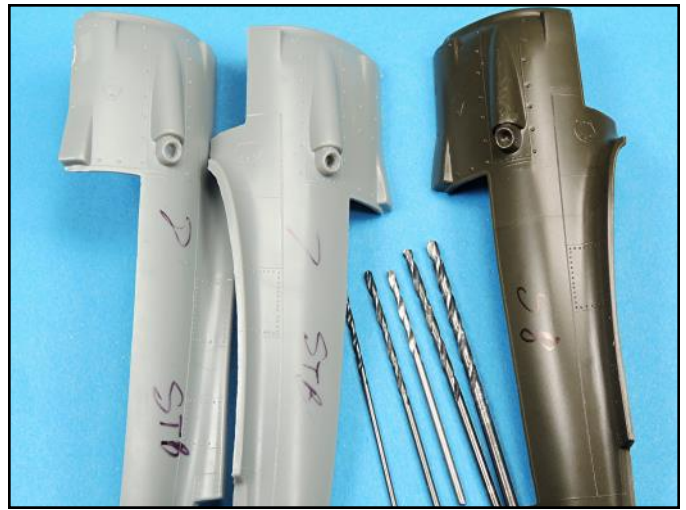
The engine exhausts were drilled deeper using progressively larger drill bit sizes. The four exhaust port openings were completed with a .086 inch bit (#44).

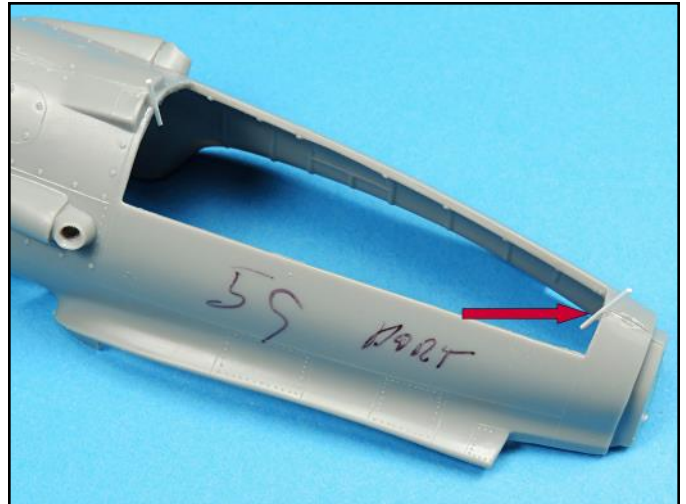
The edges of the nacelles were not square so after gluing the halves together, .01 x .02 inch strips were glued into place to fill these tiny gaps.

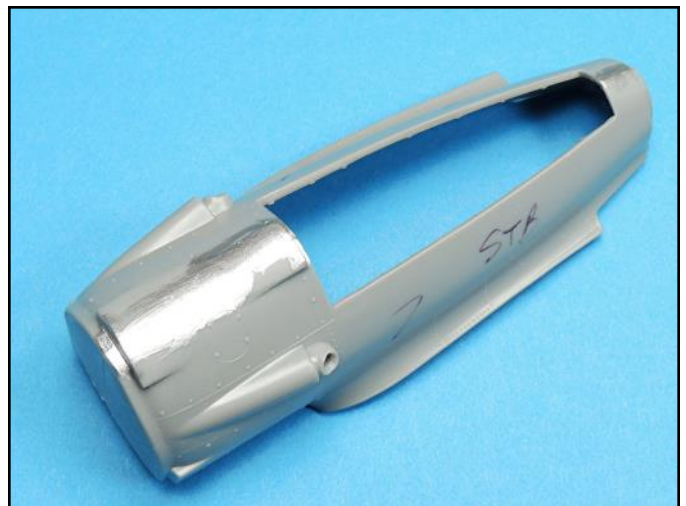
The seams on the nacelles were checked for flaws with Testors silver paint. With the addition of plastic strips to the inside seam areas these assemblies are now very strong.

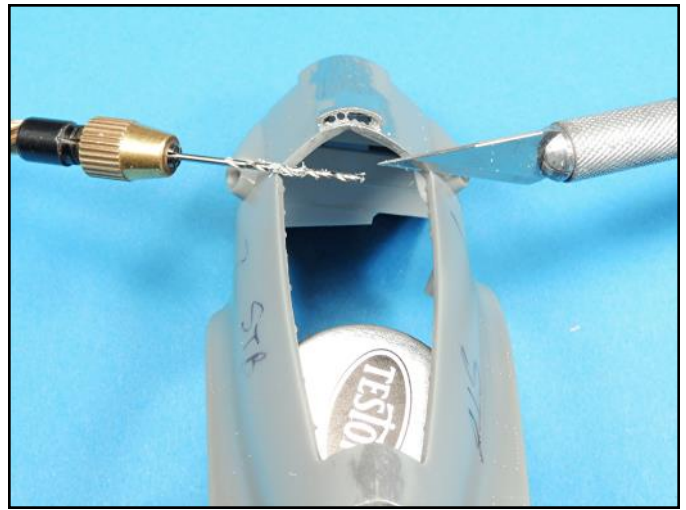
The plastic between the openings was then carefully cut out with the tip of a number 11 X-Acto blade.

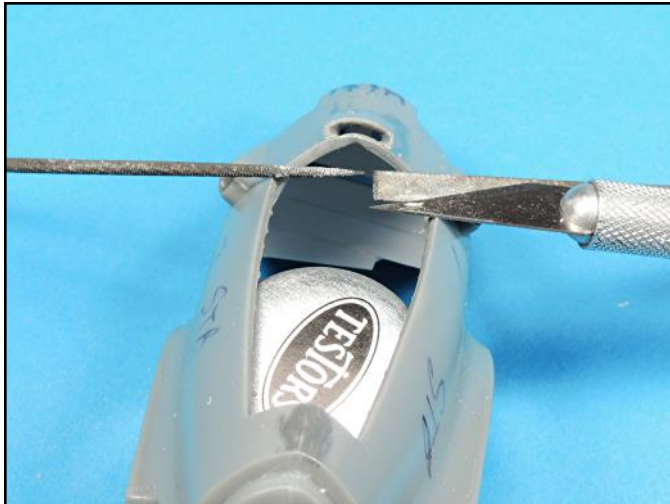
The openings were then carefully cleaned up and shaped with micro files.

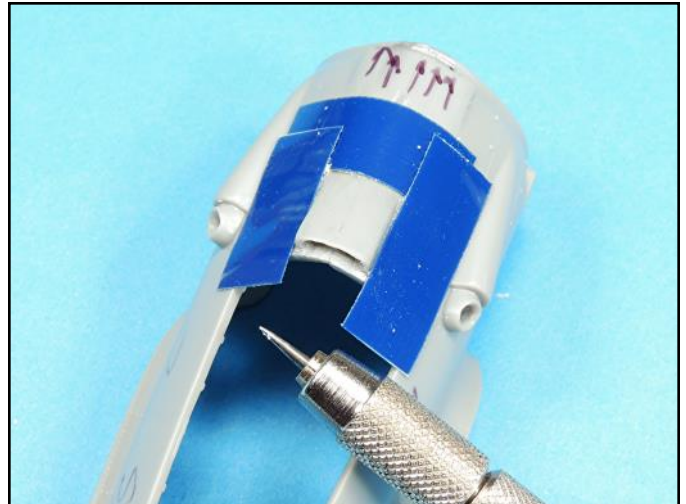
The edges of the air vents were then scribed to accent their attachments to the nacelles.

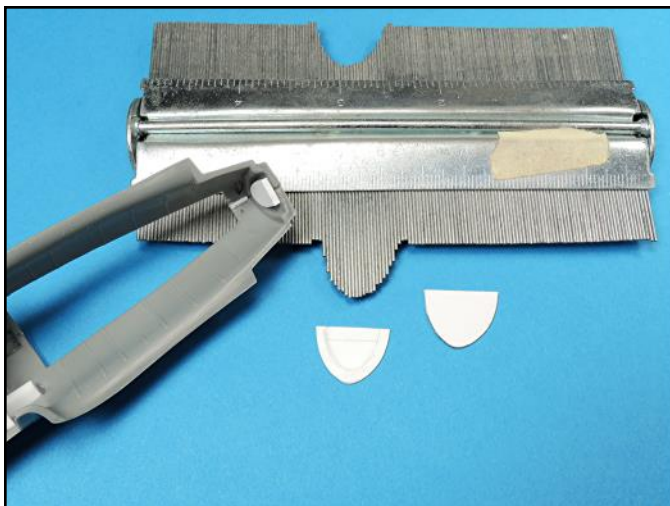
The aft interior area of each nacelle had noticeable framing that needed to be added. The framing shapes were made with a contour gauge, which was then traced onto .020 inch plastic and cut out.

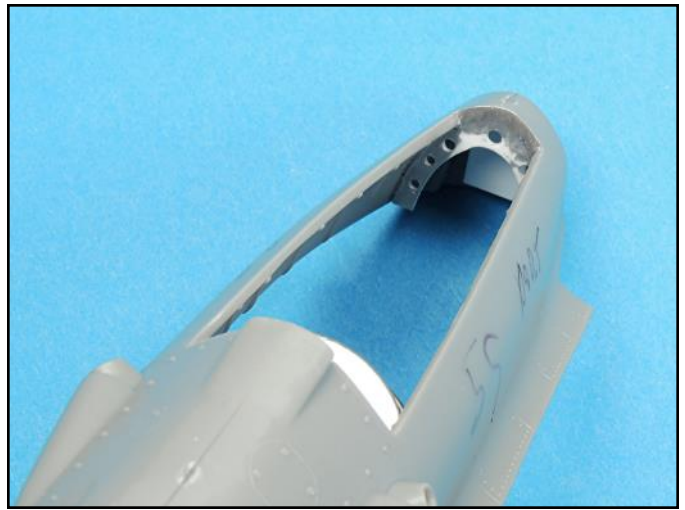
The framing was super glued into place and sanded smooth. silver paint was used to check for any surface flaws, voids or excess super glue.

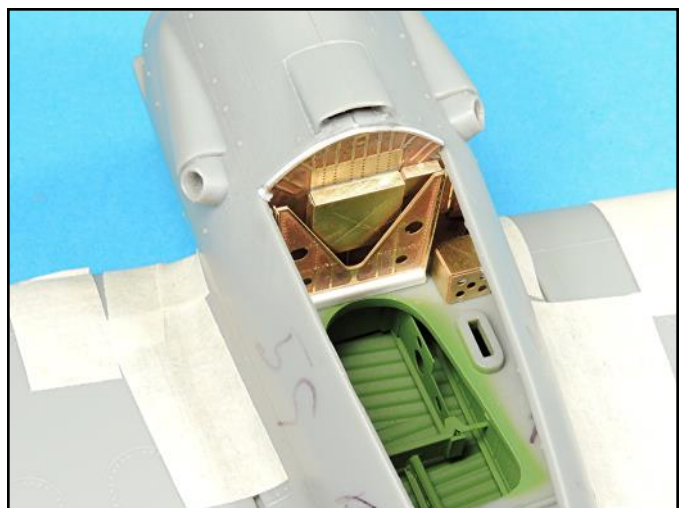
The engine nacelles were positioned onto the wings and then the remaining detail parts added. This ensures that these parts will not interfere with the nacelles.

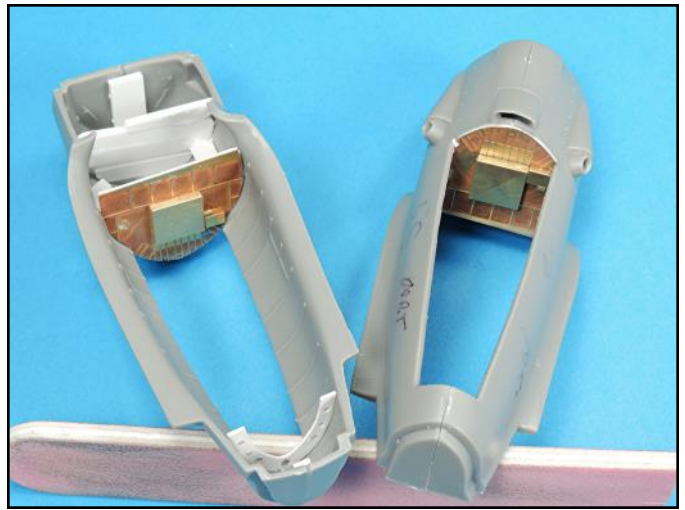
The engine nacelles are now ready for priming.

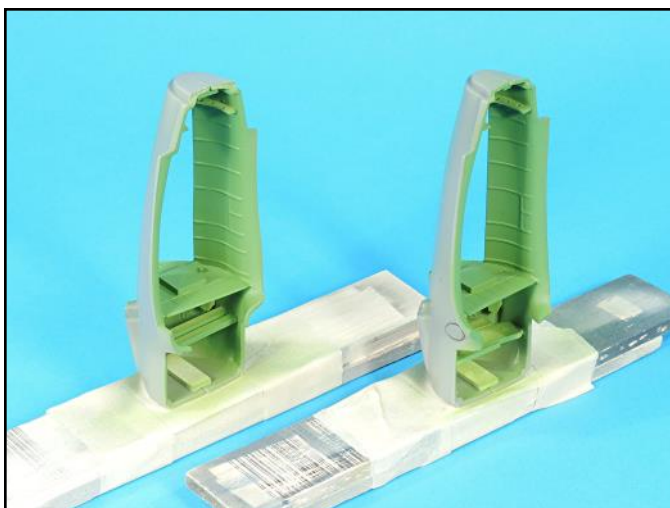
The nacelles were then airbrushed with zinc chromate green, which was slightly lightened with a few drops of flat white.

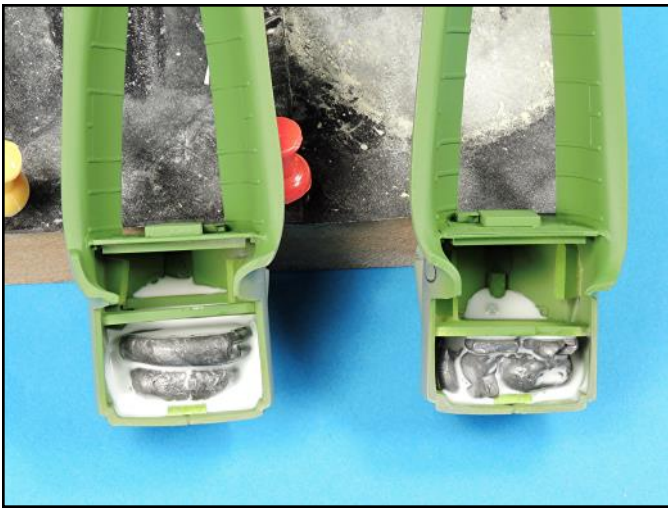
Mashed lead weight was inserted into the box areas of each nacelle and white glue added to secure the weights into place.

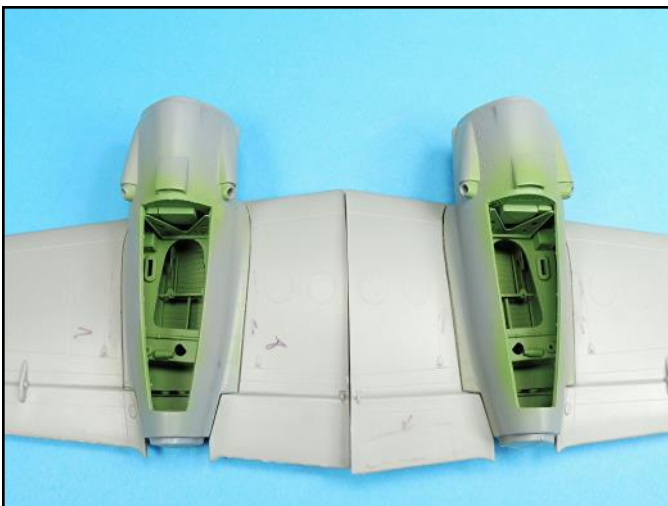
The nacelles have gaps on both sides that will need to be filled and sanded smooth.

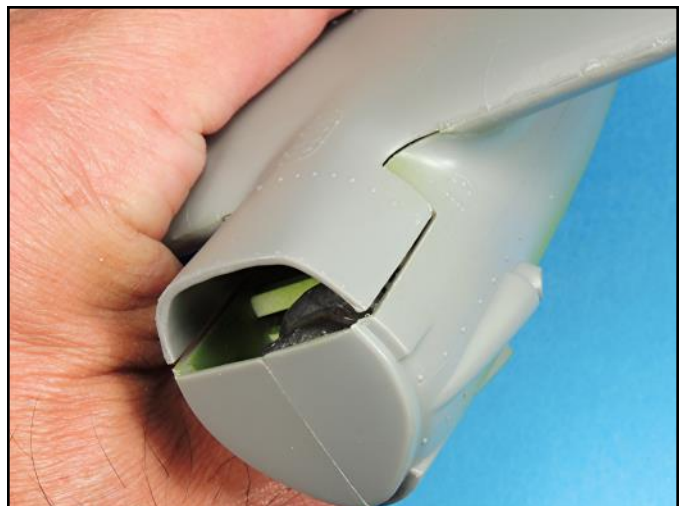
To fix the gaps between the upper and lower forward engine nacelles, they were pressed together and super glued.

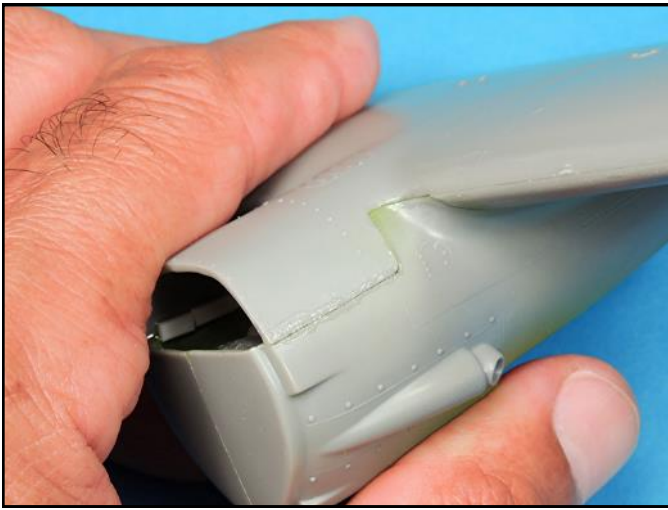
The super glue holds the gap closed, but scraping and sanding can weaken the seam.

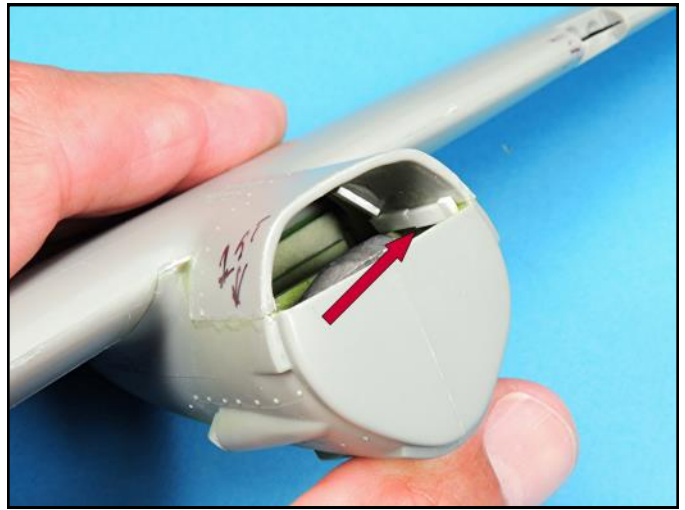
All four of the nacelle seams were reinforced from the inside with lengths of .030 inch thick plastic strips. These added interior lengths were all super glued into place.

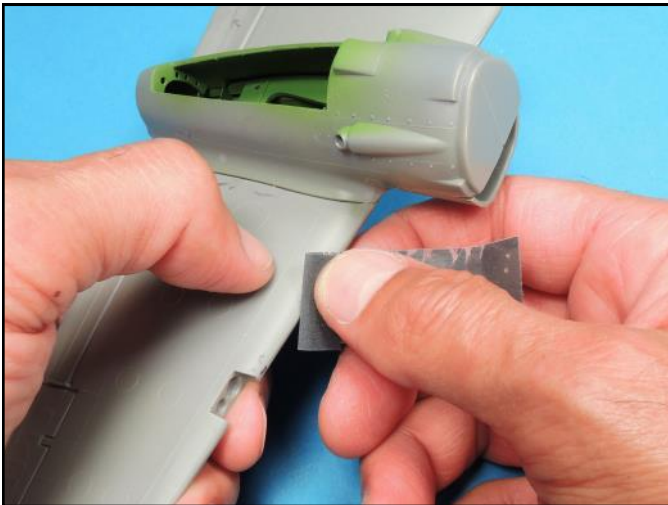
The leading edges of the wings were carefully scraped and wet sanded smooth.

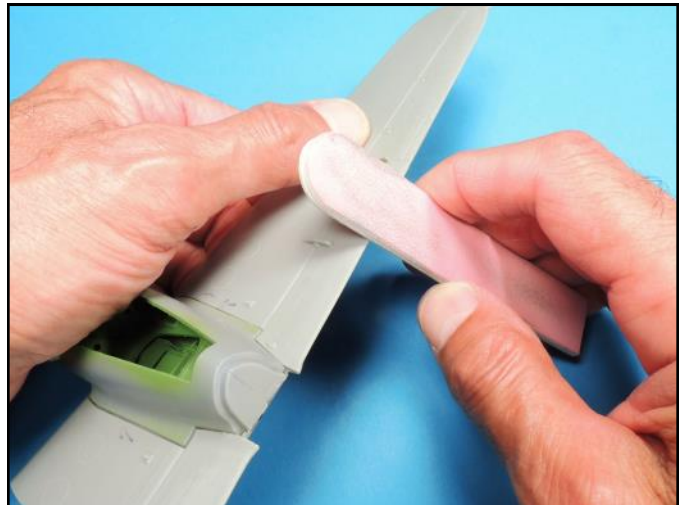
The trailing edge was scraped and wet sanded smooth with a sanding stick.

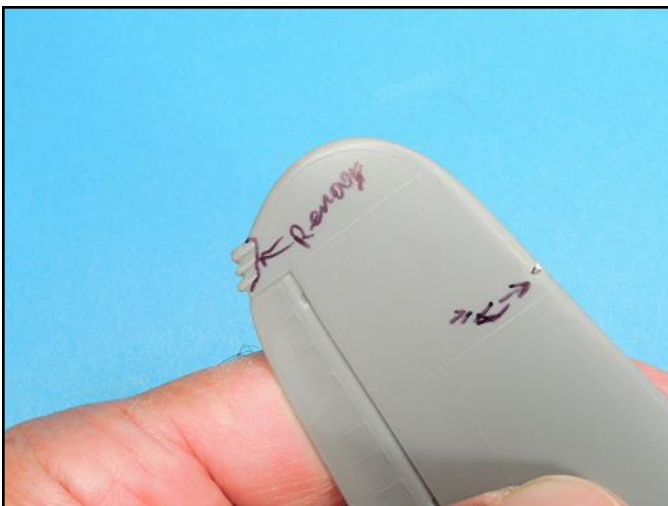
The trailing edge formation lights were badly misaligned between the upper and lower wings so they were sanded off.

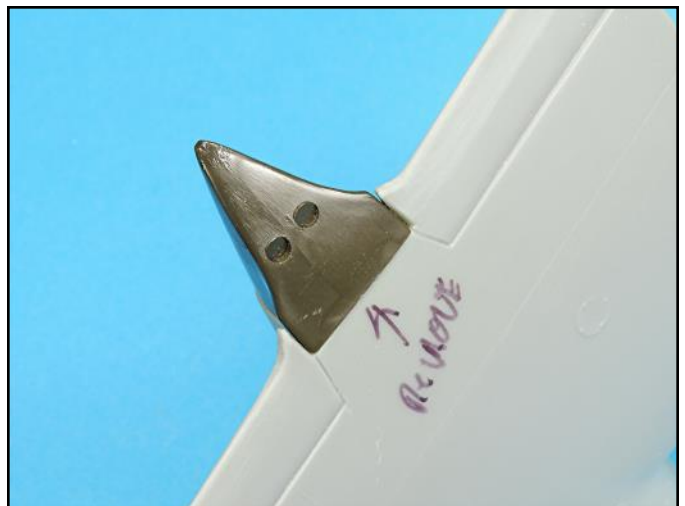
The trailing edge section of the engine nacelles have positioning tabs that need to be removed in order for these parts to sit correctly.

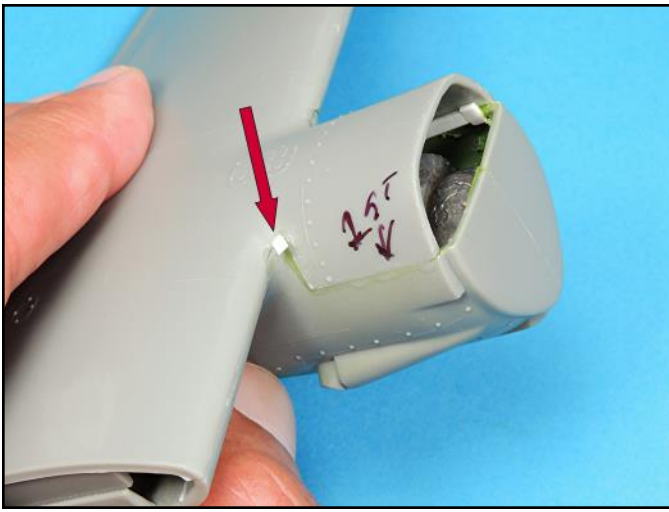
Small lengths of plastic of various thicknesses were slipped into the voids in the forward wing areas and then super glued into place.

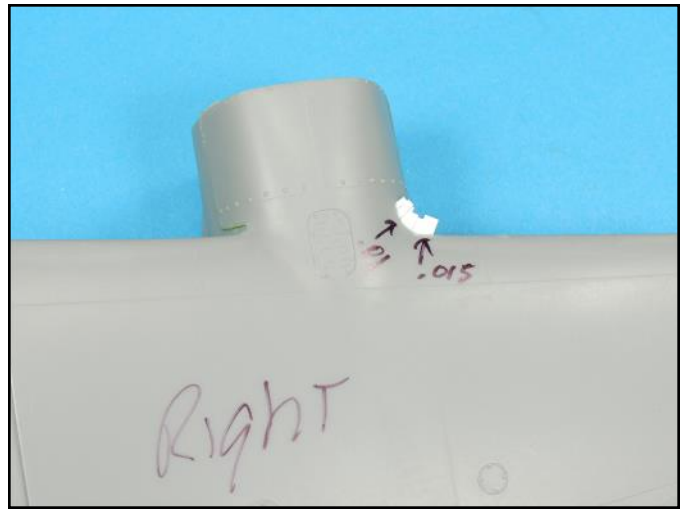
Beads of super glue were applied around the entire perimeters of these added strips using a .018 inch diameter wire as an applicator.

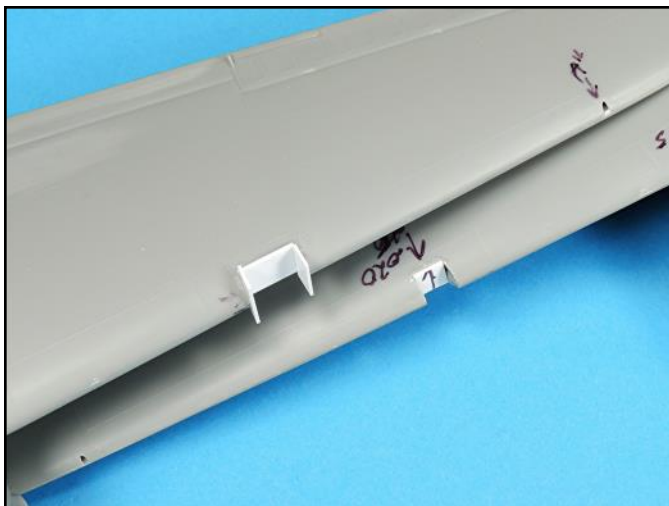
The wing light locations were boxed in with .02 x .188 inch strips super glued into place. Be sure that you apply a bead of super glue around the outer perimeter of each box.

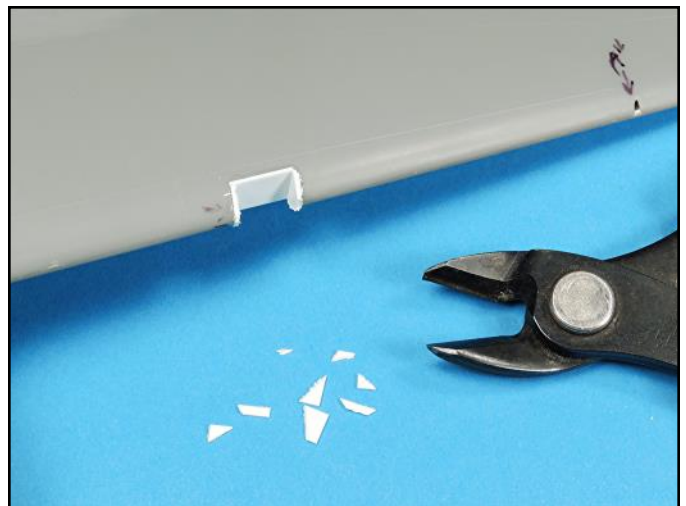
The excess plastic was trimmed with a pair of plastic cutters.

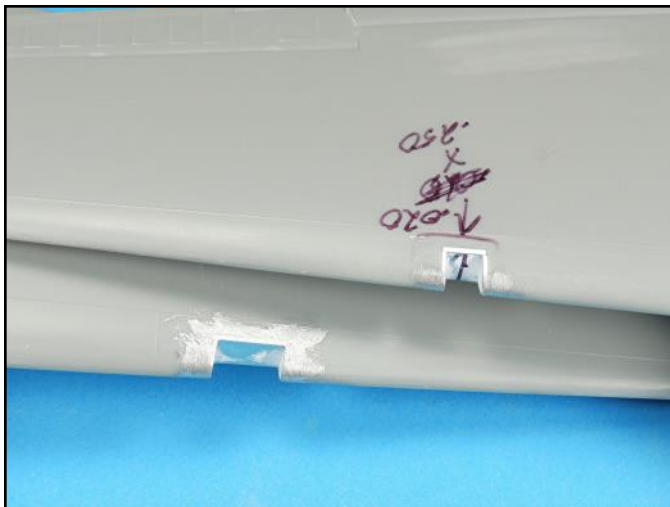
The wing light boxes are much improved and the clear inserts will need to be form fitted into place.

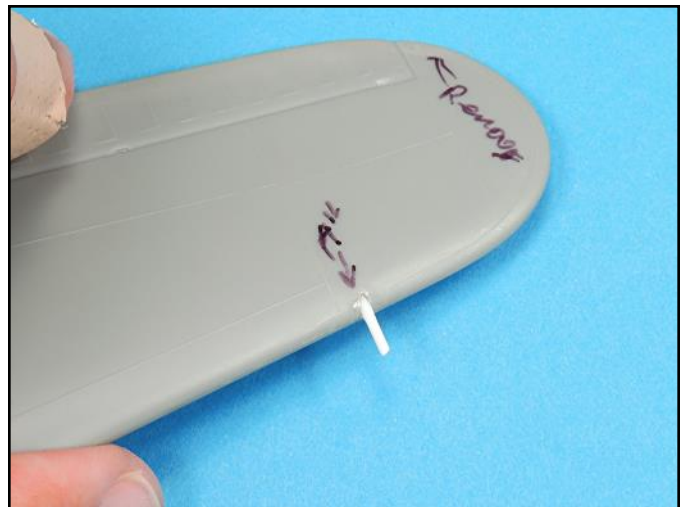
The pitot tube locations on the wings were filled in with .040 inch rod super glued into place, because the openings were too big. The openings were re-drilled with a .041 inch drill bit.

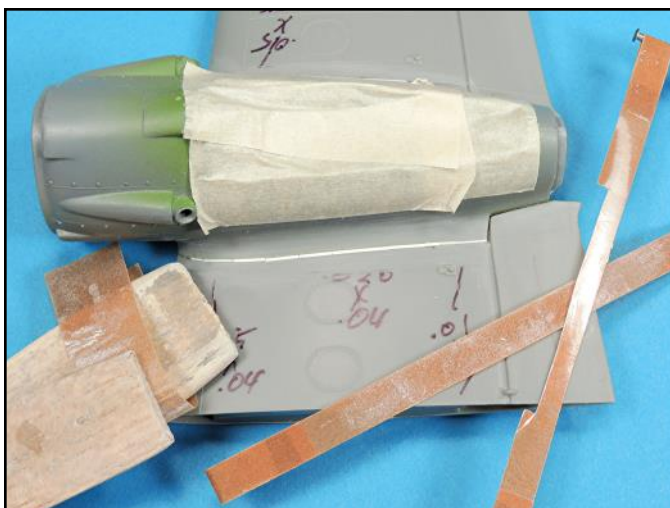
Sandpaper wrapped around balsa wood strips was used to smooth out the areas between the engine nacelles and the wings.

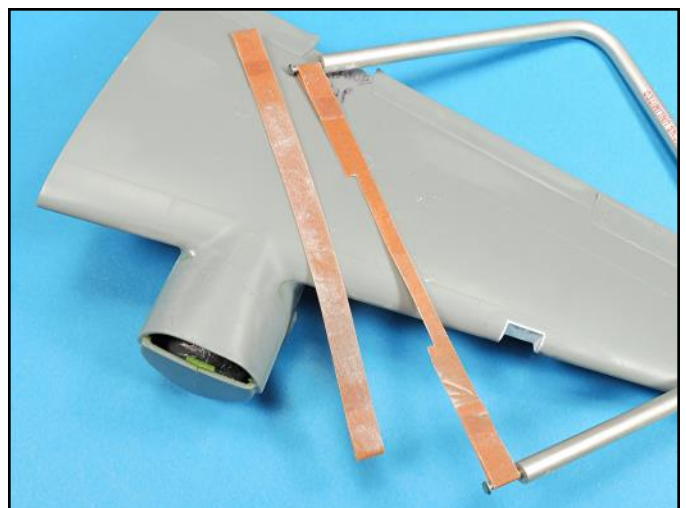
A Flex-A-File was used to smooth out the plastic around the contoured areas between the nacelles and the leading edges of the wings.

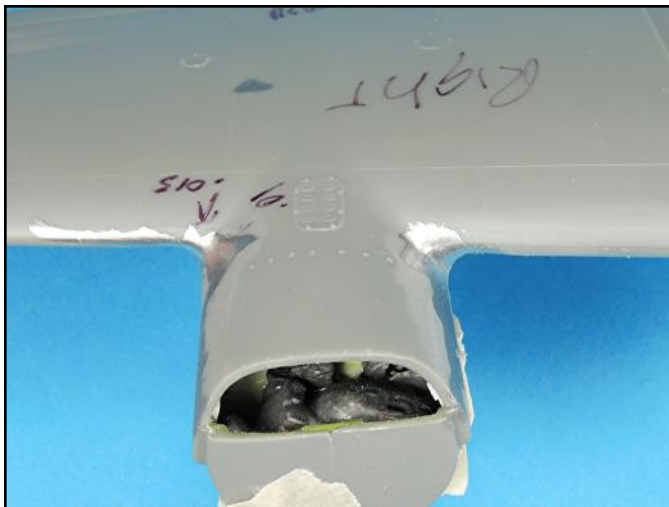
The contoured areas at the wing to nacelle connection points look good thanks to careful wet sanding with a Flex-A-File.

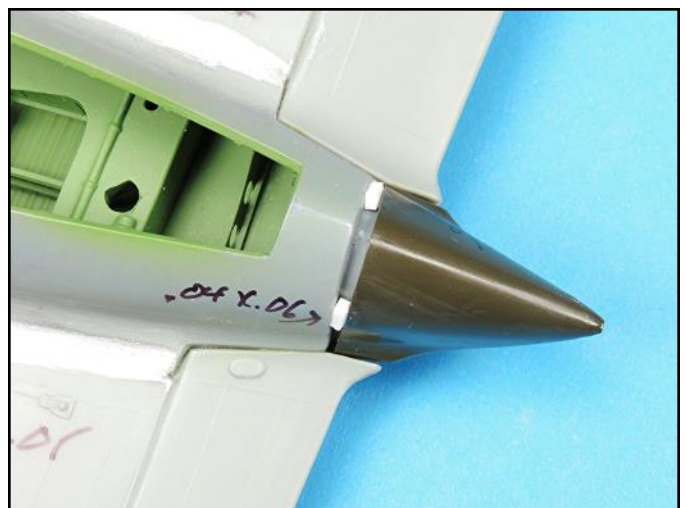
The proper positioning of these parts leaves a large gap on the lower surface. Small lengths of plastic were super glued into place to add strength to the assembly before filling the voids with plastic strips.

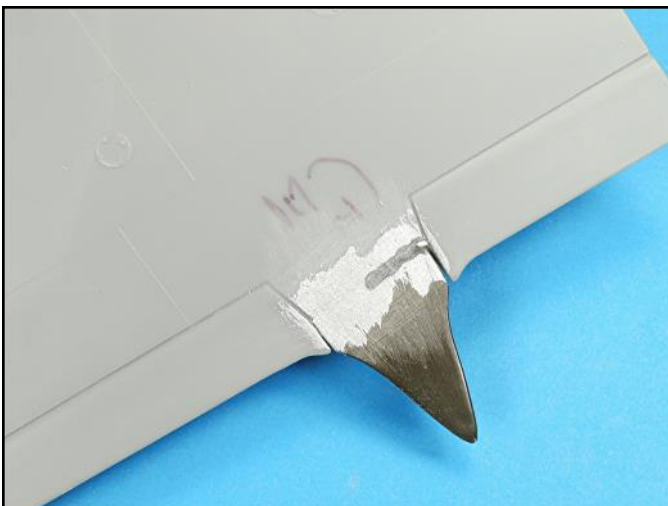
The upper surfaces also required several applications of silver paint and super glue to ensure that all the flaws were fixed.

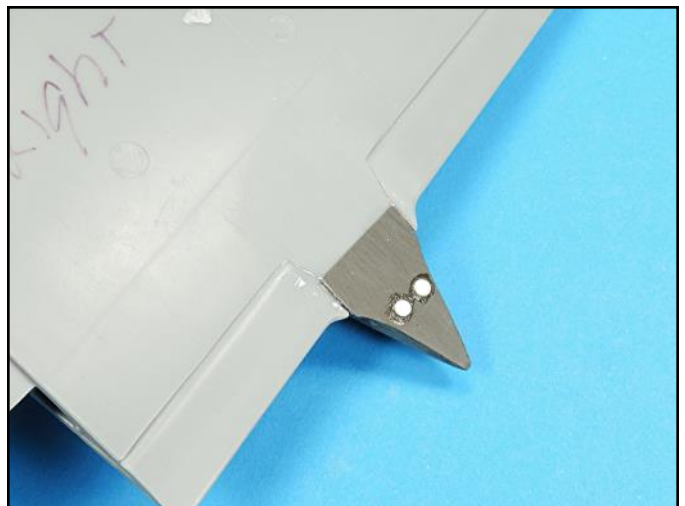
The two indentations on the right wing were filled with plastic disks punched out with a Waldron Punch tool. These will be replaced with decals punched out with the Waldron punch tool.

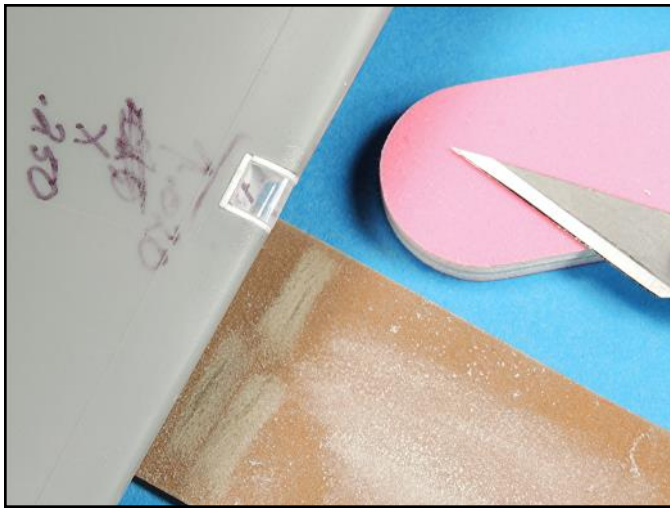
Careful sanding, shaping and form fitting of the wing light clear covers resulted in a tight fit on both wings.

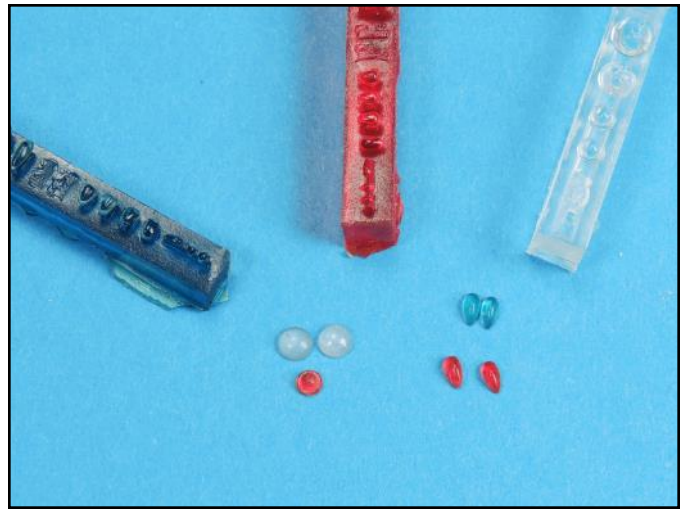
I found these Cutting Edge Model Works resin colored navigation lights and lenses on Ebay and they are perfect for detailing the wing lights and adding the wing tip navigation lights.

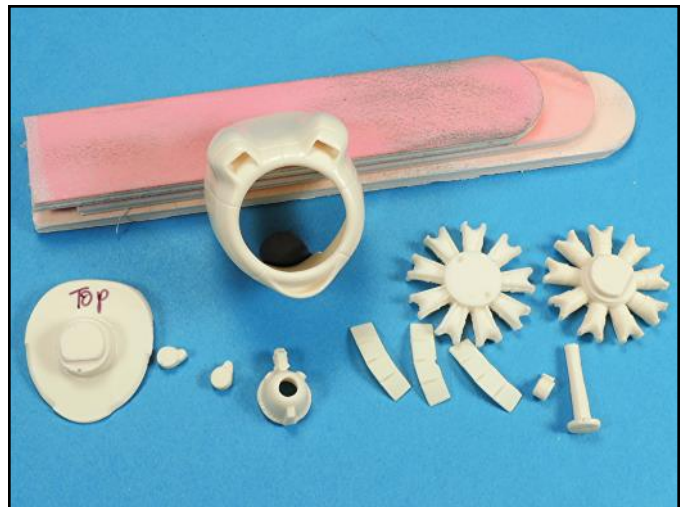
Loon Models makes replacement cowlings for the Monogram Marauder. They need to be tweaked for a good fit and the engines are better than the Monogram parts.

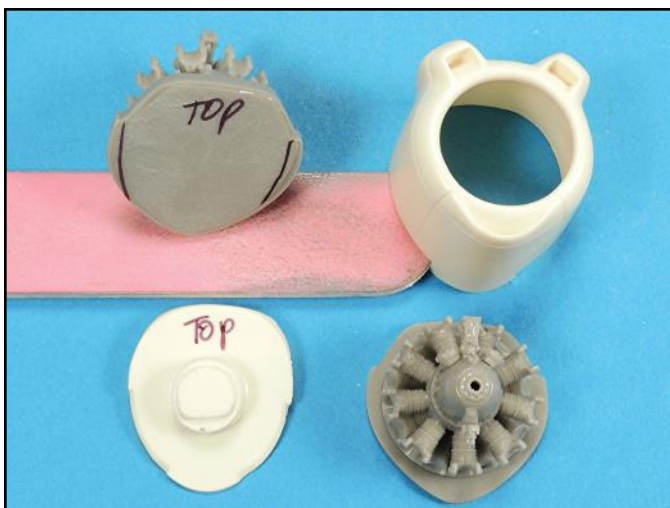
The Quickboost engines can be made to fit into the Loon Models cowlings by just tracing the outline of the Loon Models backing onto the Quickboost engine backing and then form fitting the engine into the cowl.

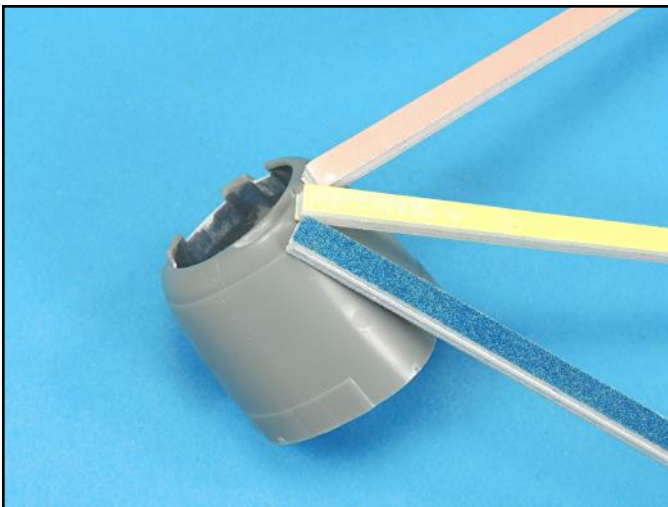
Micro sanding sticks were also used to help shape the added plastic.

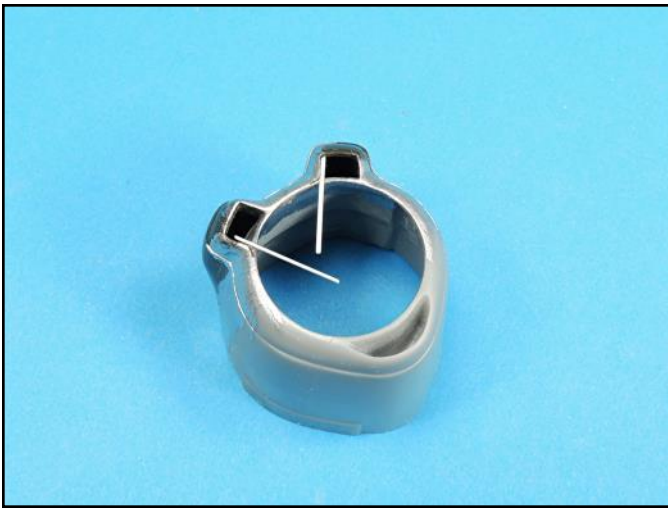
On this cowling assembly there were tiny voids in the front that were filled with .01 x .02 inch plastic strips.

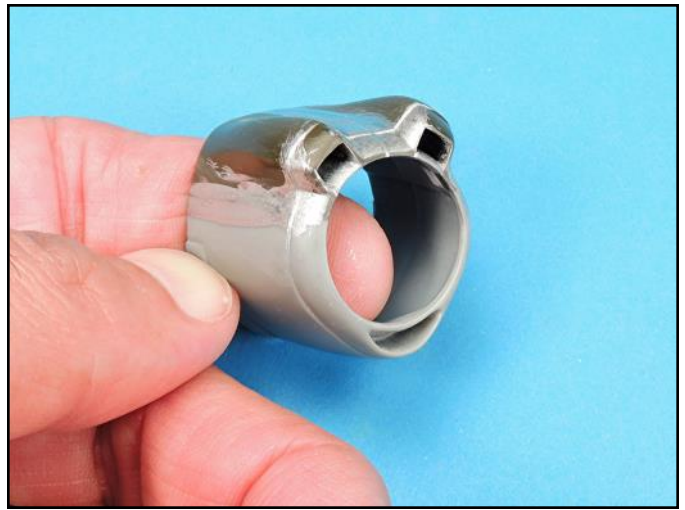
This cowling is now ready to be polished.

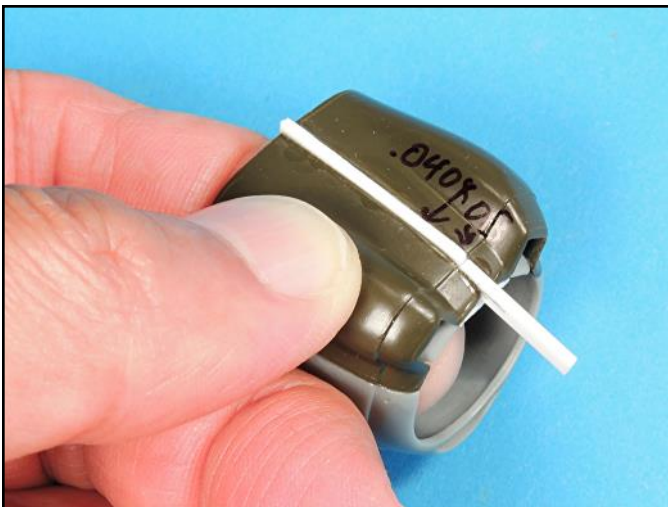
The second cowling was shaped slightly differently with a wider void between the air scoop parts.

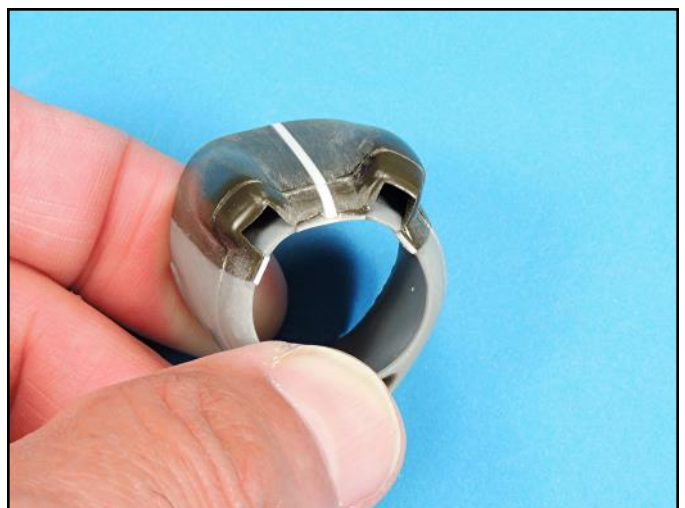
The second cowling required more plastic strip fillers to get it to look good.

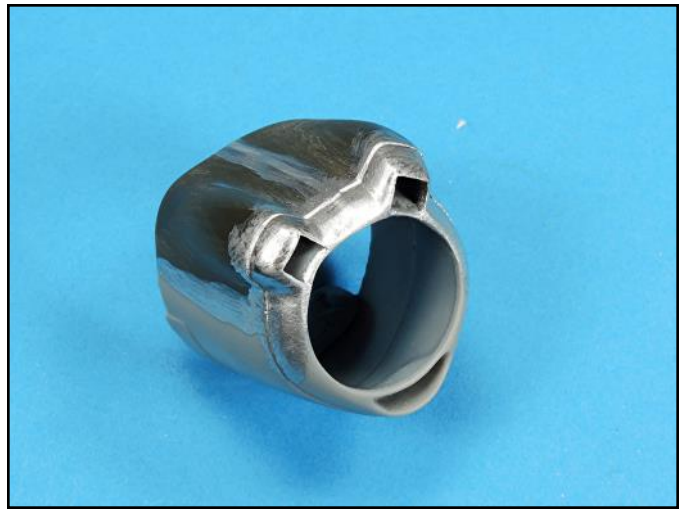
Silver paint really came in handy on the cowling assemblies and it took several iterations of silver paint and drops of super glue to finally get all the tiny voids filled.

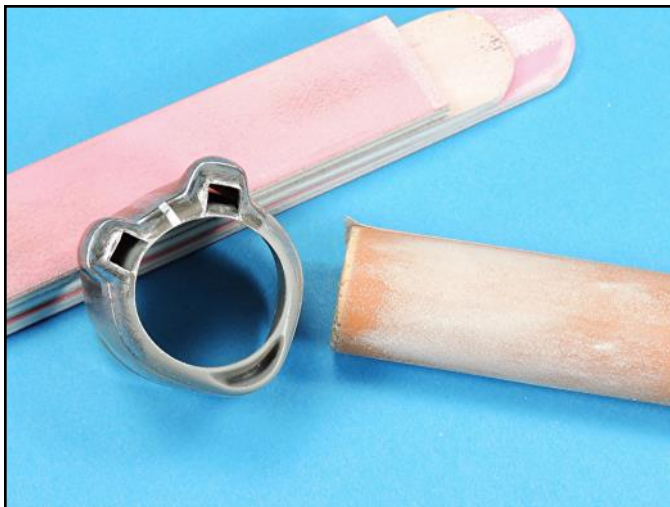
The engine cowling openings were reshaped using a 3/4 inch wood dowel with a 320 grit length of sandpaper wrapped around it.

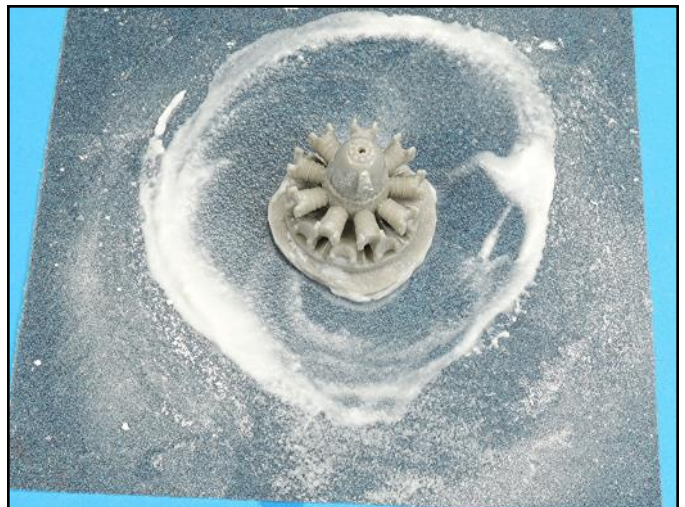
The pour plugs on the Quickboost resin engines were wet sanded off. To prevent interference between these parts and the engine nacelles, also remove some of the backing.

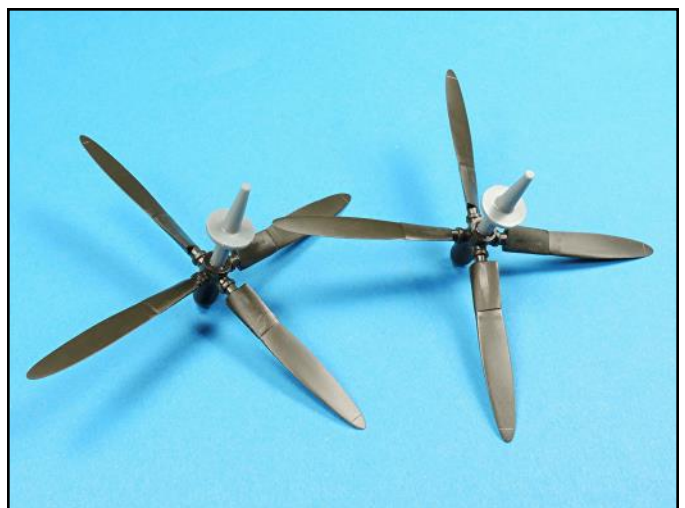
The propeller shafts were glued to the propellers and then cut off at the base of each propeller.

New propeller shafts were made using .060 inch rod. This required enlarging the holes in the engines. The propellers were drilled out slightly larger than .060 inches so that they had some play in them for proper positioning.

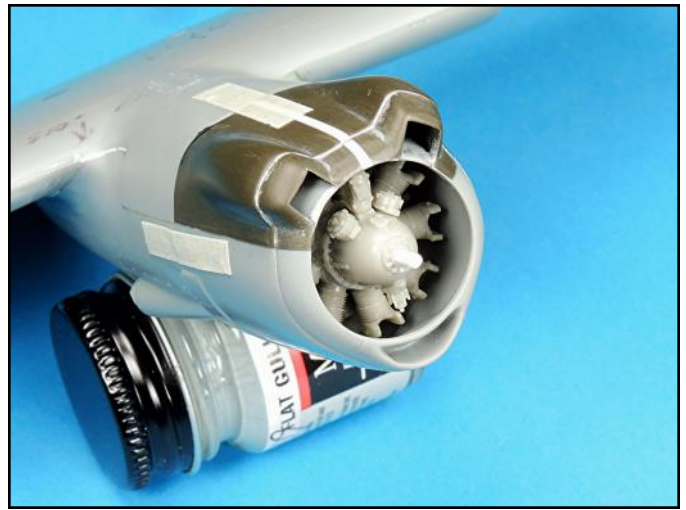
The engines were fit checked inside the cowlings and then taped to the nacelles to be sure there were no fit issues.

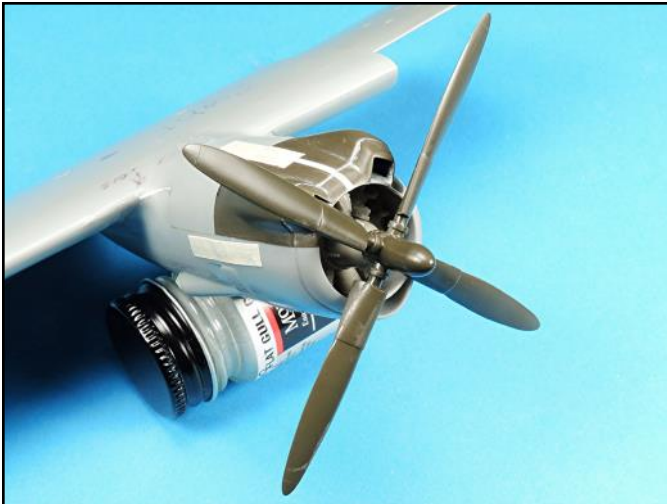
With the propellers in place the engines will add a greatly increased level of detail to the overall appearance of the model.

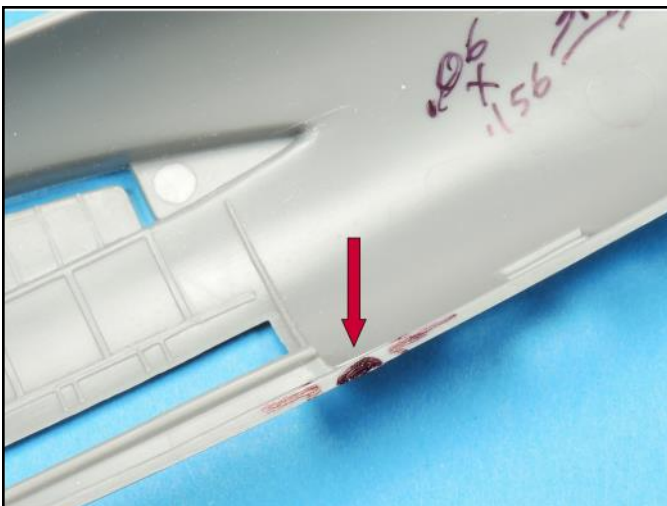
The gluing surfaces of the fuselage halves have raised areas which will need to be removed.

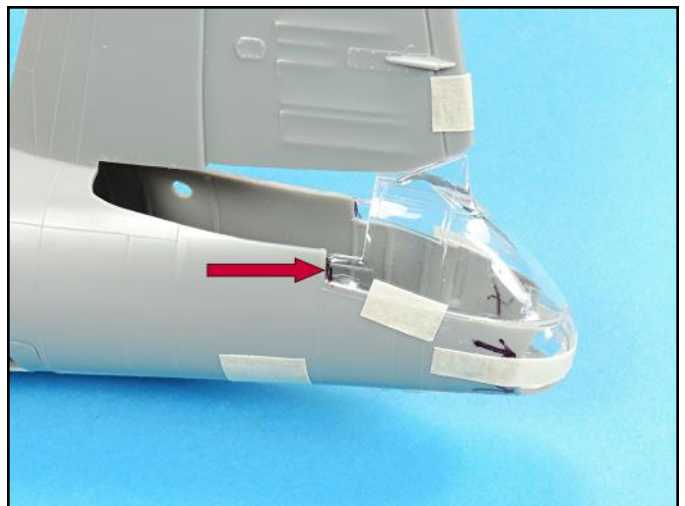
The aft clear part does not fit well. To get a better fit, angle the two sides noted by the arrow.

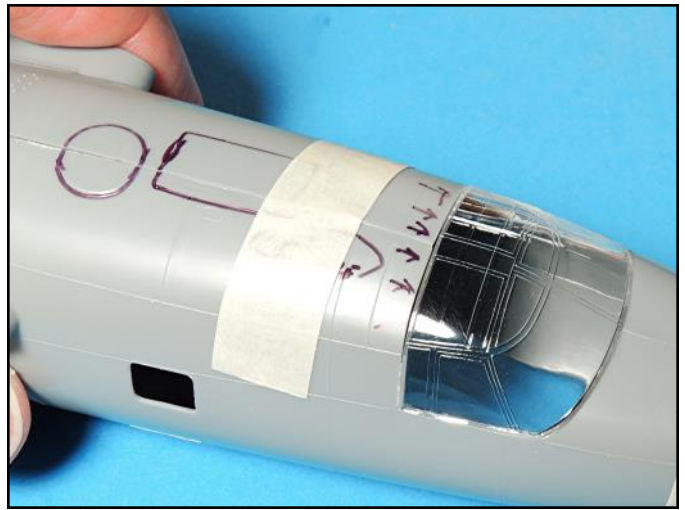
The fuselage misalignment has been corrected, but there is now a noticeable gap on the top of the canopy.

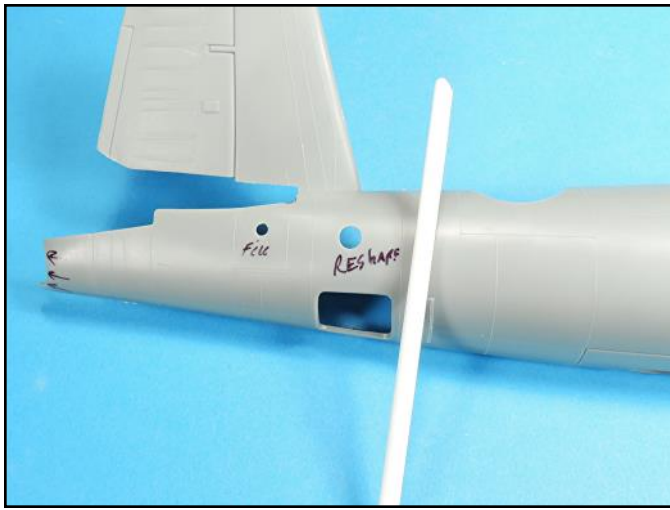
The clear parts for these openings are round, but the openings are not. Reshaping them was accomplished with a sanding rod.

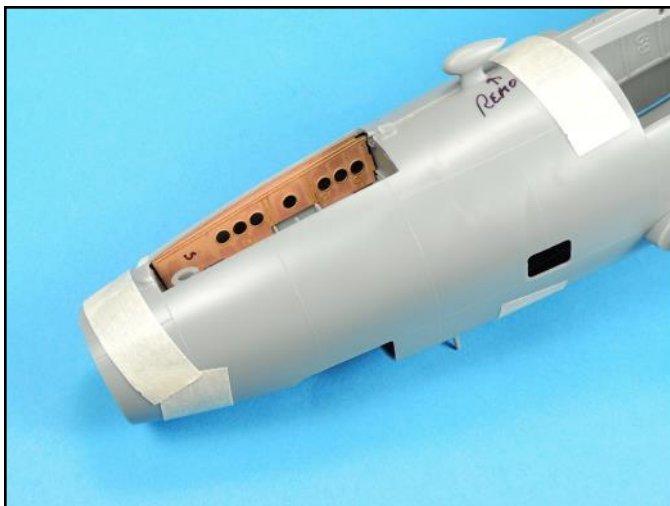
The Eduard forward landing gear photoetch details were fit checked before gluing them into place.

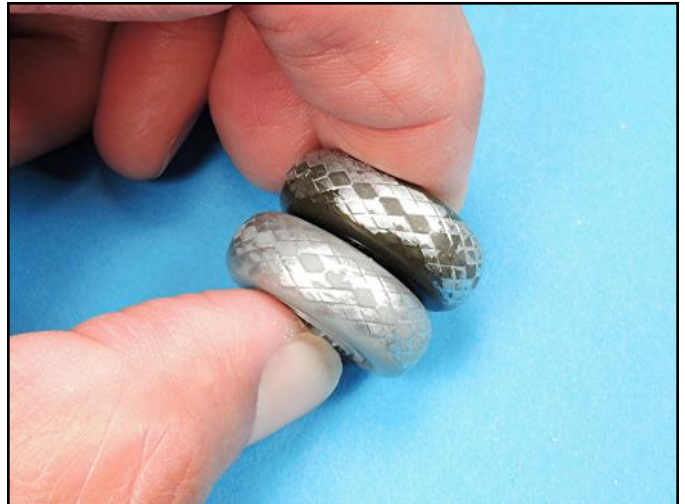
The positioning taps for the wheels were removed to get a better fit. A tiny bead of super glue was applied along the seam lines and then carefully scraped and sanded smooth.

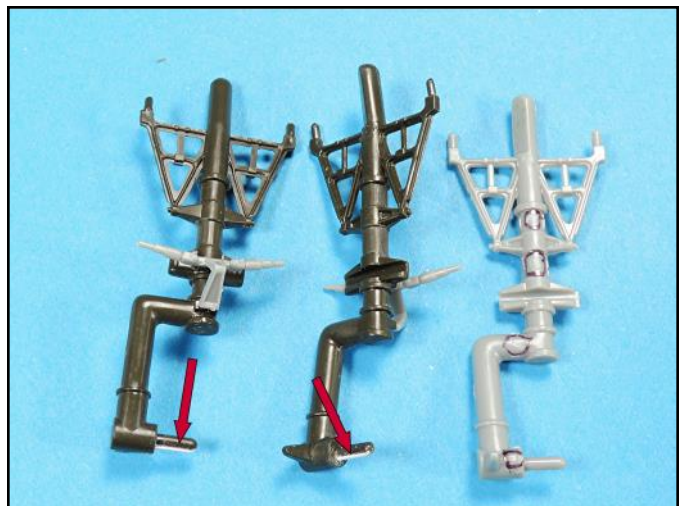
The fit of the main wheels to the landing gear was loose so tiny lengths of plastic (.01 x .02 inch) were glued to the axles to get a tight fit.

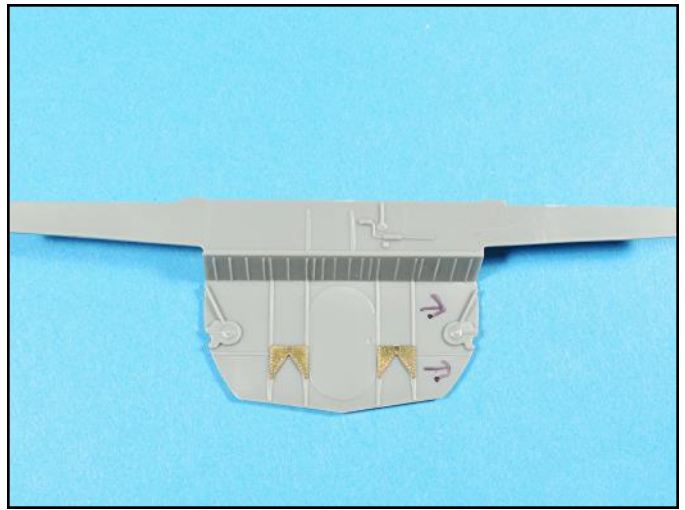
The aft bomb bay bulkhead only had two photoetch parts to be added.
