**MIKE ASHEY PUBLISHING**  
**COMPREHENSIVE SERIES SCALE MODEL AIRCRAFT MANUAL**  
**NUMBER 5**  
**BUILDING AND DETAILING THE MONOGRAM/REVELL**  
**1/48 SCALE B-26 MARAUDER**

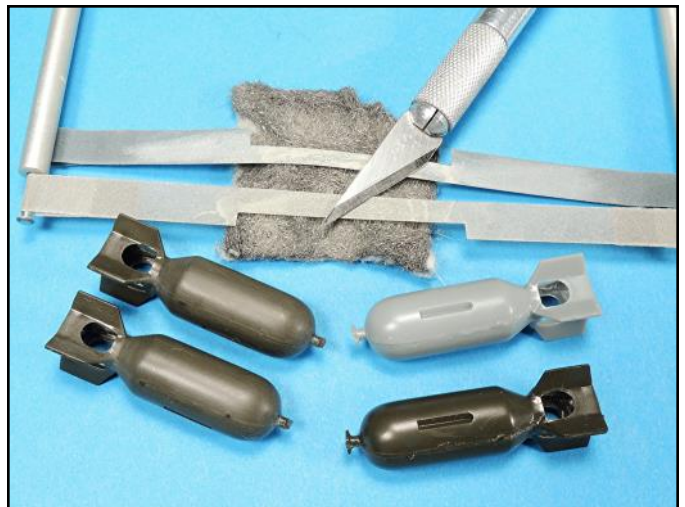
The bombs seam lines were carefully scraped, wet sanded smooth with a Flex-A File and then polished with a 0000 steel wool pad.

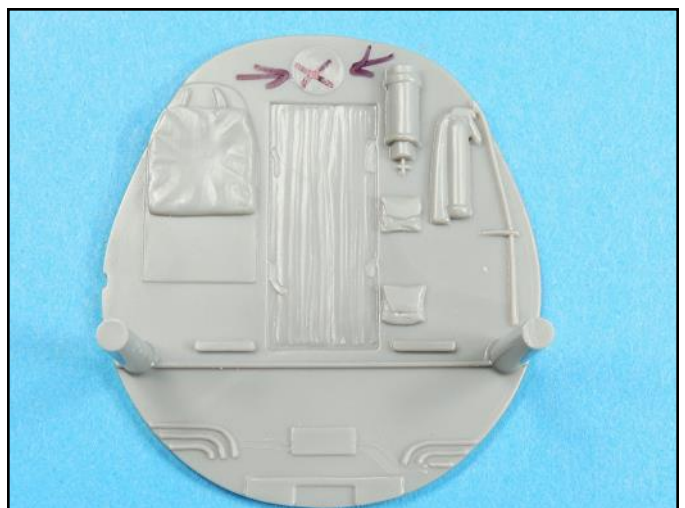
This large injection mark at the top of the cockpit bulkhead was removed with a length of sandpaper wrapped around a length of balsa wood.

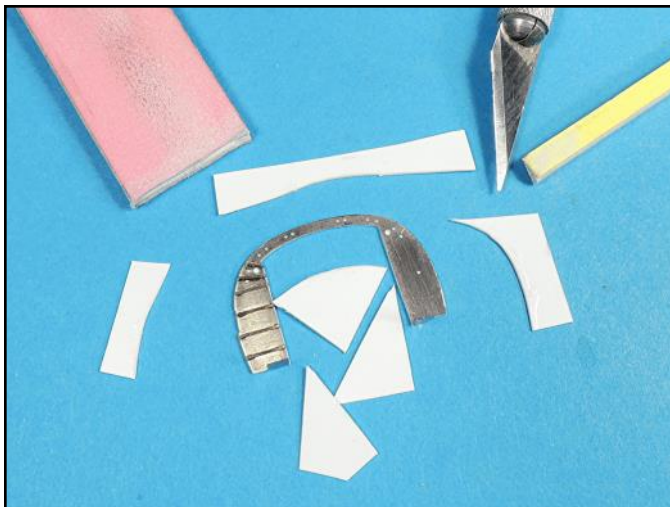
The Eduard forward cockpit bulkhead was laminated to a .015 inch thick plastic sheet to make it stronger.

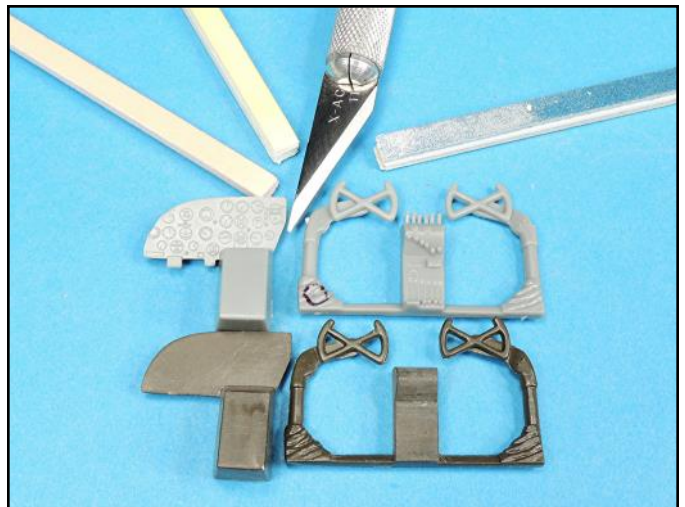
All the instrument and engine control detail was carefully scraped off and the surfaces sanded smooth in preparation for the Eduard pre-painted parts.

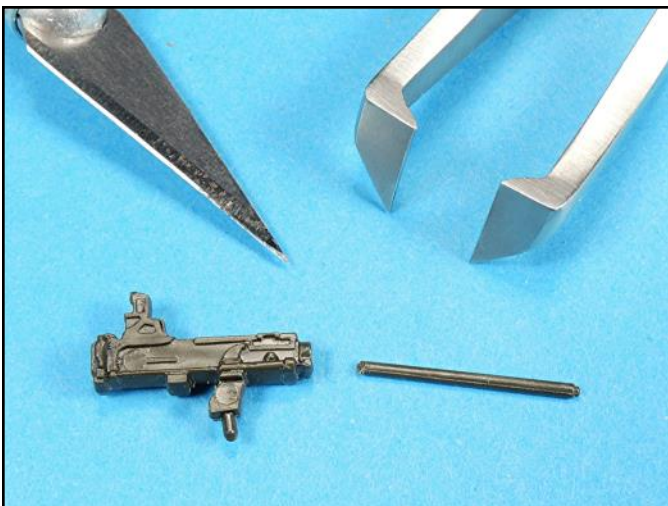
The first step in modifying the kit's guns for the Masters two part brass barrels is to carefully snip off the plastic barrel and flatten the surface.

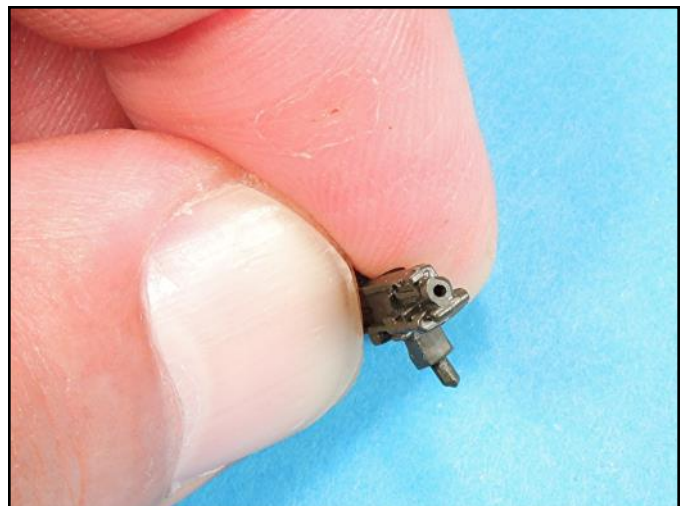
The hole for the brass barrel is progressively enlarged so that the plastic side walls will not collapse. Create a pilot hole and start with a .021 inch bit (#75) and work up to a .040 inch bit (#60).

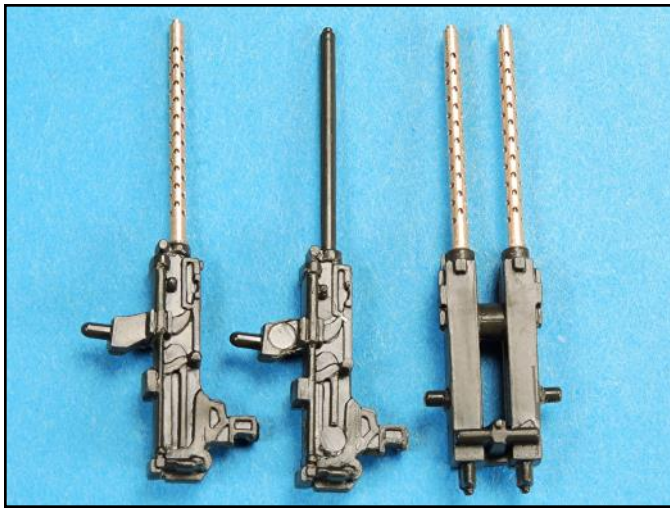
The twin tail gun looks much more realistic. Note how straight the barrels are to each other and to the base.

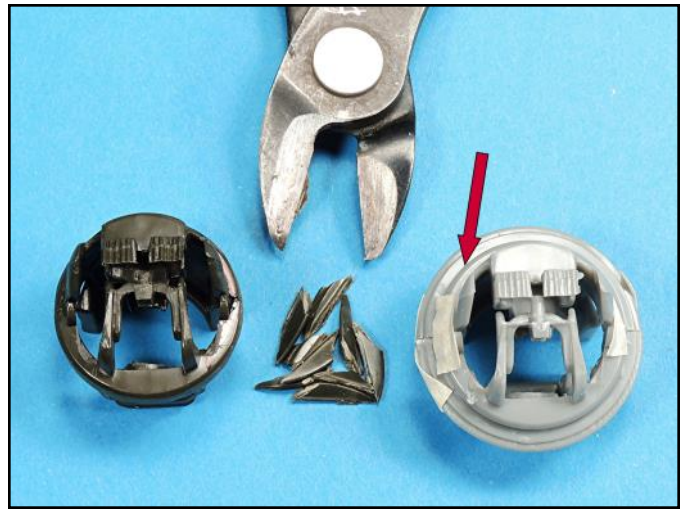
In order to be able to insert the turret into place after the fuselage halves are closed up, glue the parts together, remove the ring that allows the turret to turn, and then fix the seams.

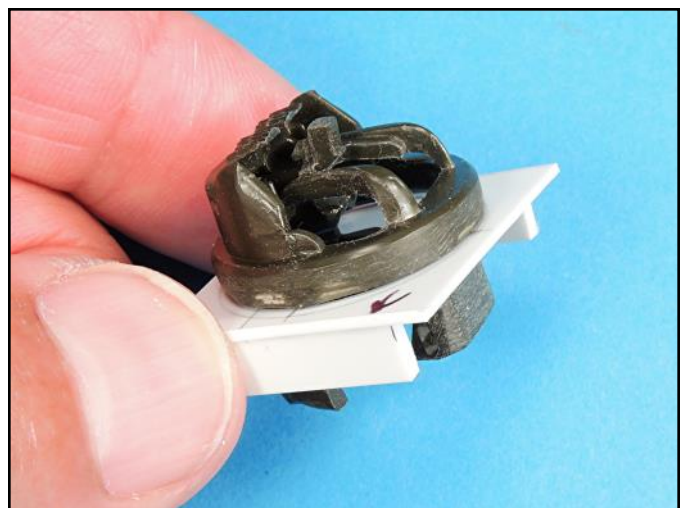
The hole should have some play in it so that the turret will just slide down into it. Note the reinforcing strips on the sides of the turret's positioned plate.

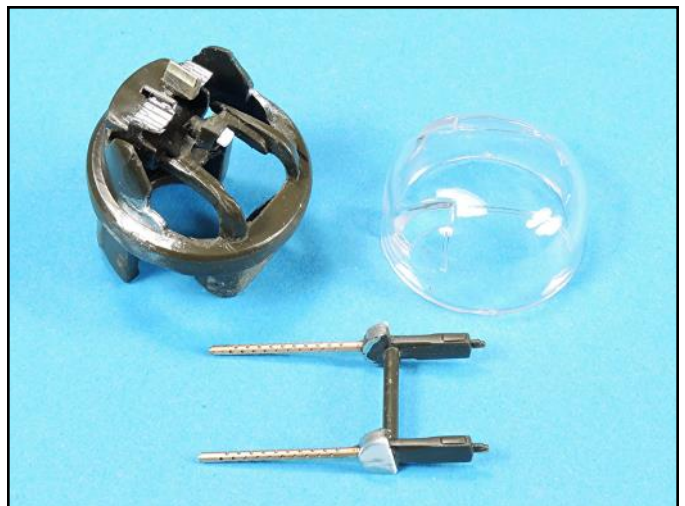
The two part brass barrels were attached using the same techniques as the other guns.

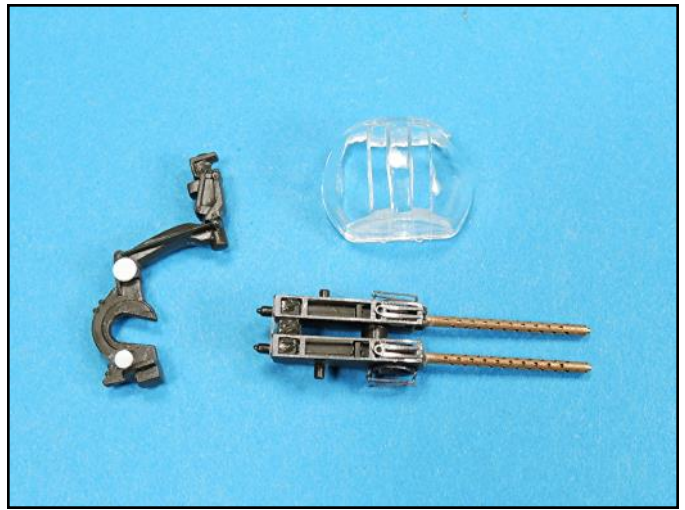
The Eduard photoetch parts have been added to the tail gun and the mold punch outs on the control arm were hidden with tiny .015 inch disks made from a Waldron Punch Tool.

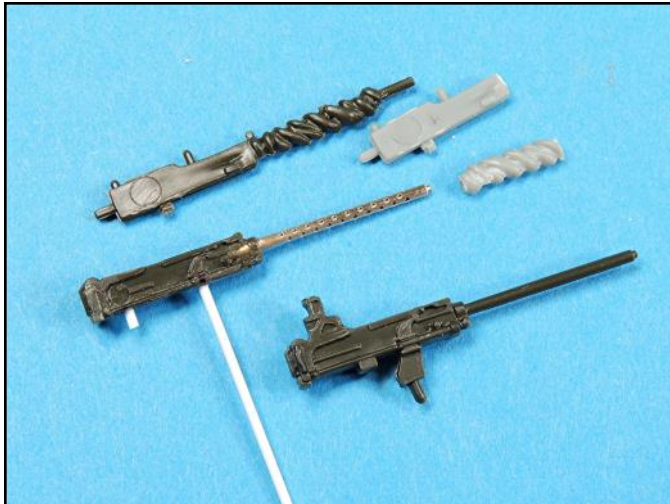
The lower nose canopy gun was replaced with a spare gun so the two part brass barrels could be added.

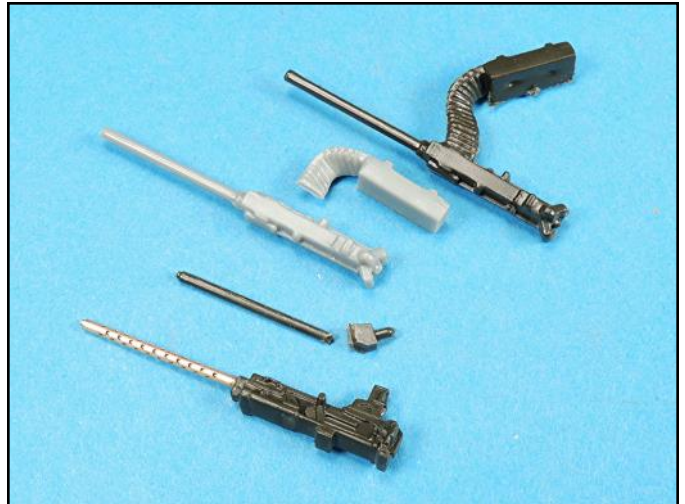
The kit's Norden bombsight is large and it interferes with the placement of the kit supplied center nose gun. It was also replaced with a spare gun, but it will still result in the gun being set at an angle.

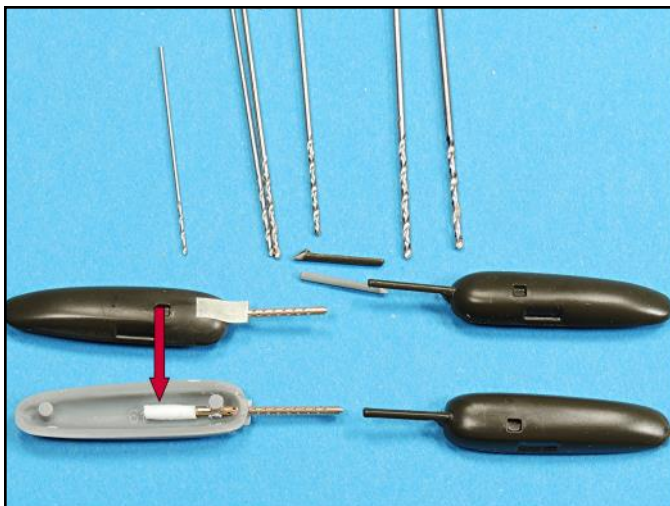
The guns for the gun packs were cut off and the fronts slightly reshaped. Holes were drilled for the two part brass barrels (.042 inches), and small lengths of .060 inch diameter rod were added to set the depth of the each barrel.

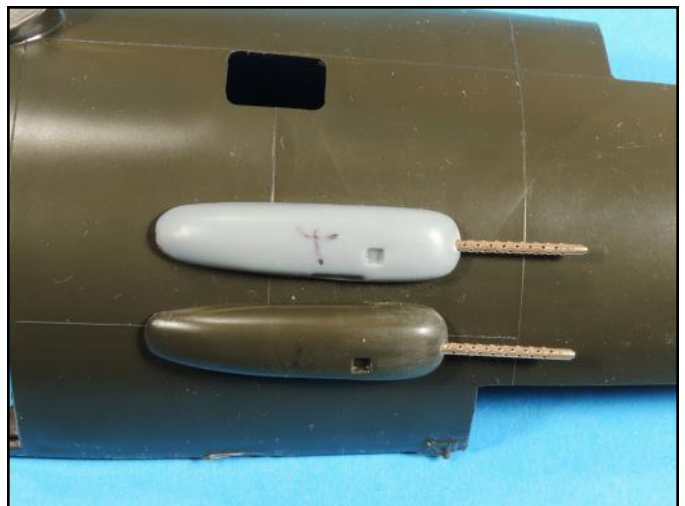
The positioning holes in the fuselage were enlarged to .065 inches to allow for some play so the gun packs could be properly positioned.

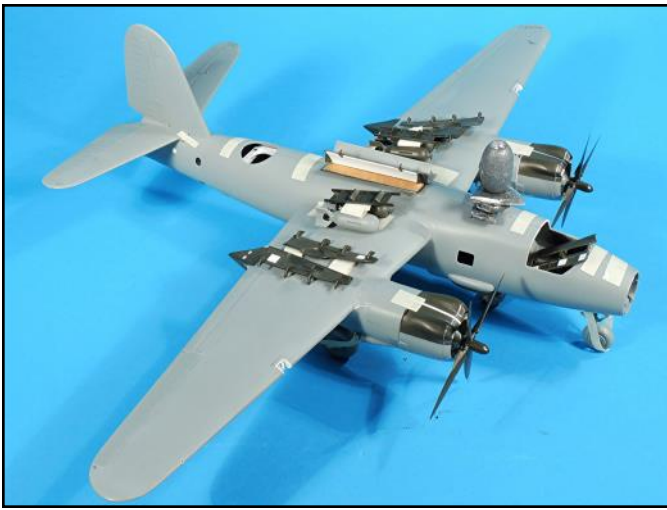
The get the correct amount of weight, the model was taped together and all the parts added. Weights were then carefully added until the fuselage was sitting firmly on its landing gear.

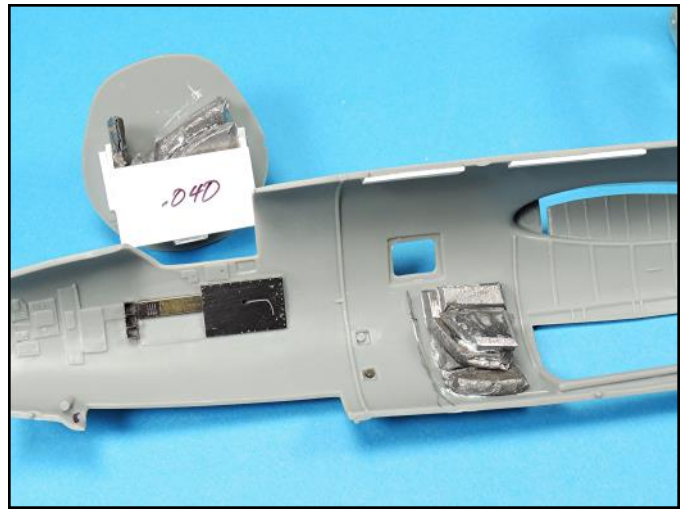
A box was made on the backside of the cockpit bulkhead and filled with lead weight. Additional weight was super glued into place on both sides of the fuselage between the cockpit bulkhead and the forward bomb bay bulkhead.

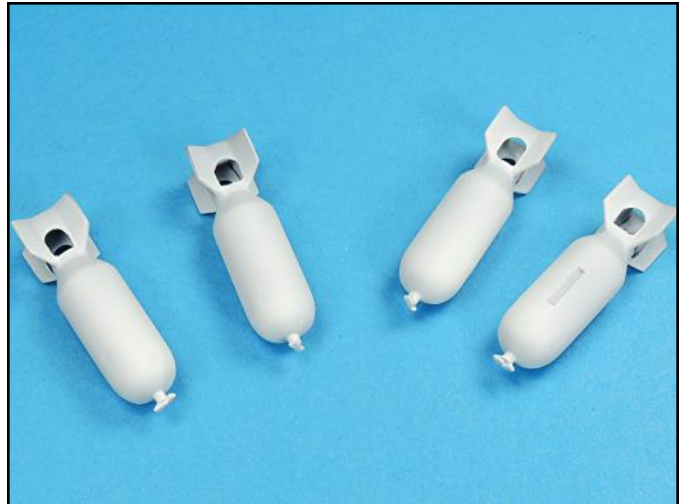
A base coat of flat white should always be used for a flat yellow color.

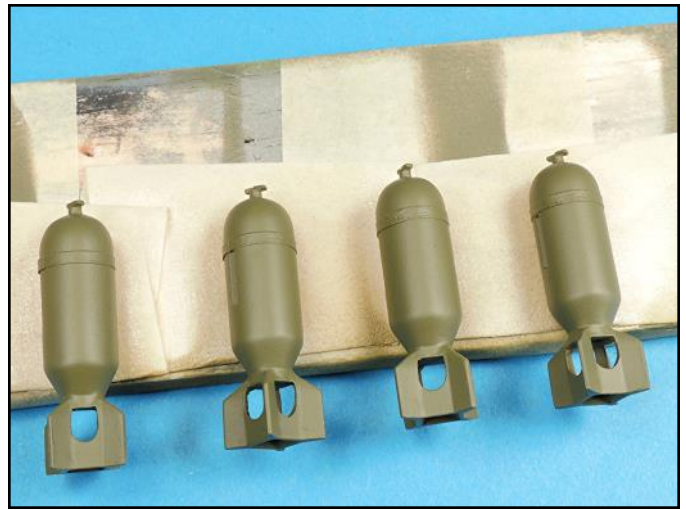
The bombs were then airbrushed olive drab.

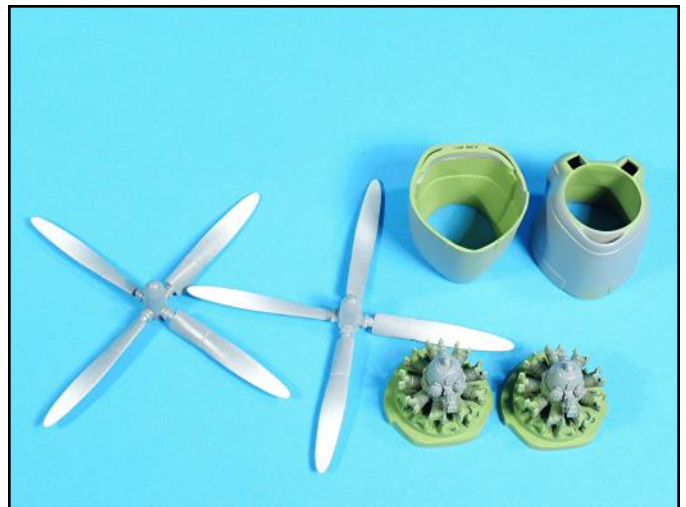
The propeller tips were airbrushed flat white first, and the inside areas of the cowling and the backsides of the engines were airbrushed zinc chromate green.
