MIKE ASHEY PUBLISHING
COMPREHENSIVE SERIES SCALE MODEL AIRCRAFT MANUAL
NUMBER 4

**BUILDING AND DETAILING THE TRUMPETER 1/32 SCALE
P-38 LIGHTNING**

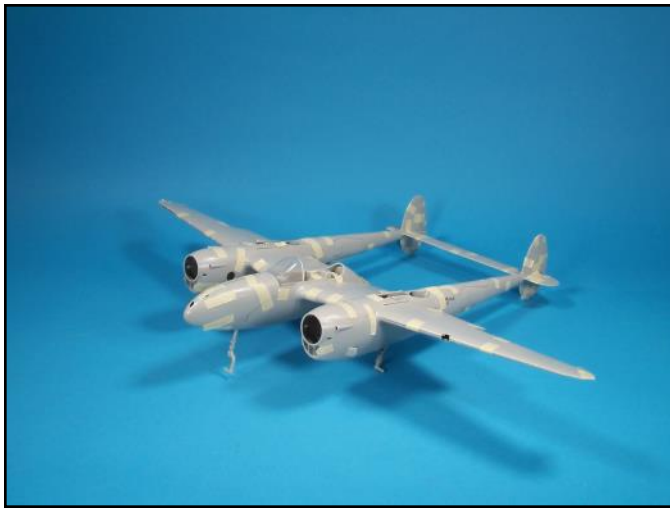
The initial test fit of the kit showed that there were no alignment issues between the booms, which is a typical problem with many P-38 kits. Notes were made on the kit's instruction sheet where voids and fit issues were identified.

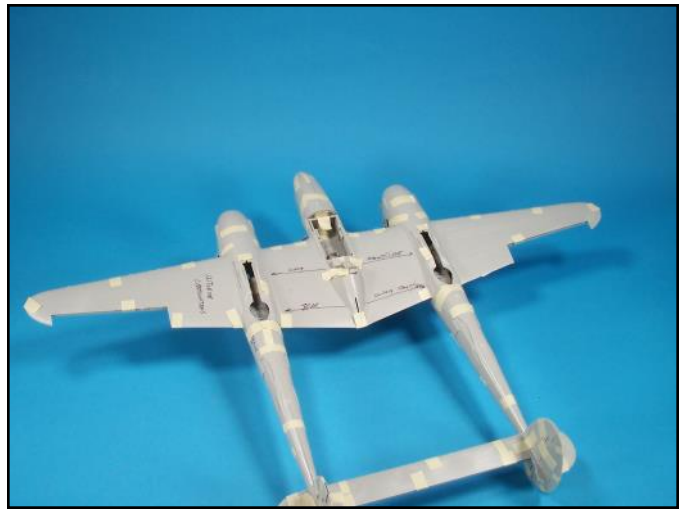
There was considerable flexing between the center fuselage and the engine booms due to the thin plastic. I like to add notes to the surface of the model to identify where reinforcement is needed.

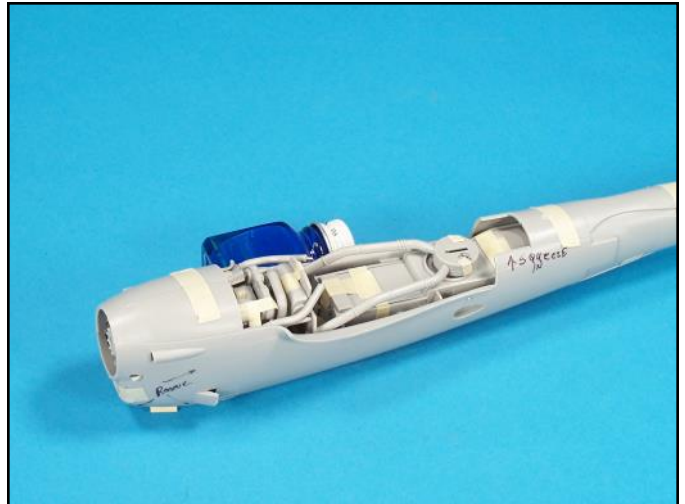
With the booms taped together, all the interior parts fit together without any alterations to the booms. Here again I made notes on the surfaces of the plastic.

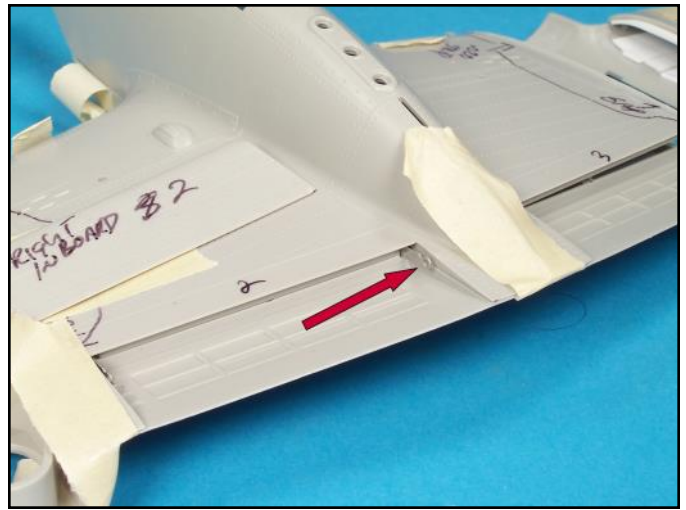
The metal strips were test fitted to be sure that nothing interfered with their positioning.

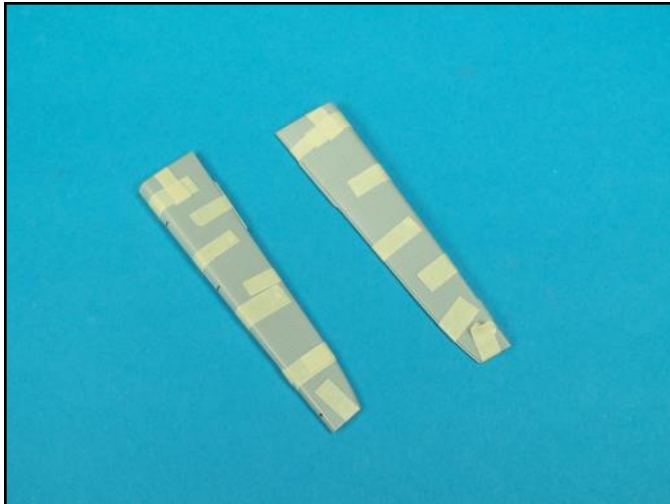
Tiny beads of super glue were applied along the seam lines of the ailerons between the tape. After the glue dried, the tape was removed and additional glue was applied. The seams were then carefully scraped and sanded smooth.

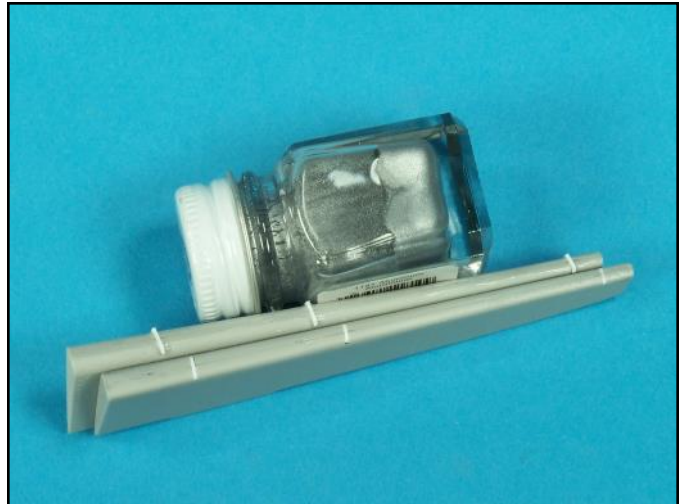
The inside areas of the ailerons had grooves for hinges. These were filled with plastic strips.

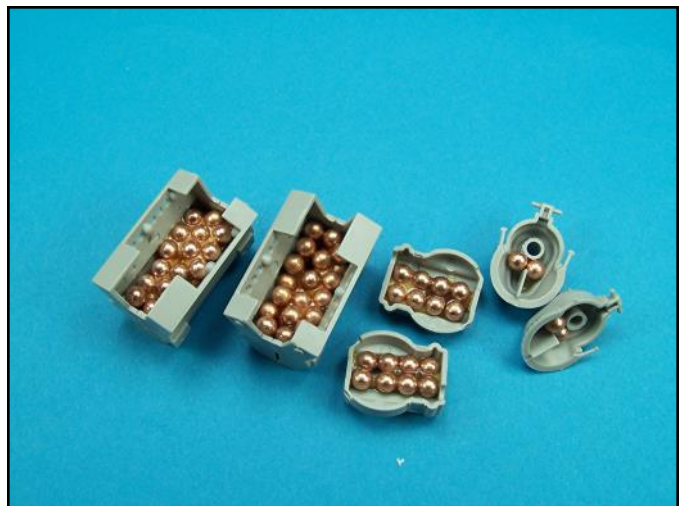
The engines are forward of the center of gravity of the model so I started adding weight using their interior areas. The copper bee bees were glued into place with Elmers white glue.

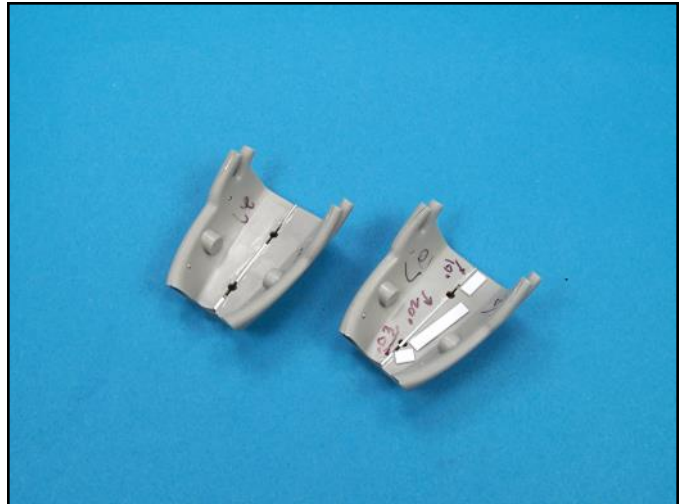
The engine saddles/air ducts needed extra plastic strips to close up the voids. The thicknesses ranged from .010 to .030 inches.

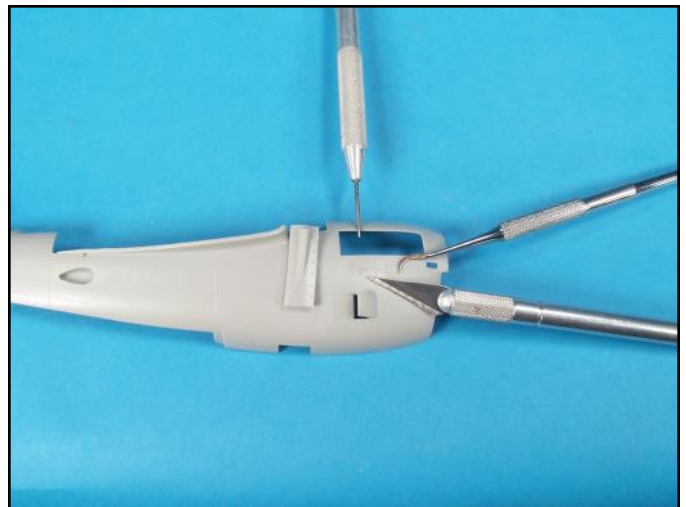
To display some of the engine on each boom, I carefully cut out an access panel on each side of the outside booms. I then thinned the plastic around the cut out areas by scrapping the surface with a number 11 X-Acto blade.

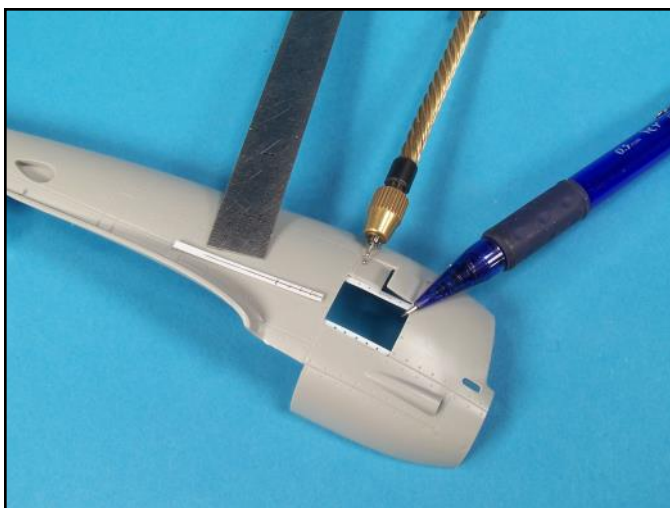
Interior framing for the access panel quick release fasteners was made from .015 inch thick strips. The holes were measured, marked and then drilled out. I also cleaned up and thinned the already opened vent flaps.

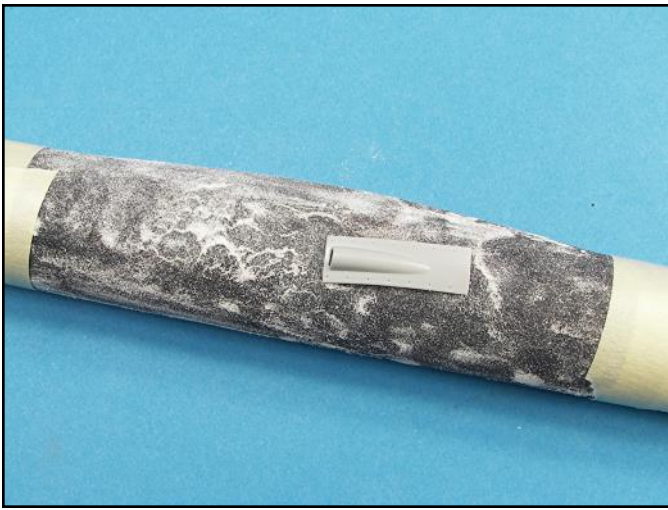
The air scoop panel was thinned out by running it across a wood dowel wrapper with sandpaper.

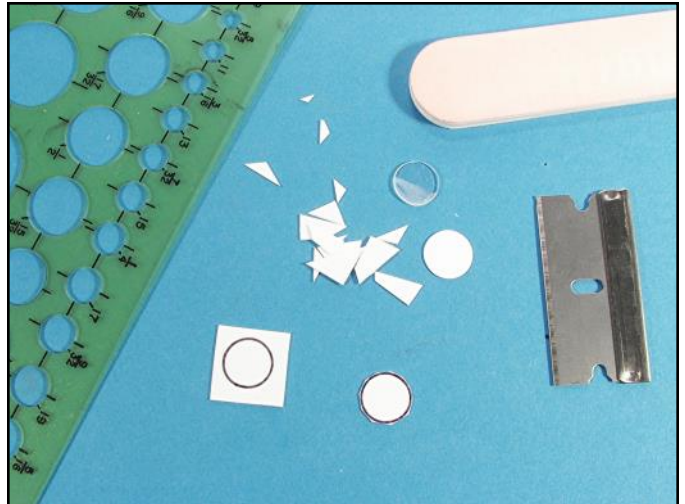
The reflective mirrors on the inside areas of the booms were slightly distorted due to the tree tabs so I made new ones. It took several tries before I got a perfect round shape.

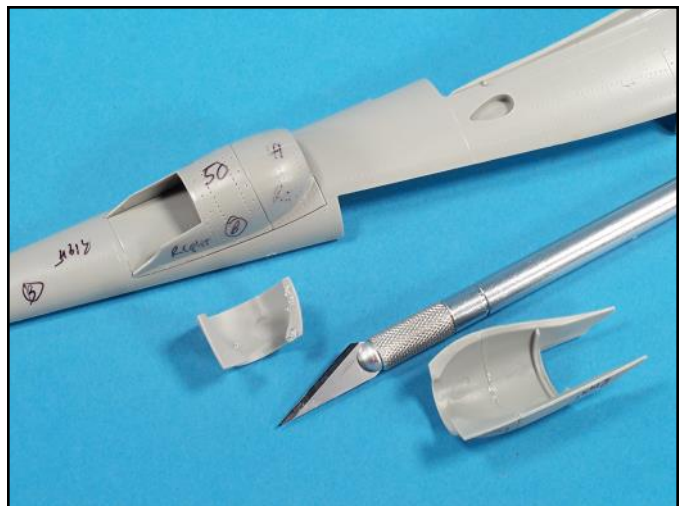
The gluing surfaces of the boom side scoop parts had to be flattened and adjusted to get them to fit into the depressions on the boom surfaces.

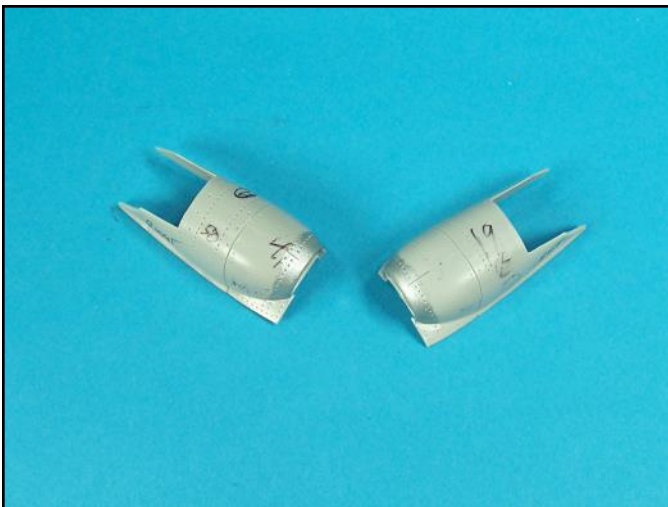
Silver paint was applied to check for flaws. Some areas needed additional super glue.

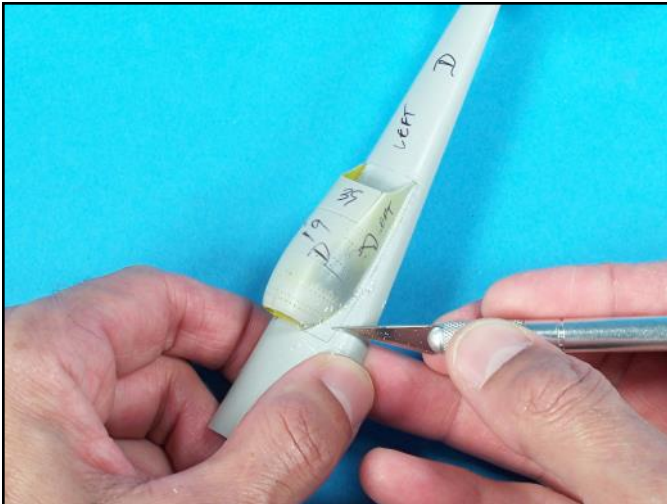
The seams were filled with super glue and then the edges were carefully scraped flat. Be careful not to let the tip of the blade gouge the air scoop.

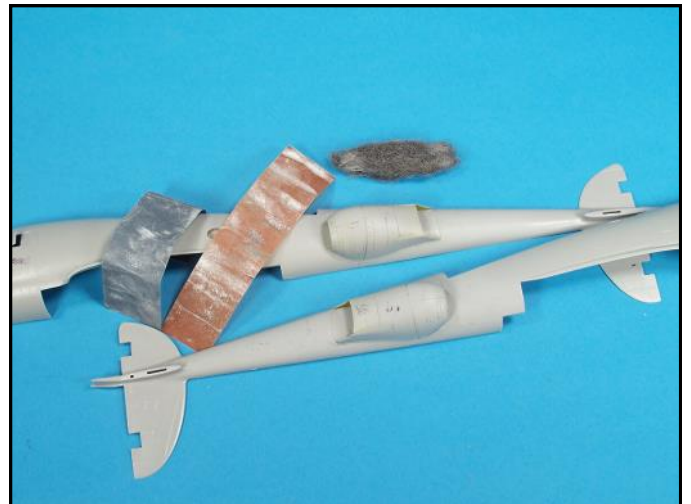
The surfaces on the air scoops and the surrounding surface of each boom was carefully wet sanded smooth and then polished with 0000 steel wool.

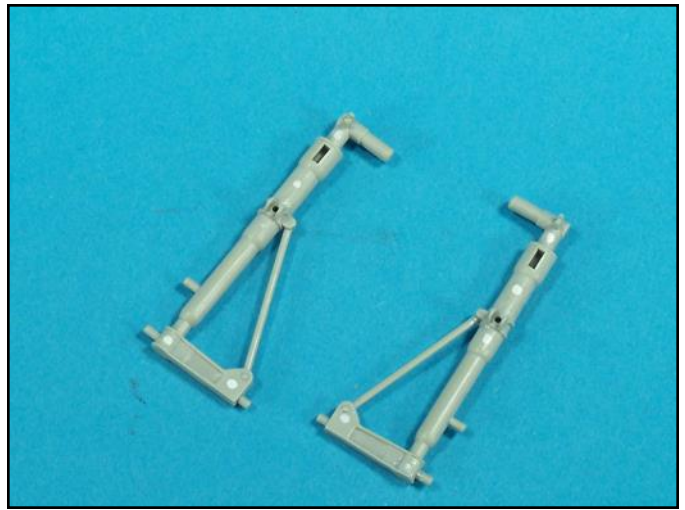
The landing gear had round depressions. I drilled the depressions to a slightly deeper depth and then filled the holes with a corresponding diameter rod. The rods were then cut and sanded smooth.

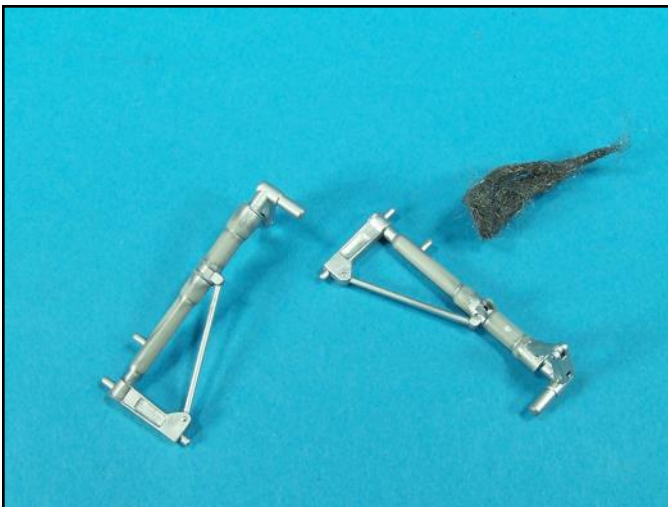
I painted the landing gear with silver paint to check for additional flaws. Having found none, I polished the plastic with 0000 steel wool.

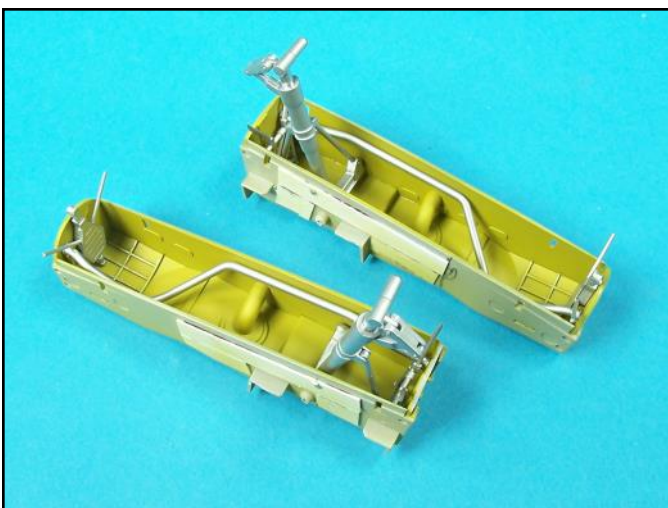
The remaining landing gear parts were airbrushed, the raised interior surface detail of the landing gear bays dry brushed, and then everything was glued together. Note the plastic sheeting laminated to the outside areas for added strength.

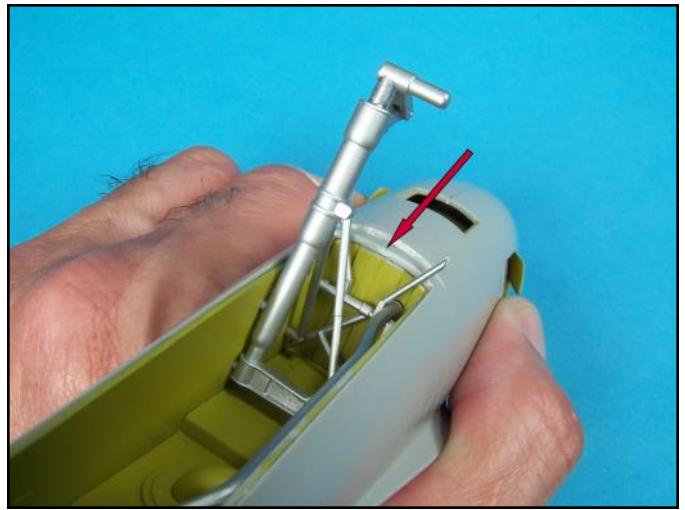
There were tiny voids between the bottom areas of the landing gear bays and the booms. These areas were filled with white glue applied with a .015 diameter stiff wire and contoured with a damp Q-Tip.

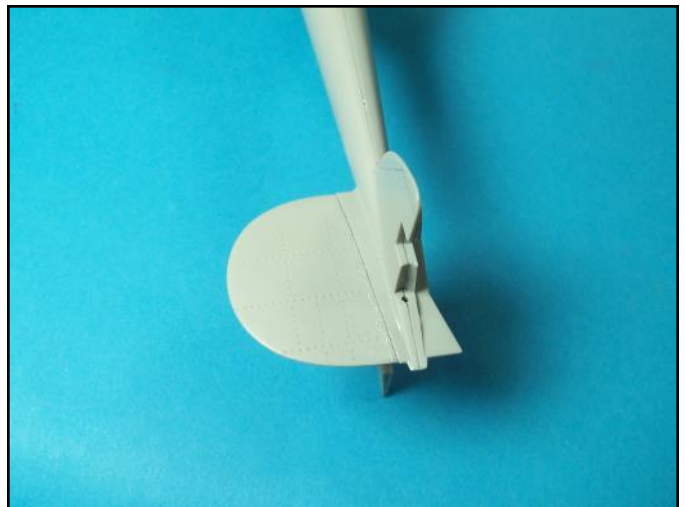
The outer elevator wings were glued into place with Testors tube glue so that minor adjustments could be made to their positioning. The voids were filled with super glue.

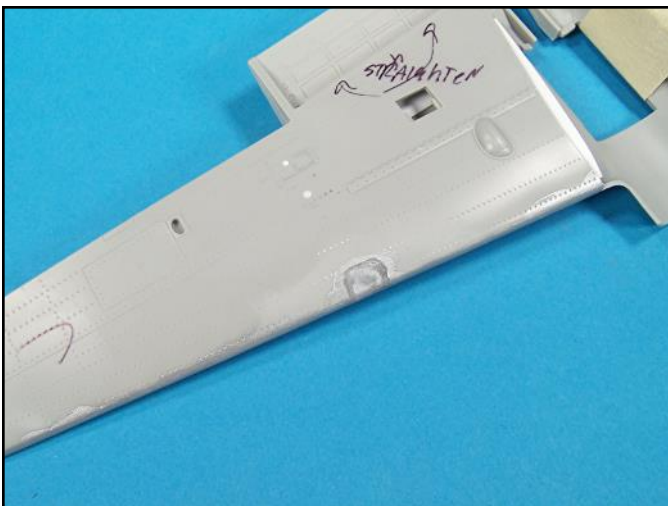
Note the additional super glue applied along the seams after silver paint was applied to detect flaws.

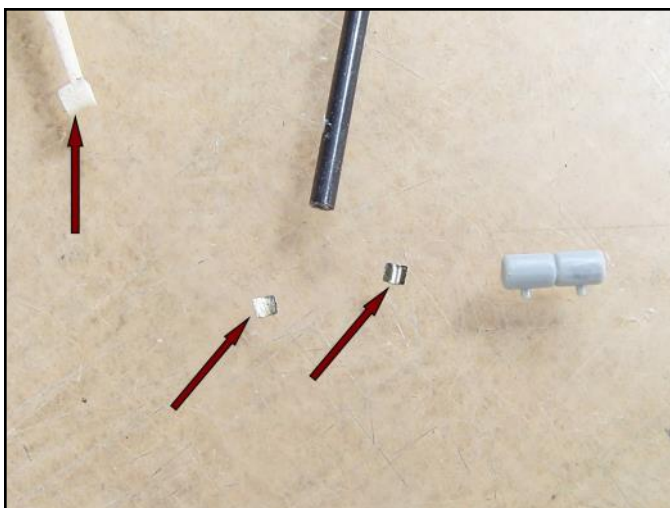
These small name plates were shaped by rolling a Drill bit end across the part. Use a slightly smaller diameter for rolling so that the photoetch parts will fit snugly into place.

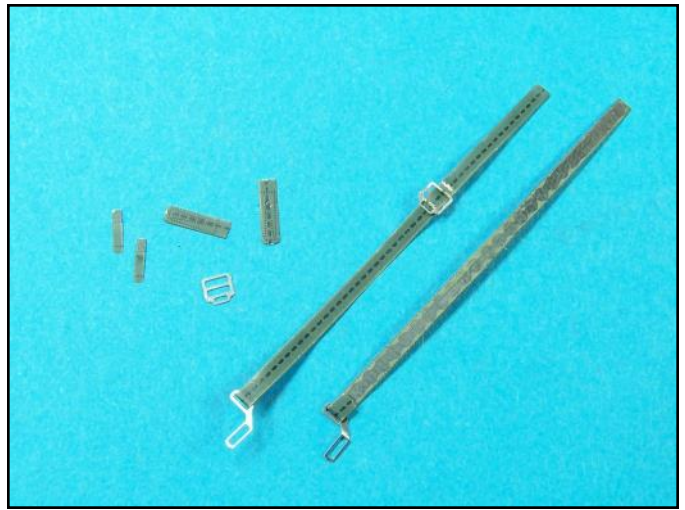
Positioning the adjustment buckles on the long shoulder straps can be very tedious and you need to be careful to not scrape off the paint.

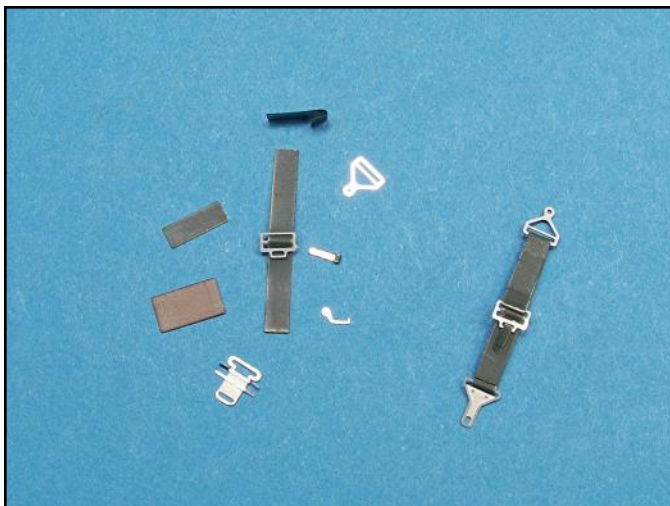
These lap seat belts have several pieces and you have to be very careful when bending the ends of the belts for the locking buckles.

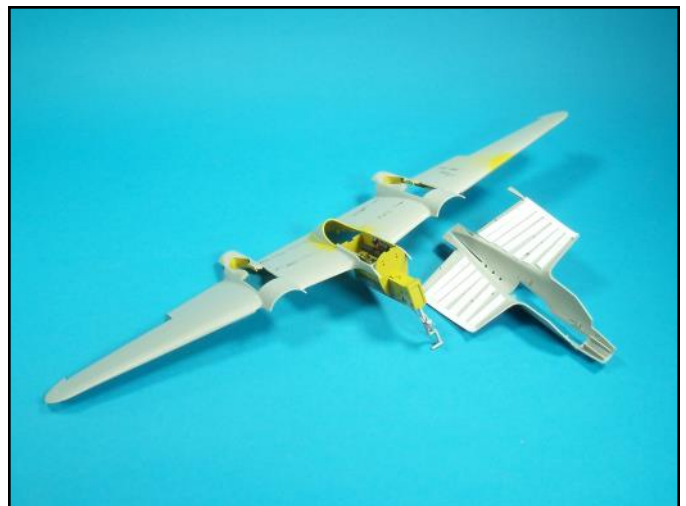
The cockpit was test fitted to be sure that it did not interfere with the upper and lower fuselage after they were taped together.

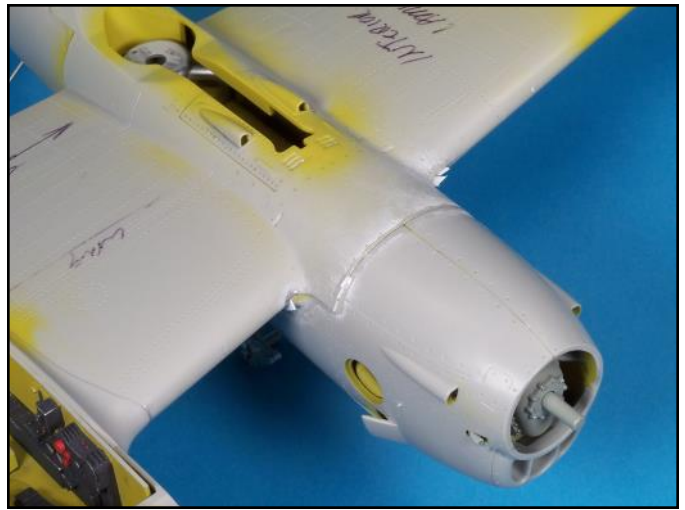
There were tiny voids between the boom and wing connections that were filled with different thicknesses of plastic. It took several applications of super glue to fill the seams. The seam lines were scraped and wet sanded smooth.

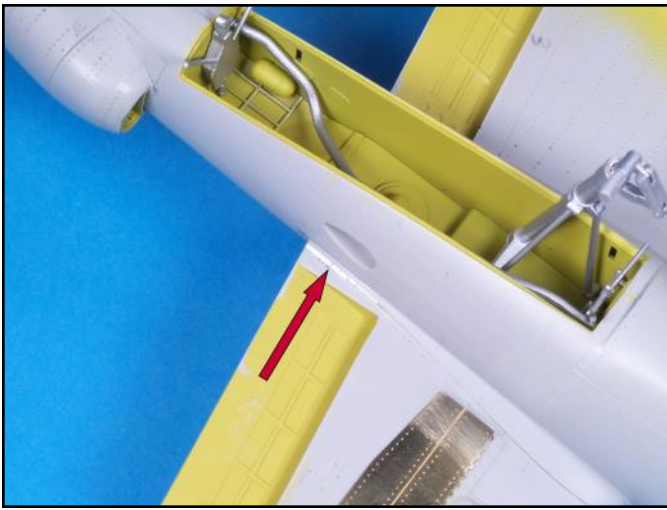
The voids were filled with tiny strips of plastic and super glue was applied to the entire seam line. The seam was then sanded smooth with wet, fine grit sandpaper wrapped around a length of thin balsa wood.

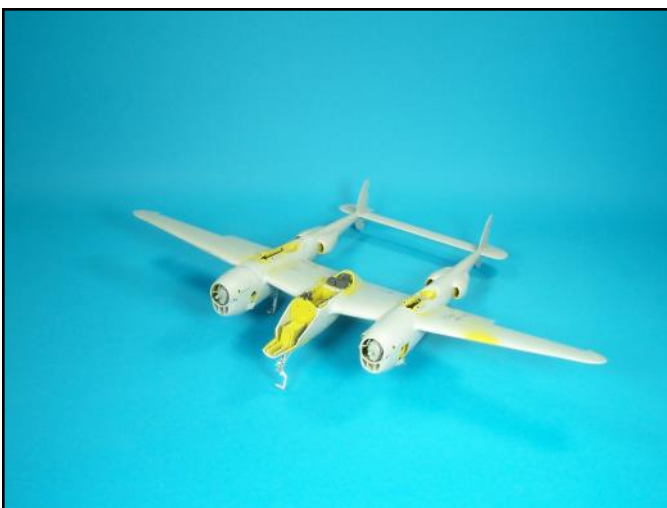
The seams and voids along the boom to wing connection points on the starboard side were the same as on the port side.

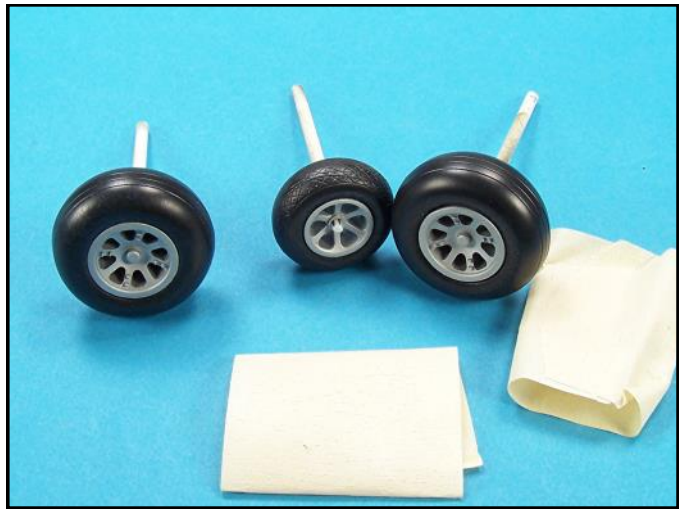
The wheel rims were airbrushed with metalizer aluminum and then glued into place. The flexible tires were perfectly cast, however they were dust magnets. Masking tape was used to remove the dust.

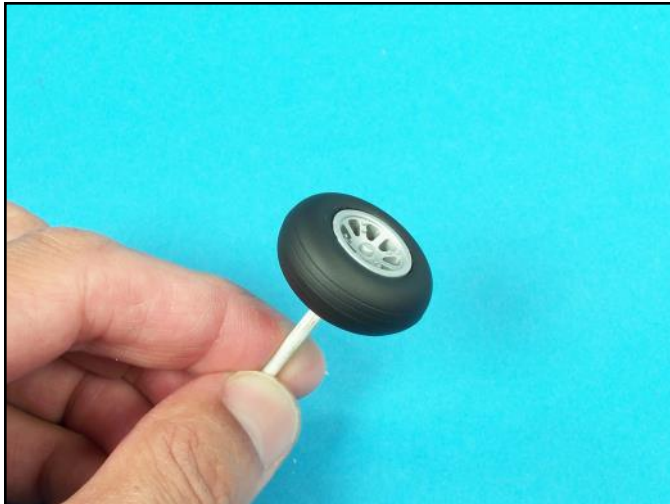
Once the dust was removed with masking tape, they were then immediately airbrushed with a clear flat finish to seal the flexible tires and tone down the metalizer color.

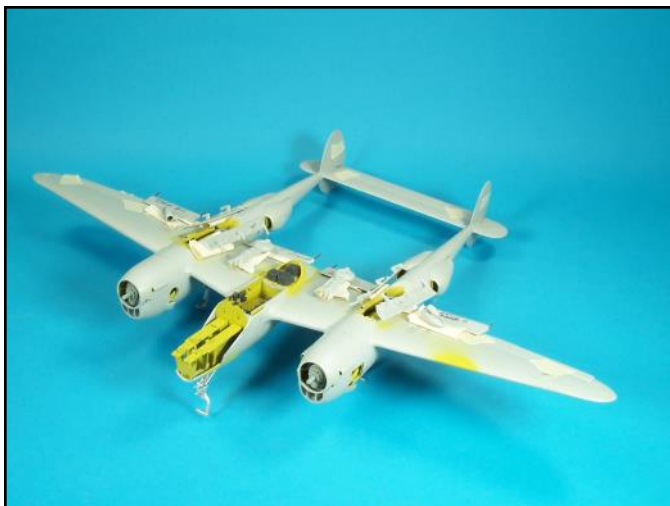
Since I planned to fill the nose with weight I started taping parts at their approximate locations on the upper wind to help determine the proper amount of weight that will be needed.

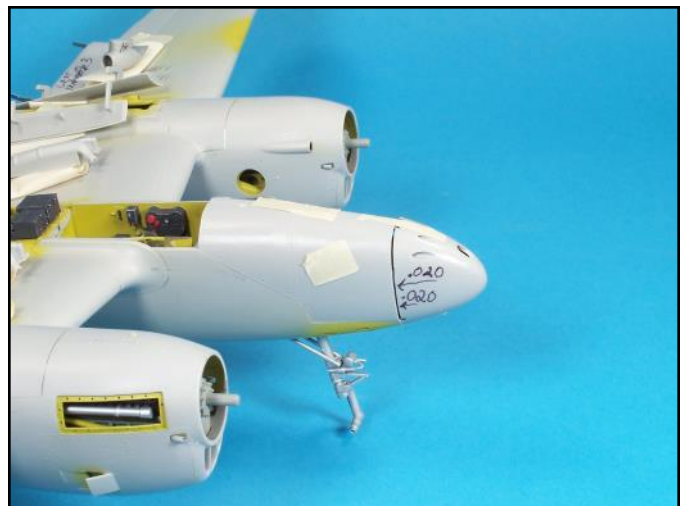
I also taped the nose and the forward fuselage halves in place to check the fit and made notes on the parts. There were voids on these parts that will need to be filled with plastic strips once they are glued into place.

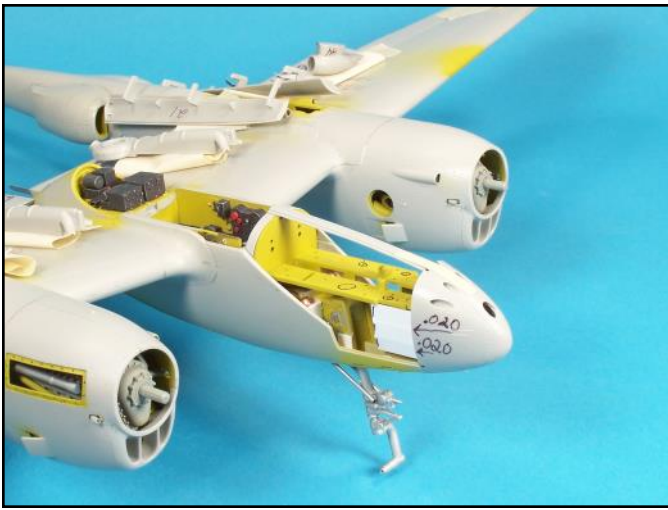
With the forward fuselage panels removed I started to add weight. I flattened fishing weights and then cut and shaped them to fit inside the tight areas of the forward fuselage.

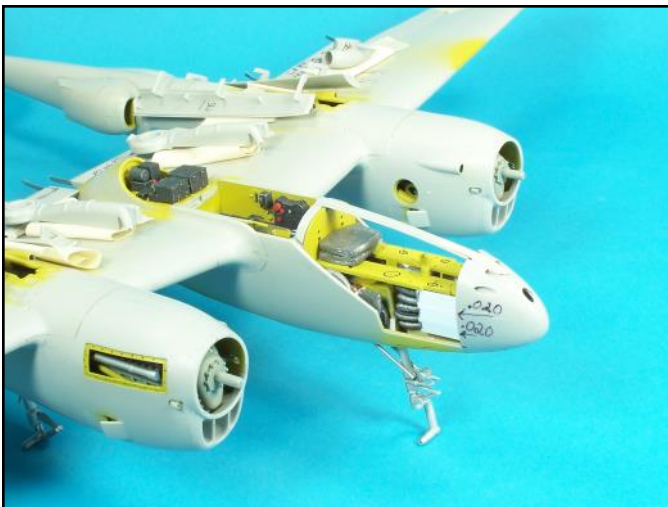
With the weight added, the aircraft seemed to be properly balanced on its landing gear.

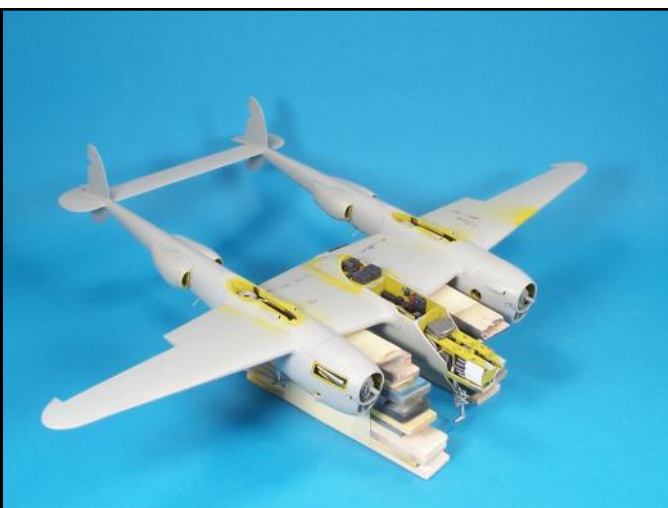
With the weight issue addressed I made two cradles out of balsa wood to complete the construction of the fuselage nose area.

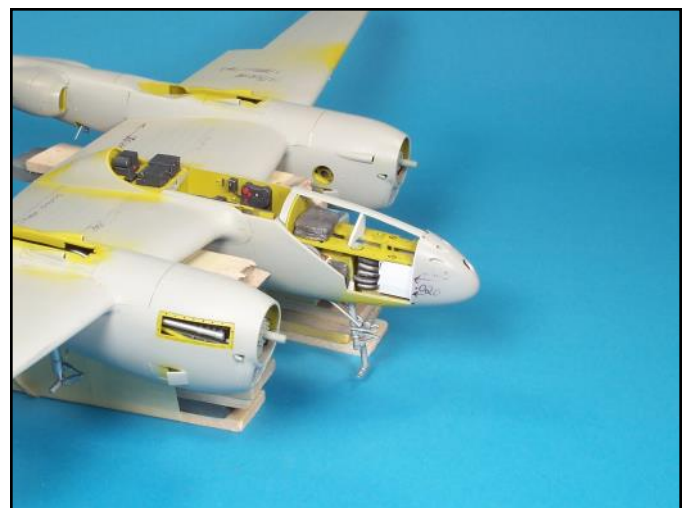
Additional plastic was added to the starboard side of the nose to fill the void and then the nose and upper frame were glued into place.

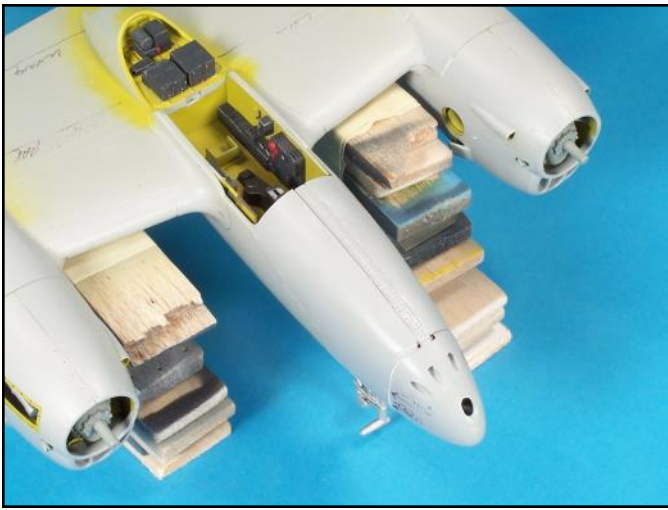
The forward fuselage panels were then glued into place.

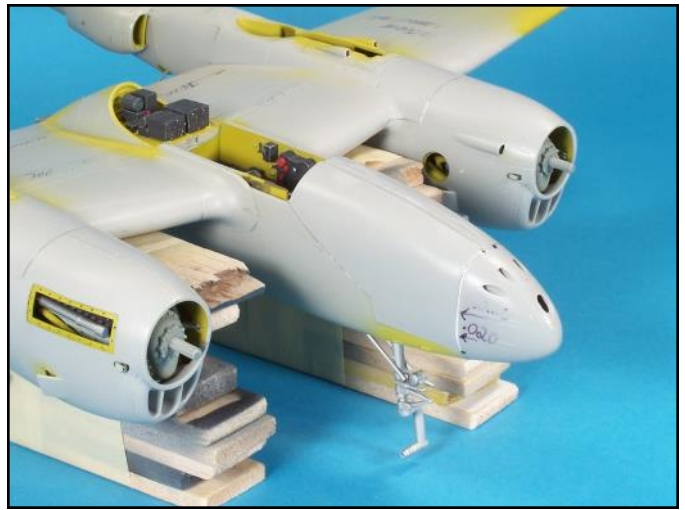
There are misalignments between the upper forward fuselage panels and additional voids along the seam area where the forward fuselage halves meet the lower fuselage.

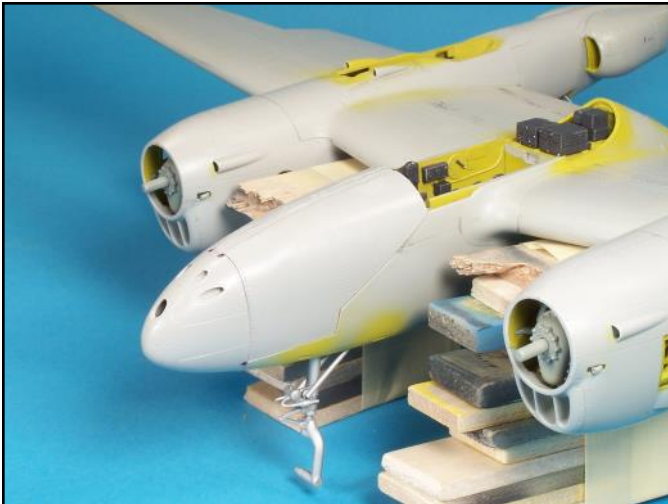
The portside forward fuselage panels were slightly worse than the starboard side.

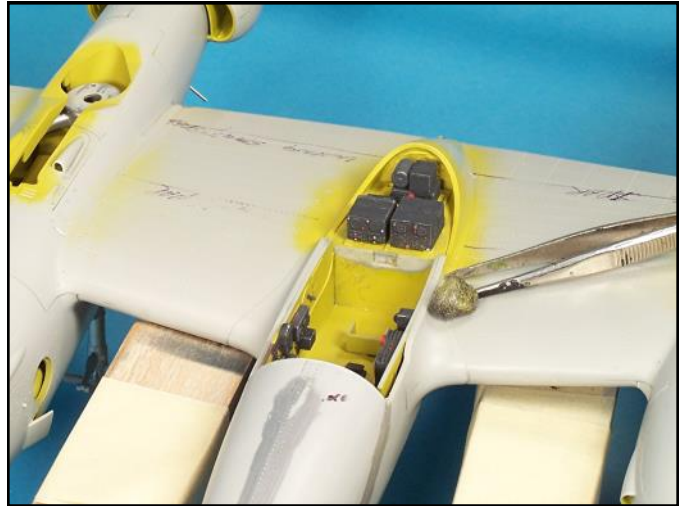
The seam between the cockpit tub and the electronics shelf was carefully filled with tiny drops of super glue and then scrapped smooth. I used a tiny ball of 0000 steel wool to polish the plastic and smooth it out.

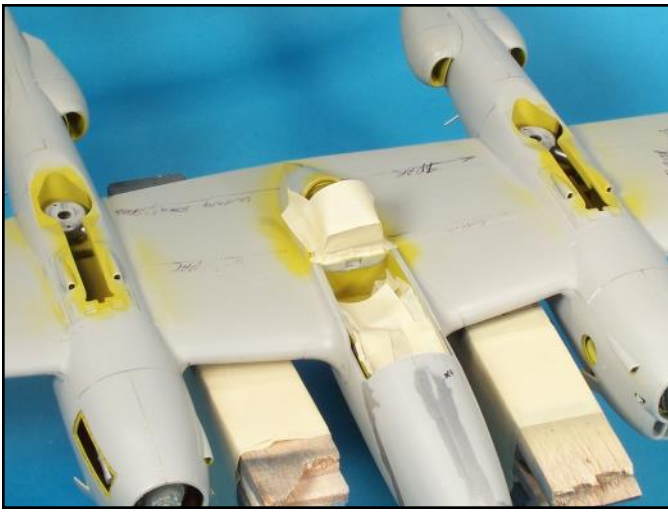
The cockpit area was then carefully masked for airbrushing the seam area.

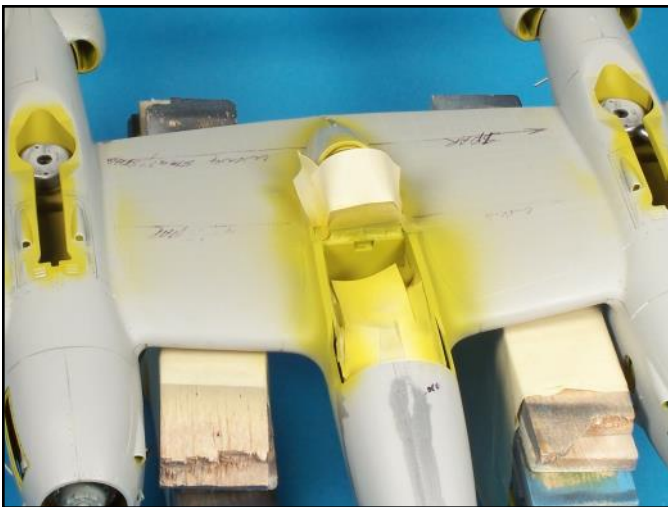
The area was then airbrushed with zinc chromate.

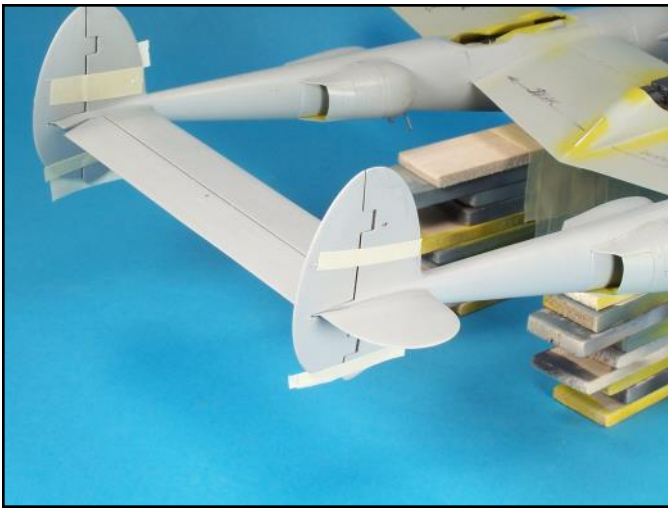
Next, the rudders and elevator were taped into place, carefully positioned and then super glued with tiny drops of glue.

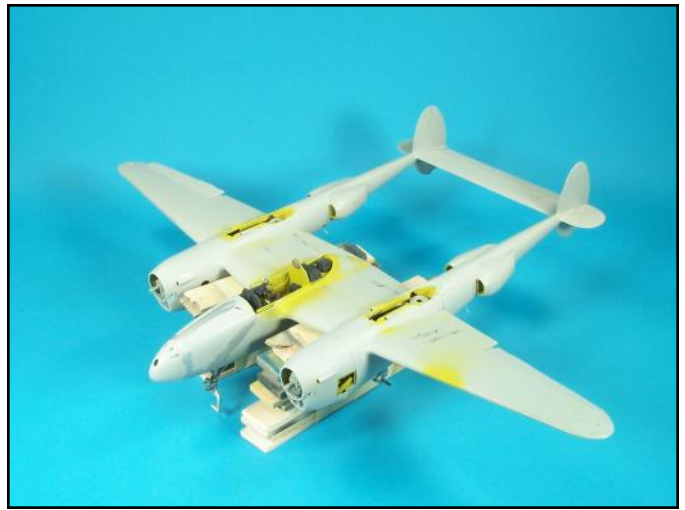
The balsa wood cradles really helped with the construction of the forward fuselage area and the aft control surfaces.

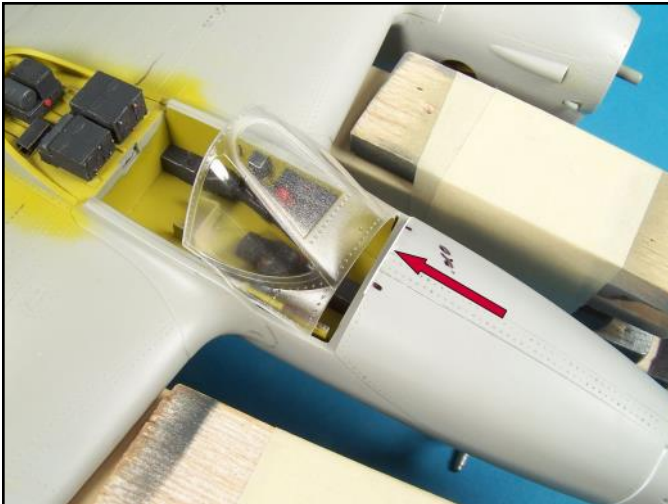
The canopy windscreen/fuselage part was test fitted.

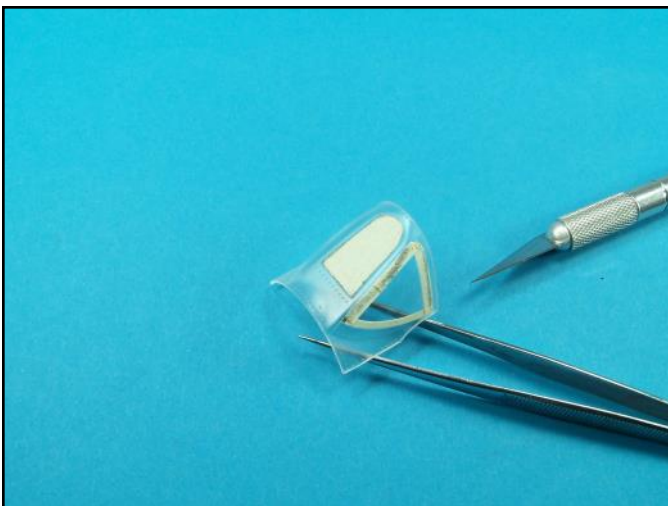
Thin strips of masking tape were applied along the edges of the framing on both sides of the windscreen.

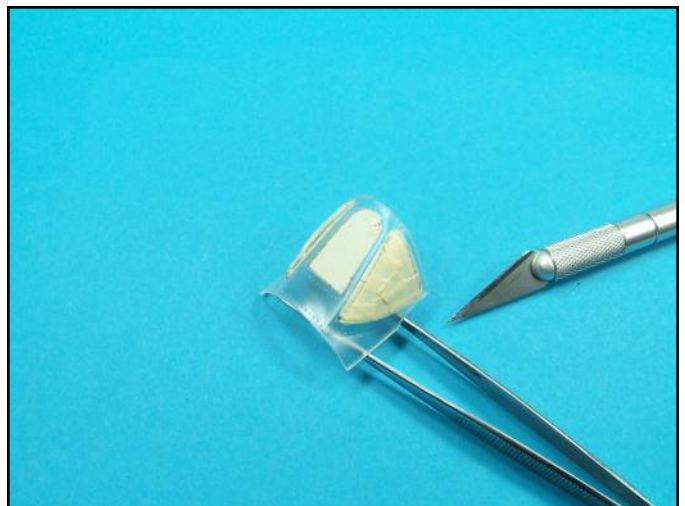
Smaller sections of masking tape were added to fill in the areas outlined by the masking tape.

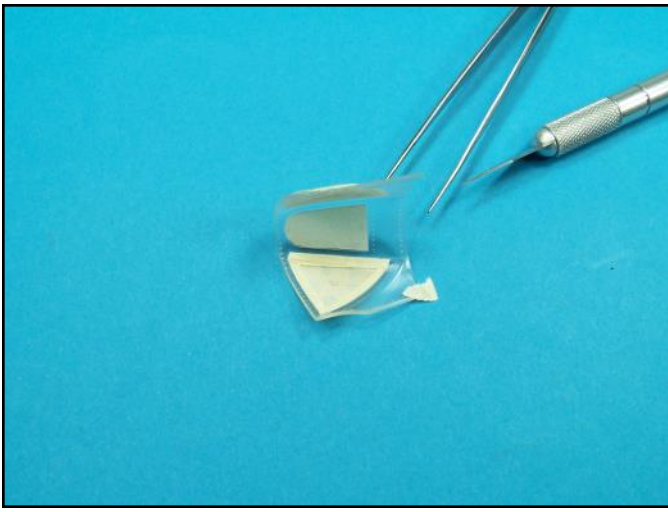
Once the outside masking was complete, the exterior edges of the masking were used as a guide for the interior masking.

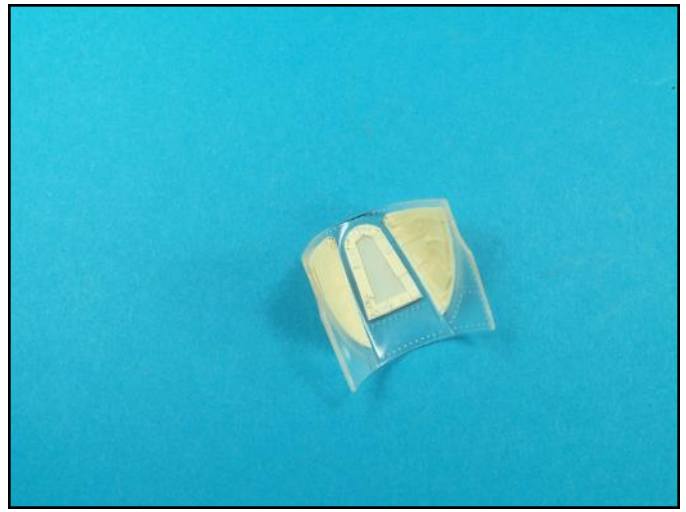
Note how tiny strips of masking tape were used to outline the center windscreen panel.

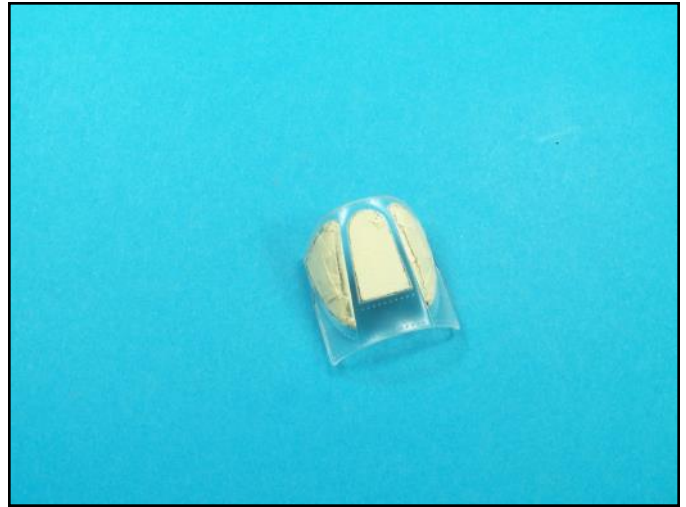
I made a final close inspection of the masking and made minor adjustments to the edges of the interior masking.

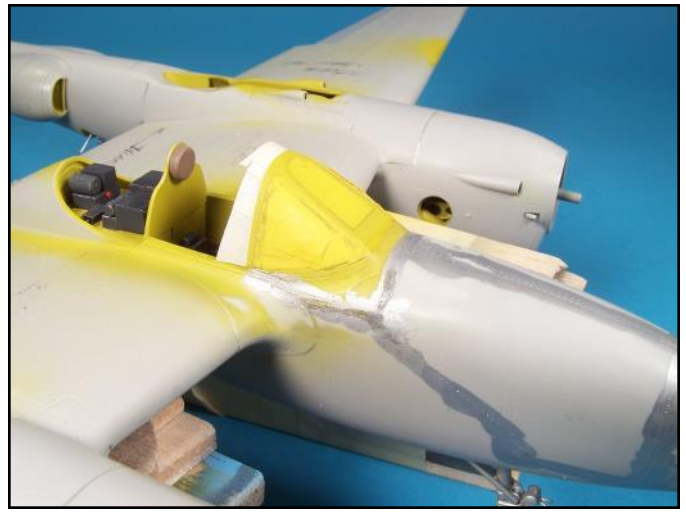
Several iterations of super glue applications and wet sanding were needed to fill the seam between the windscreen and the fuselage.

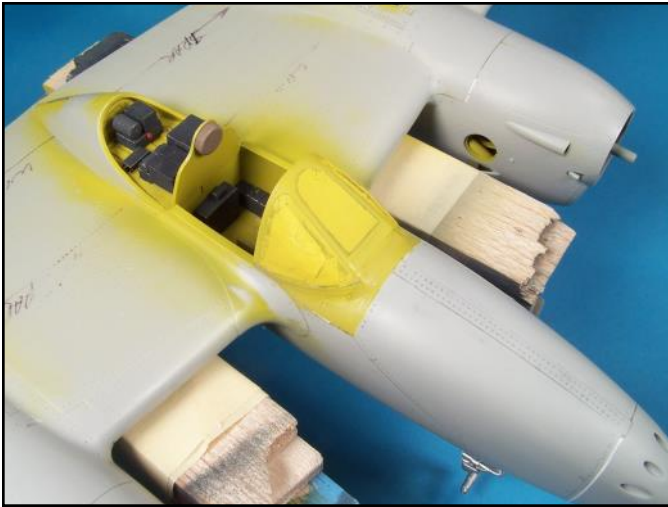
With the windscreen complete, the interior masking has been removed.

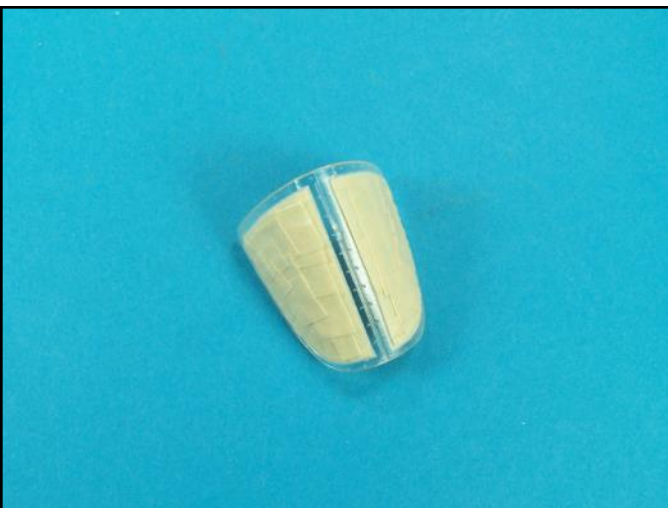
The exterior area of the aft canopy was masked first.

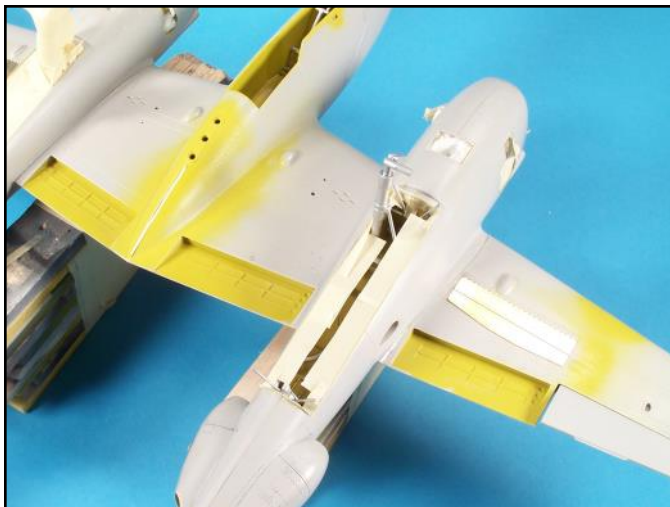
To prepare the aircraft exterior for airbrushing I started masking the landing gear bays first.

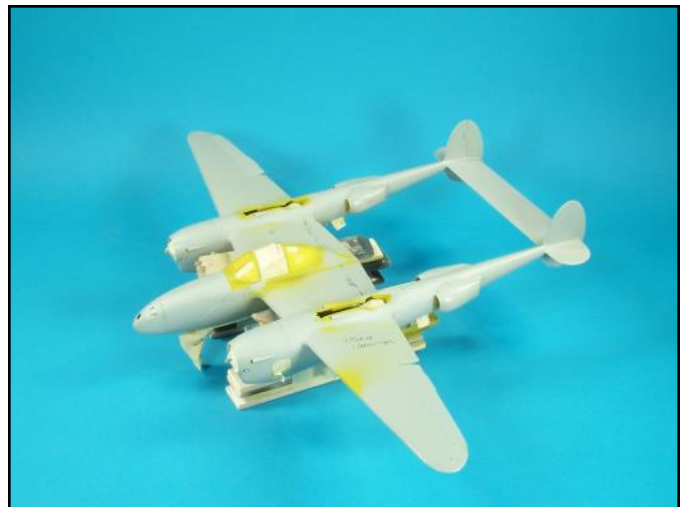
The balsa cradles will also be used for the airbrushing of the aircraft. A final check of all the masking was done prior to priming the surfaces.

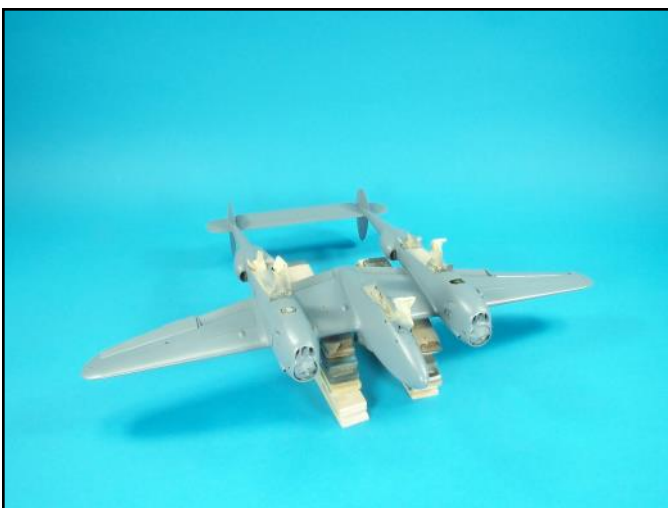
The entire aircraft was primed and a final check of the fuselage and wing surfaces was completed prior to applying the final paint colors.

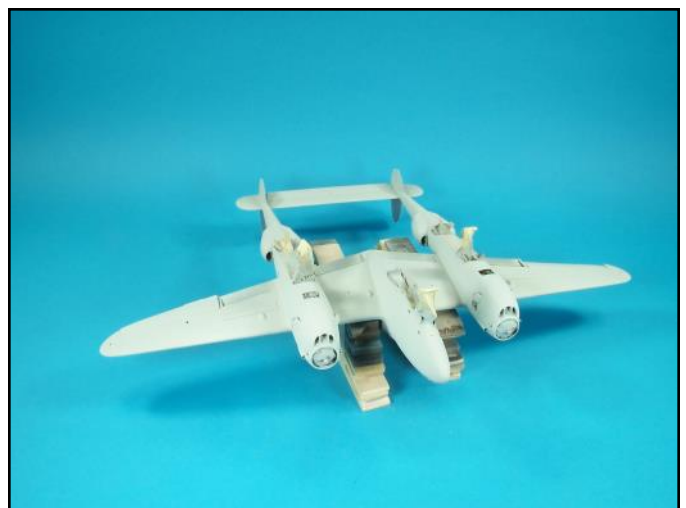
Two coats of light sea gray were applied to the underside of the aircraft. This color was also applied along the sides of the booms.

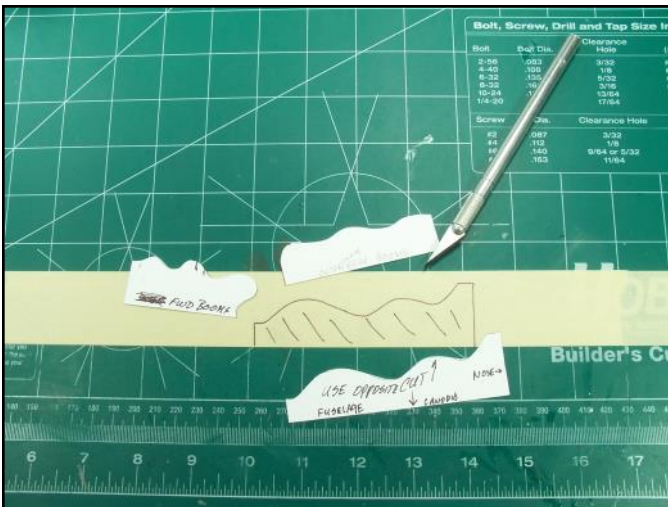
I made templates for the demarcation lines between the light sea gray and the olive drab colors with cardstock and then traced the shapes onto masking tape.

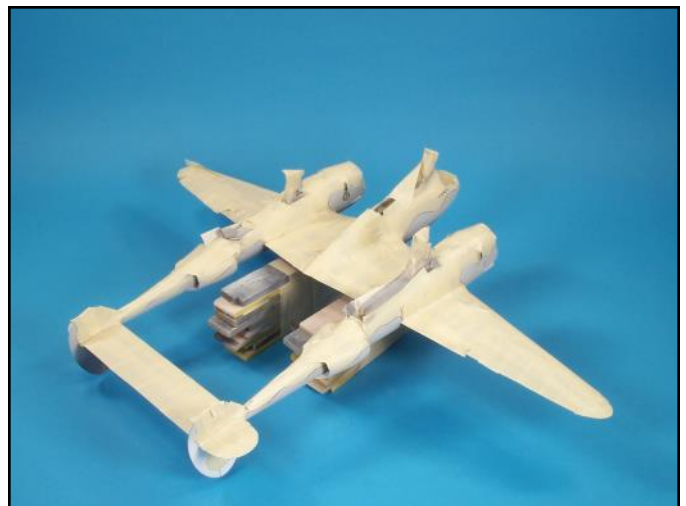
The aircraft underside and lower boom areas are completely masked and it is time to apply the olive drab color.
