MIKE ASHEY PUBLISHING
COMPREHENSIVE SERIES SCALE MODEL AIRCRAFT MANUAL
NUMBER 4

**BUILDING AND DETAILING THE TRUMPETER 1/32 SCALE
P-38 LIGHTNING**

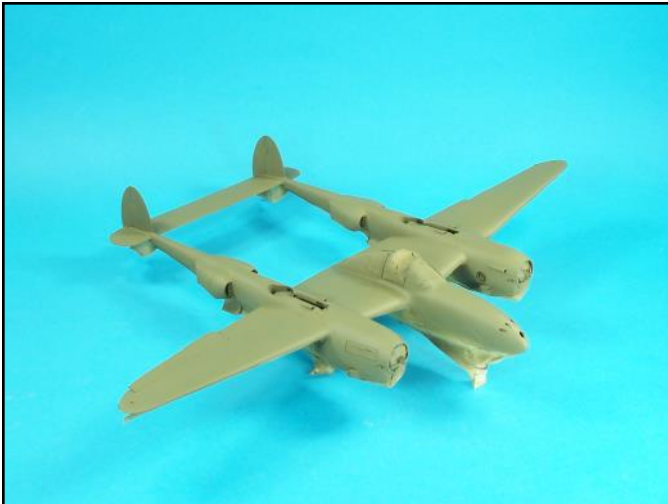
The olive drab color was slightly lightened with a few drops of flat white.

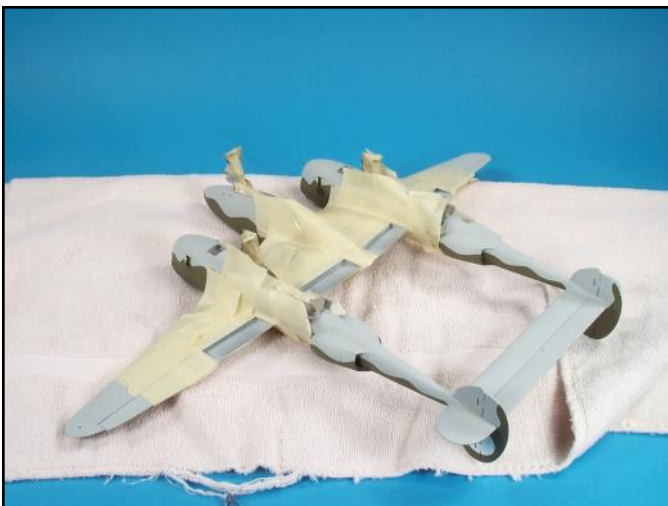
The areas around the interior flap areas were masked off and then zinc chromate was airbrushed at 15 PSI.

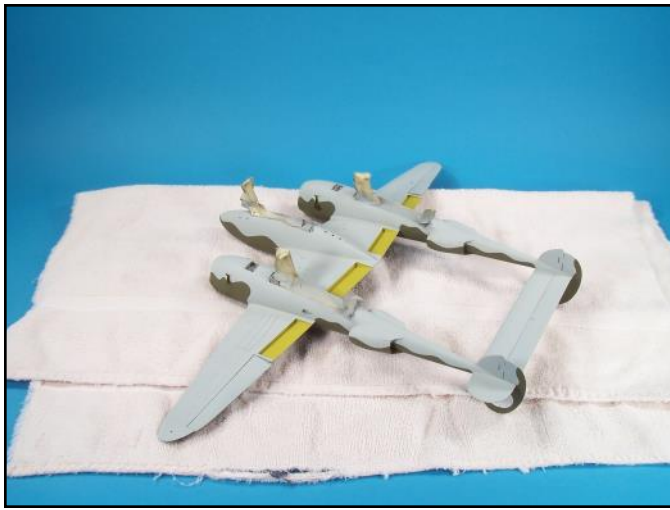
The tape around the interior flap openings was removed to check the surfaces around the flap openings for paint bleeding.

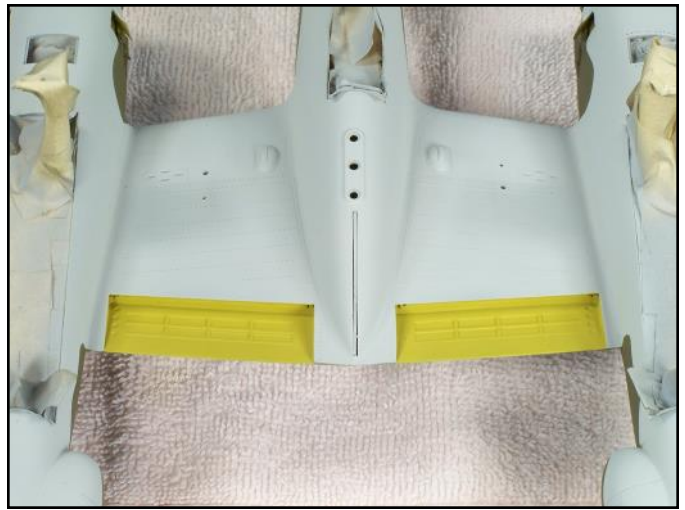
Note the sharp demarcation lines between the light sea gray color and the zinc chromate color.

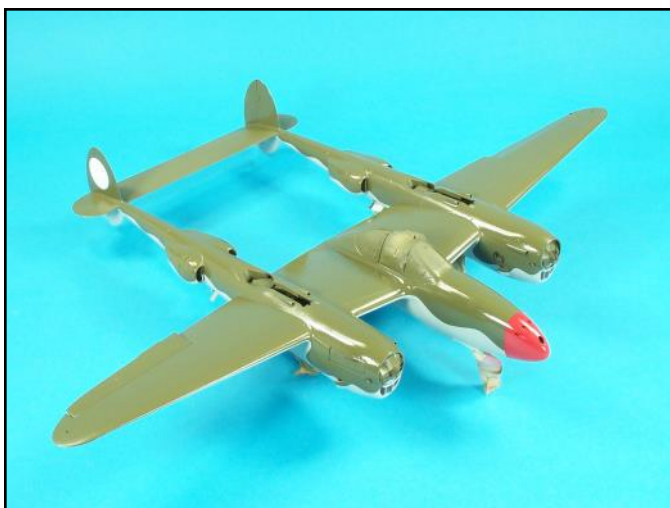
The entire surface of the aircraft was given a coat of clear gloss for the application of the decals.

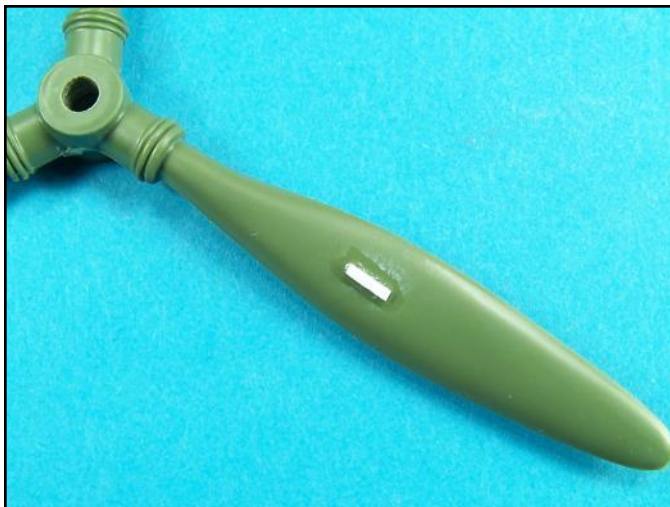
Revell P-38 propellers had a better shape than the kit's propellers, but each blade had a depression, which was filled with a small strip of plastic. The surface was then wet sanded smooth and then primed.

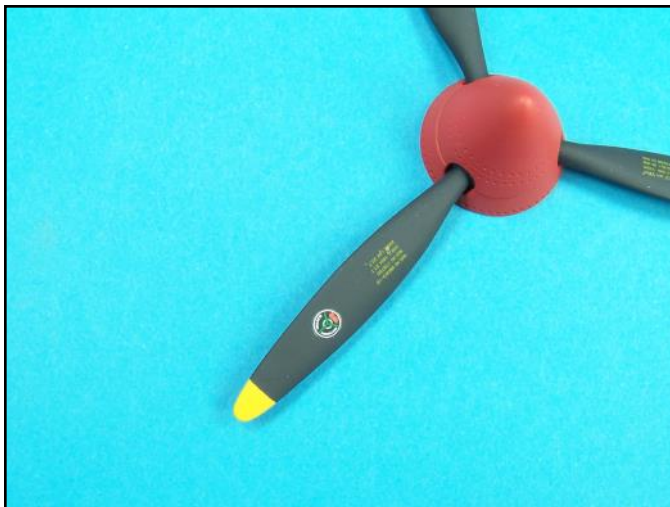
The propellers were airbrushed with a clear flat and then the hubs were airbrushed with the same flat red color as the fuselage nose area. The hubs were then glued to the propellers.

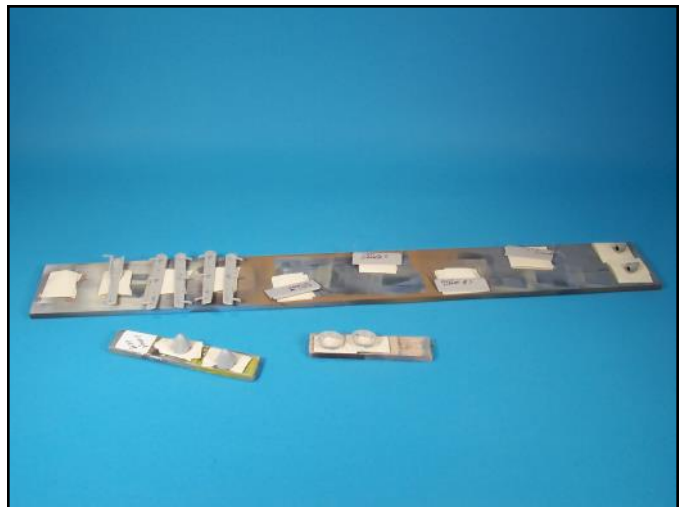
The flaps, landing gear doors and other parts were attached to a length of balsa wood and then primed.

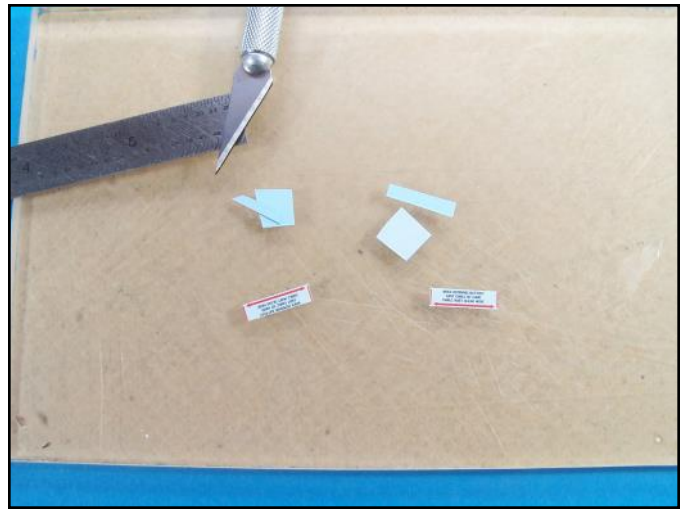
Even small decals should have as much of their clear film removed.

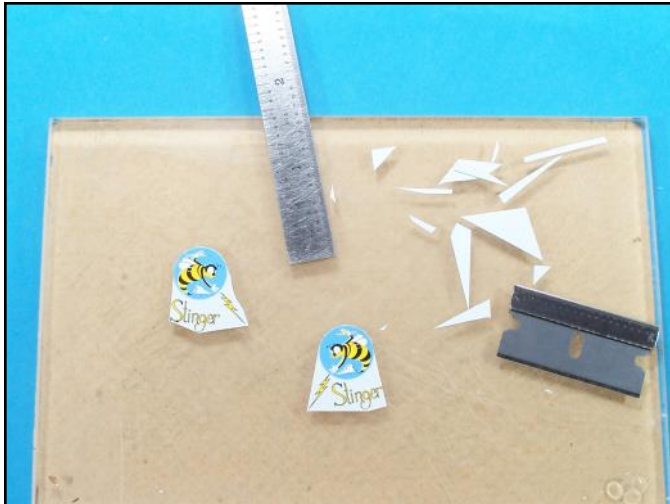
Larger decals can also benefit from removing as much clear film as possible.

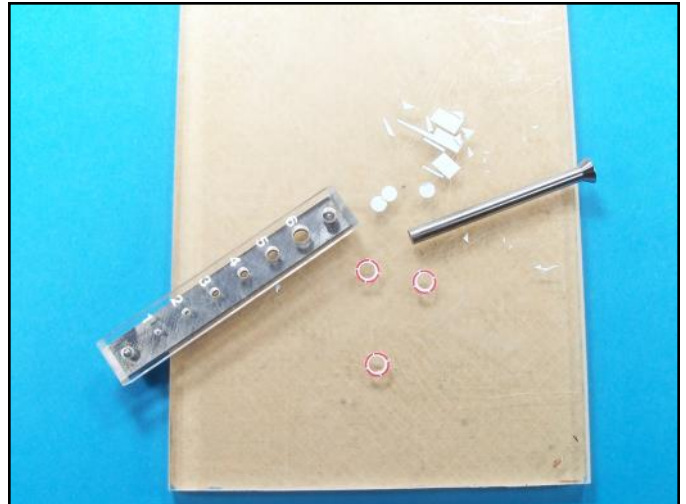
The round circles around fuel ports can sometimes silver so to prevent this from occurring, use a Waldron Punch Tool to remove some of the clear film from the center area.

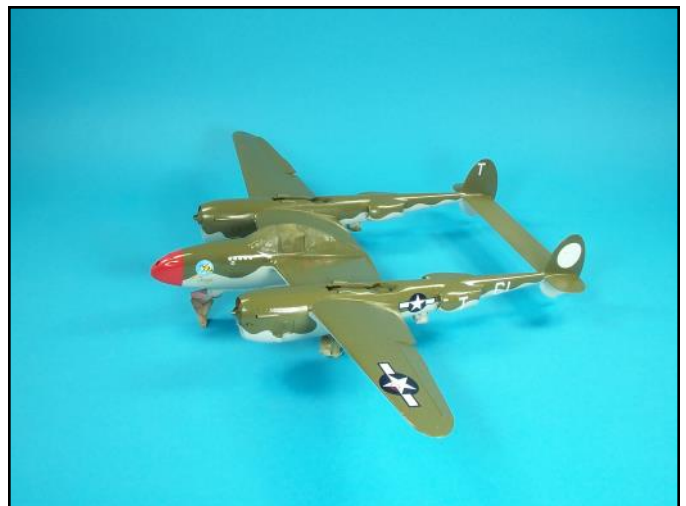
With all the decals applied, its time to seal them and restore the flat olive drab color with a clear flat overcoat.

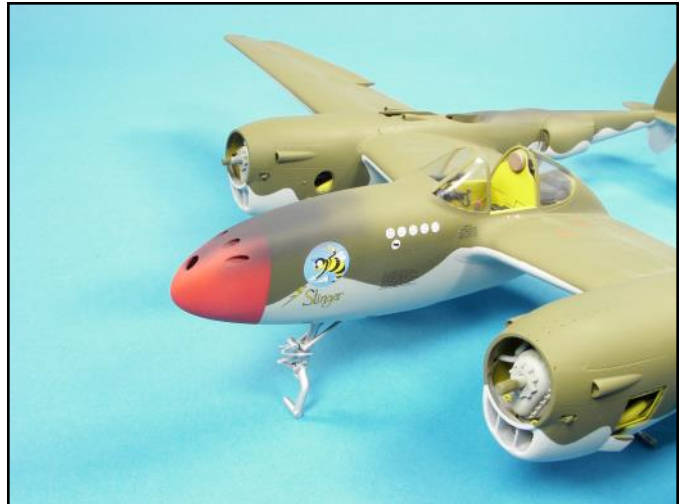
I used a slightly darker shade of flat black to represent the gun power stains across the nose area of the fuselage.

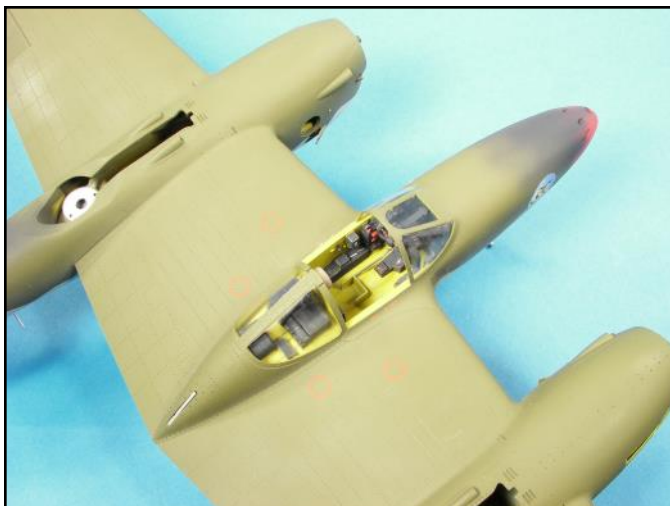
I should have applied the gun power stains in more of a streaked appearance rather than across the surface of the nose area.

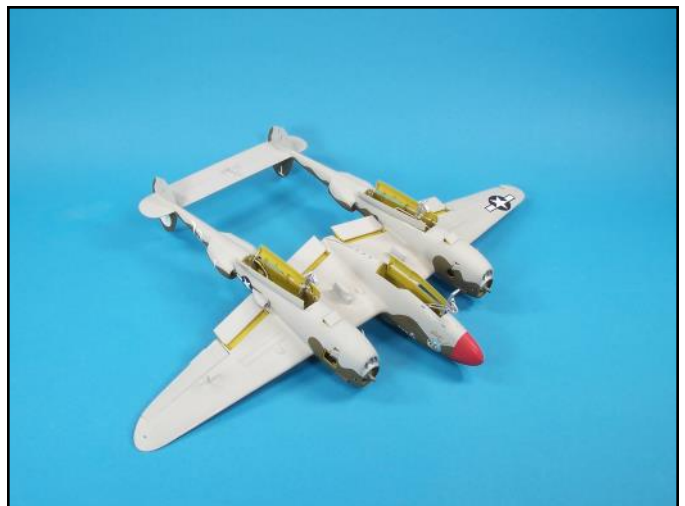
The flaps and the landing gear doors were attached with tiny drops of white glue. White glue sticks very well to flat paint colors.

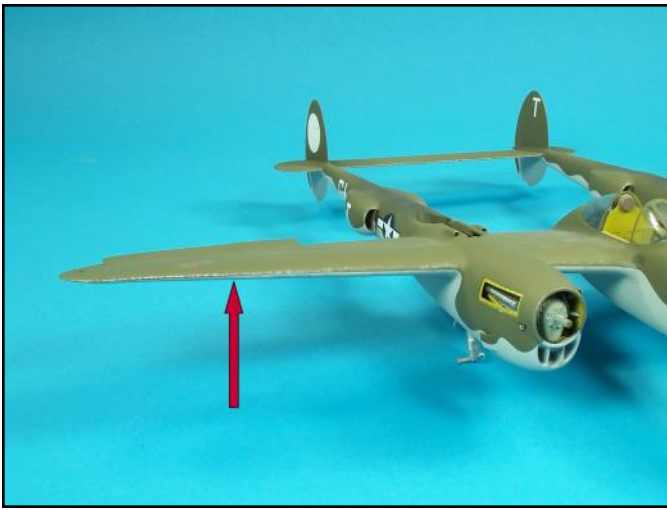
I used a small flat brush to apply tiny amounts of silver paint along the leading edges of the wings and around the engine openings.

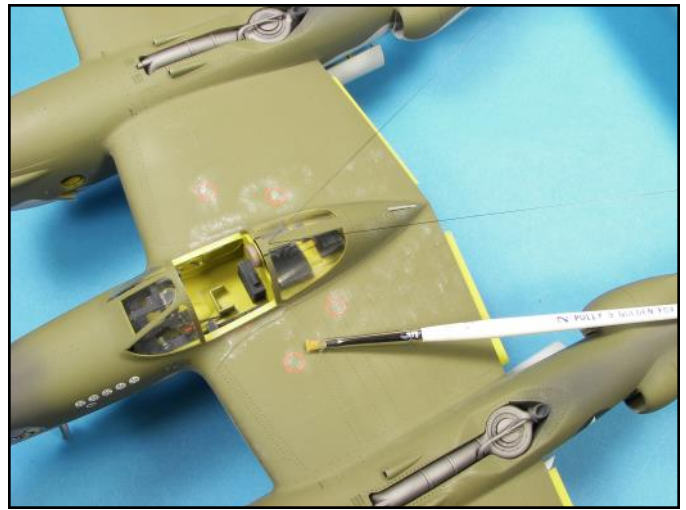
I used the same flat brush to stipple the surface of the wing areas around the canopy.

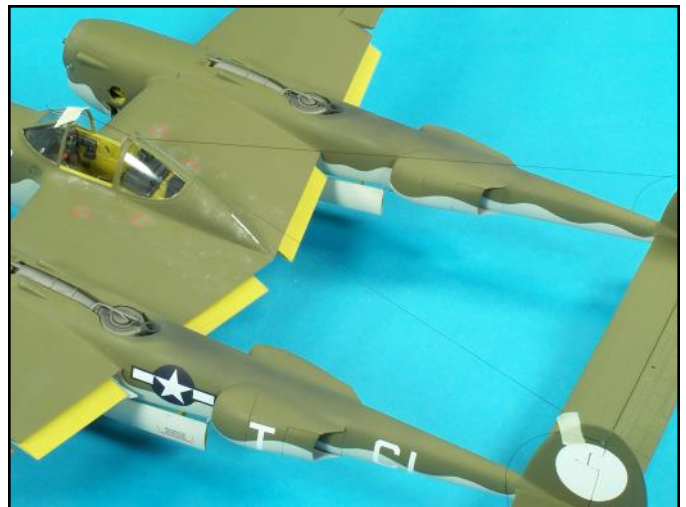
I drilled a hole through the canopy and through the tails using a .0136 (number 80) drill bitt for the antennas.

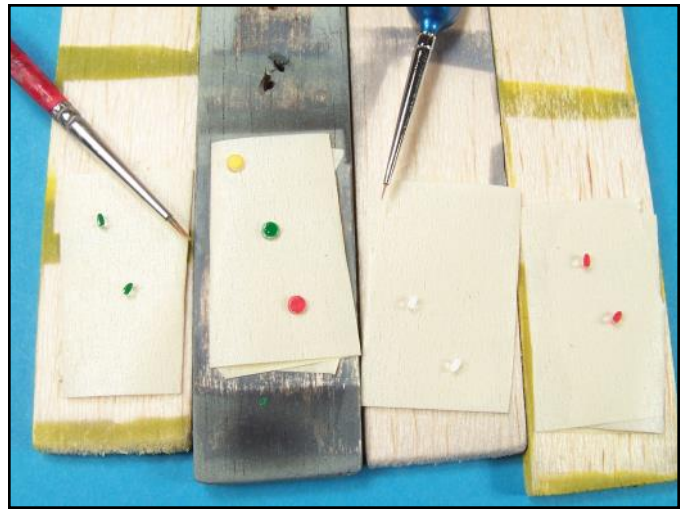
The navigation and formation lights were painted on the inside surface with a detail brush with flat yellow, red and green.

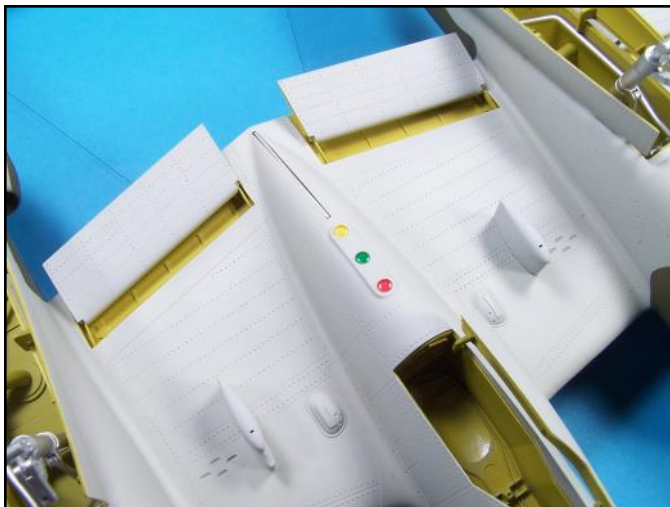
The formation lights were attached with tiny drops of white glue.

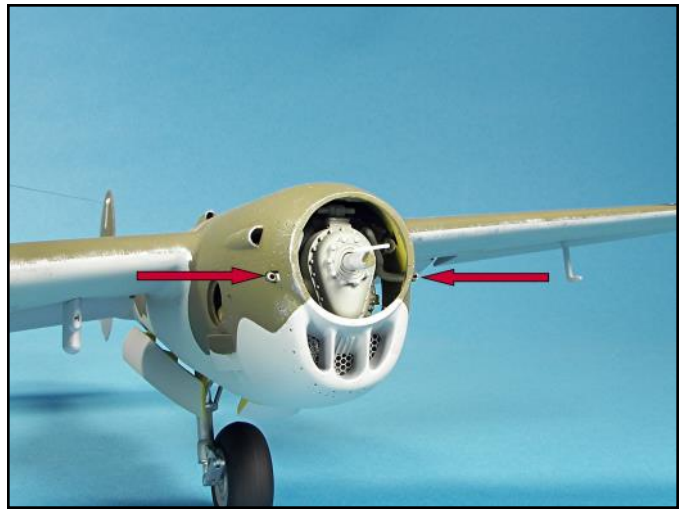
Note the hollowed out air injectors.

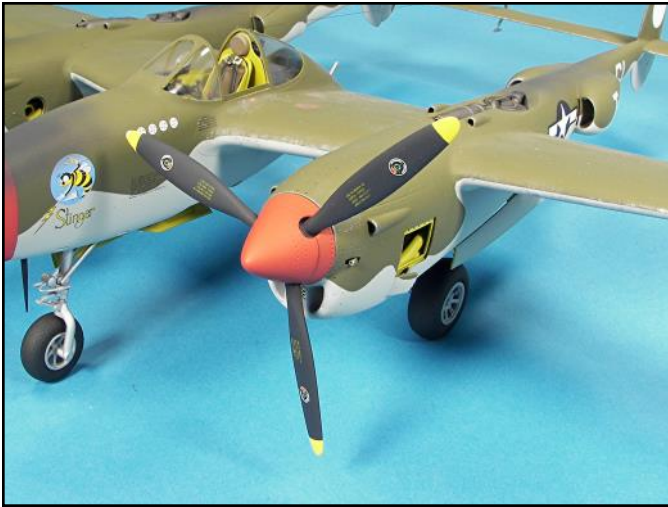
The propellers now have a tight fit. They were attached with tiny drops of Testors tube glue.

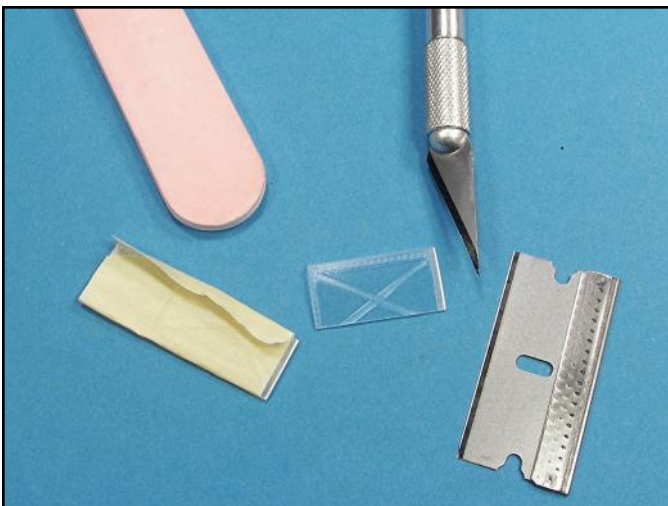
The clear areas were masked to protect them and then the plastic strips were cut to length.

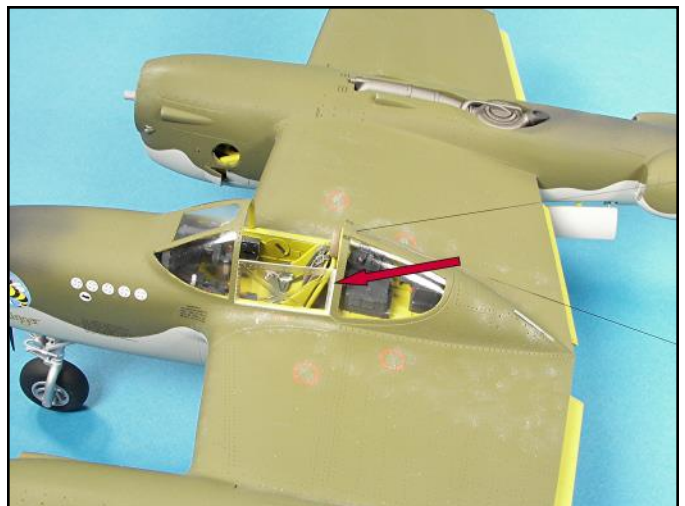
Now the side canopy parts fit snugly into place. They were carefully masked and airbrushed.
