MIKE ASHEY PUBLISHING
COMPREHENSIVE SERIES SCALE MODEL AIRCRAFT MANUAL
NUMBER 1
BUILDING TRUMPETER'S 1/32 SCALE SBD-1 DAUNTLESS

This manual is applicable to all versions of the Trumpeter 1/32 scale SBD series.

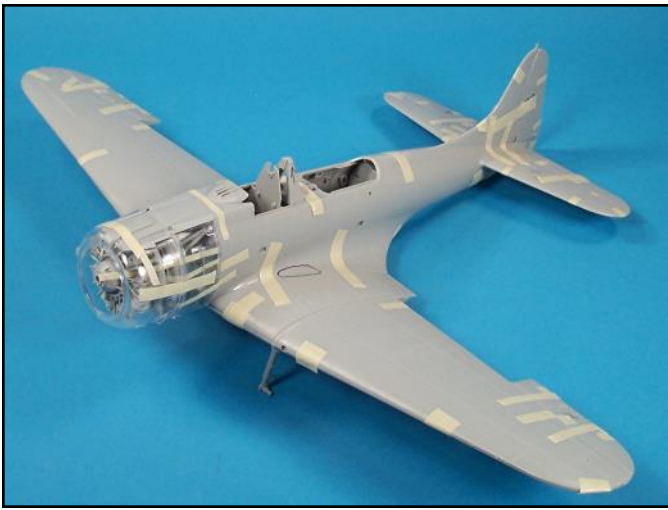
Taping all the major parts together helped identify fit challenges some of which were noted on the instructions and others were marked on the kits surface.

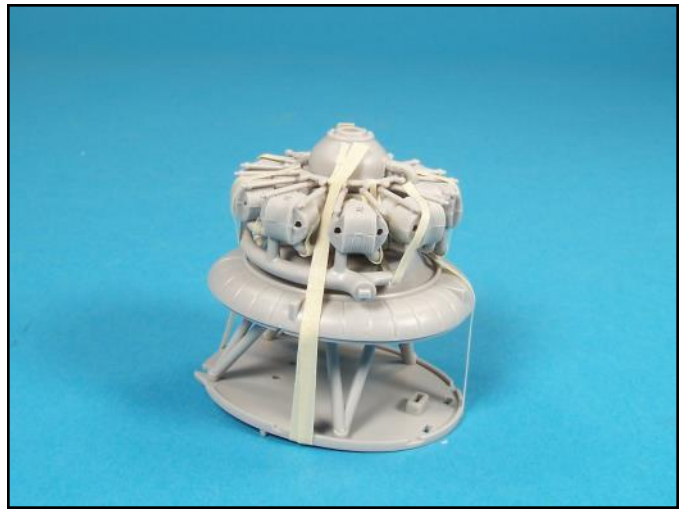
The kit has a nicely detailed R-1820-60 engine. With the engine having so many parts taping it together helped identify fit issues before assembly.

The clear cowling parts around the engine and the engine frame have some fit issues that will need attention if you decide to close up this area.

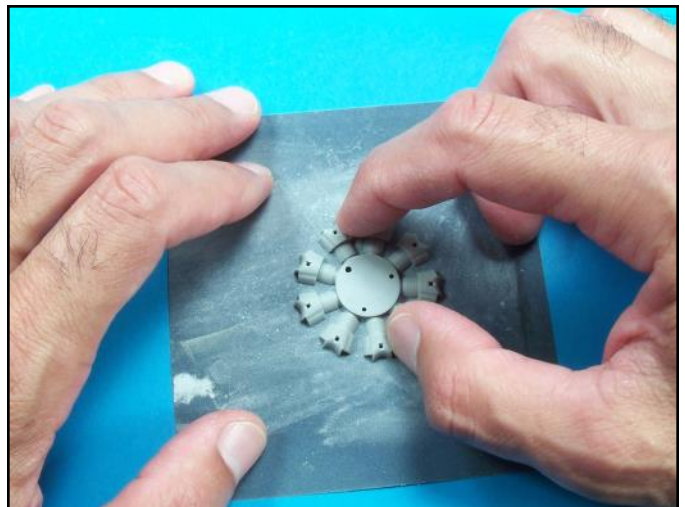
The engine cylinder halves were sanded flat so that the seam line would be minimal.

The exhaust piping tree attachment tabs were removed with a set of snippers. Each part had a seam line around the perimeter that need to be scraped off and the surface sanded smooth with a Flex-I-File.

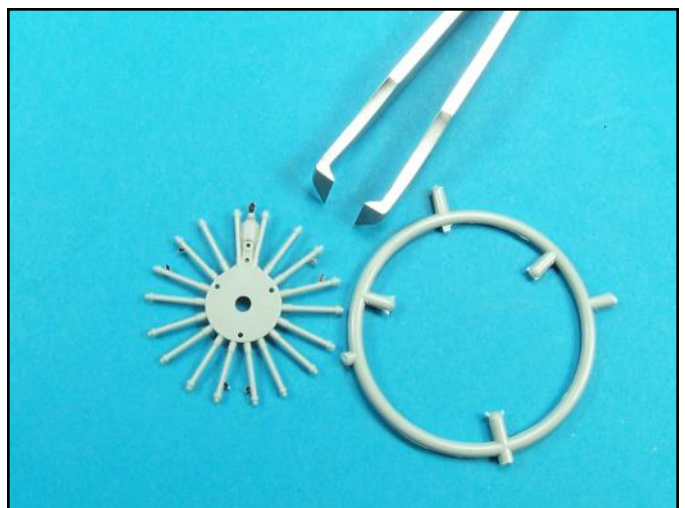
The cylinder push rods were very delicate and were carefully snipped off the tree ring. Then the seam line on each rod was carefully scraped off with the tip of a number 11 X-Acto blade.

The engine mounting frame had noticeable mold lines that needed to be removed.

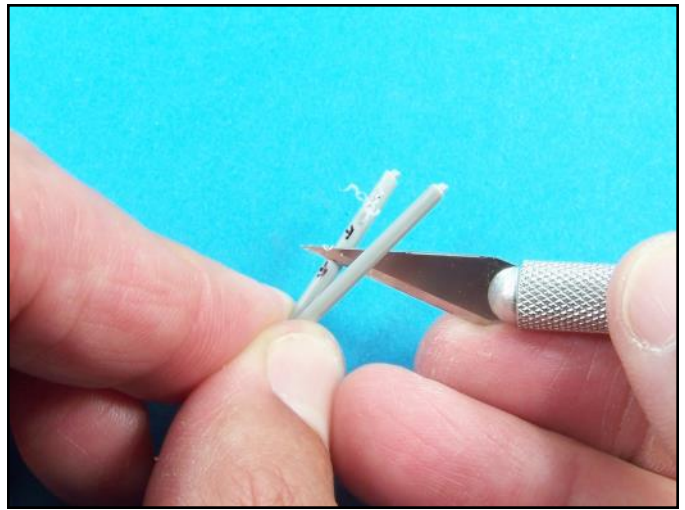
Holding the number 11 X-Acto blade at a 45 degree angle to the surface peels away the mold line layers at a time.

The aircraft lifting cable had a very delicate tree attachment tabs that were best cut with snippers.

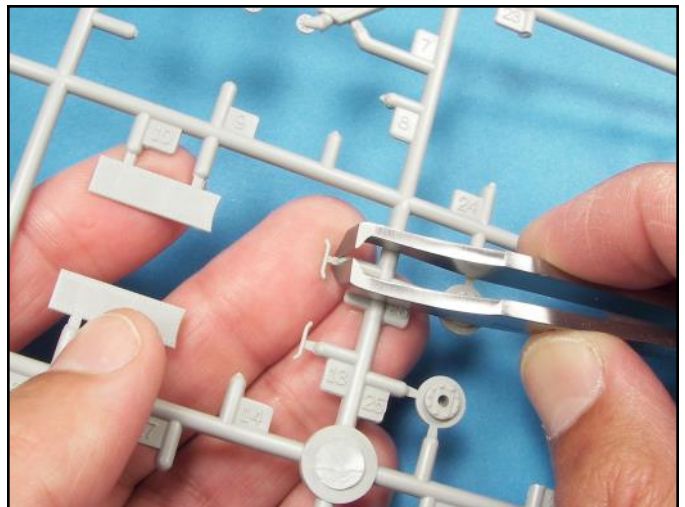
Cutting parts off the trees and leaving some of the connecting tab in place helped ensure that these small and delicate parts are not damaged during the removal process.

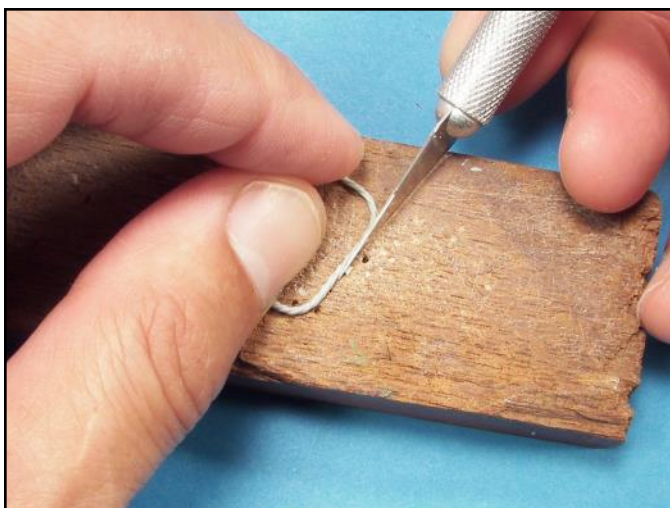
Set small parts onto a small elevated wood cutting board and carefully trim off the remaining tree tabs with the tip of a sharp number 11 X-Acto blade.

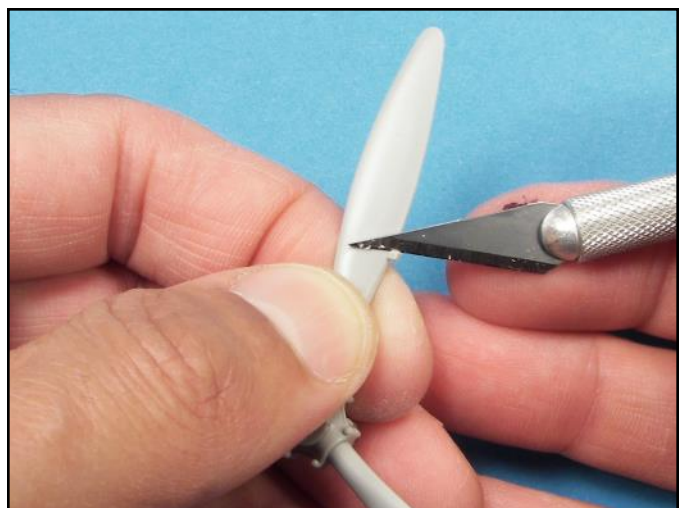
The surfaces of the propellers had a portion of the tree tabs connected to them. After snipping the propeller free from the tree, carefully slice through the remaining tabs so as to not gouge the surface.

The wood cutting board is also ideal for trimming off excess tabs on parts that have a flat surface.

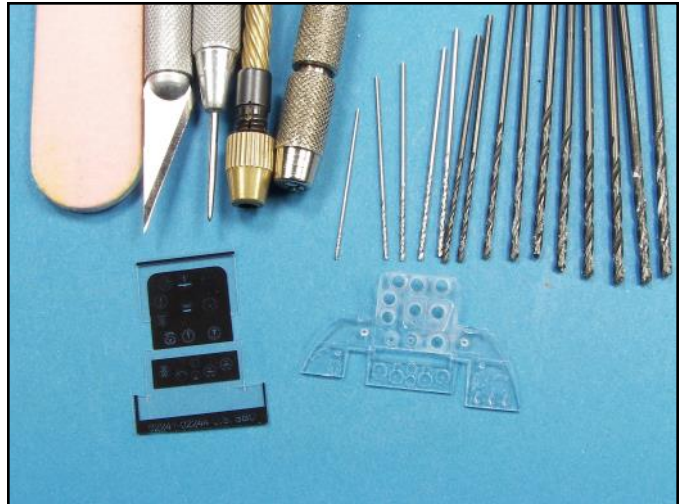
To enhance the console, I carefully drilled out the instrument faces using drill bits of slightly larger diameters so that the clear plastic would not crack.

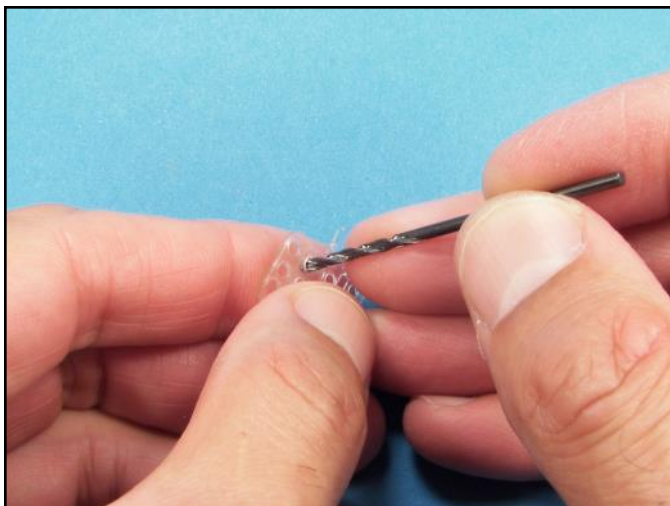
Each larger size drill bit was used to carefully and slightly enlarge the opening. Drilling by hand also helped ensure that the clear plastic would not crack.

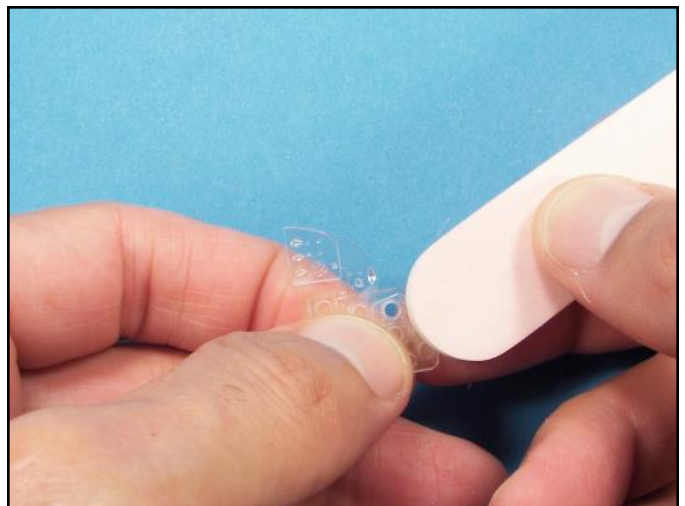
To remove the plastic burs along the edges of each opening, the surface of the console was sanded smooth with a damp sanding stick.

To ensure that each opening was smooth, I used the tip of a number 11 X-Acto blade to remove any excess plastic.

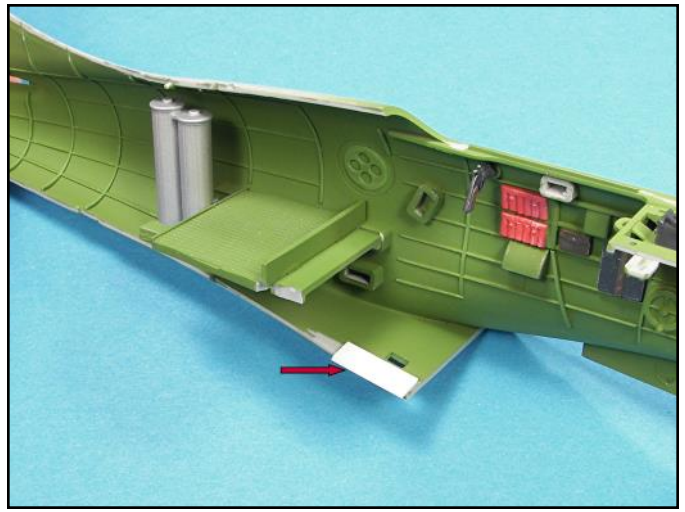
To ensure a strong bond on the bottom of the fuselage, attach a length of plastic strip to the interior. Once this area is glued, the capillary action of the super glue will pull the glue into the area where this strip is located.

The fuselage halves were taped tightly together and a bead of super glue was applied to the seam lines between the masking tape. Do not let the glue get too close to the masking tape.

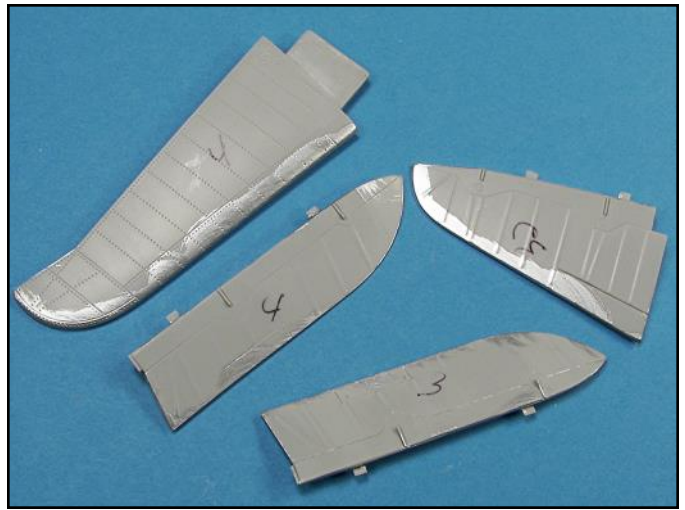
The separate control surfaces were glued together. The seams got beads of super glue which was then scraped flat and sanded smooth. The silver paint was used to highlight flaws in the seams.

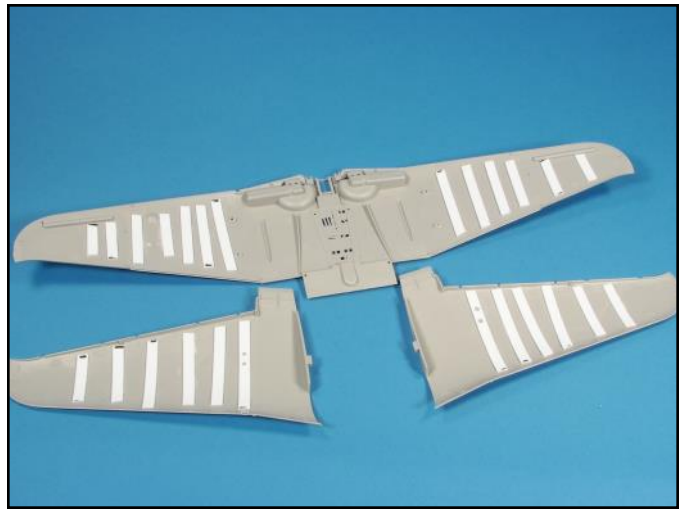
The wings also received sections of .020 inch strips laminated in place with super glue. This helps prevent flexing of the wing surfaces which would crack the seams.

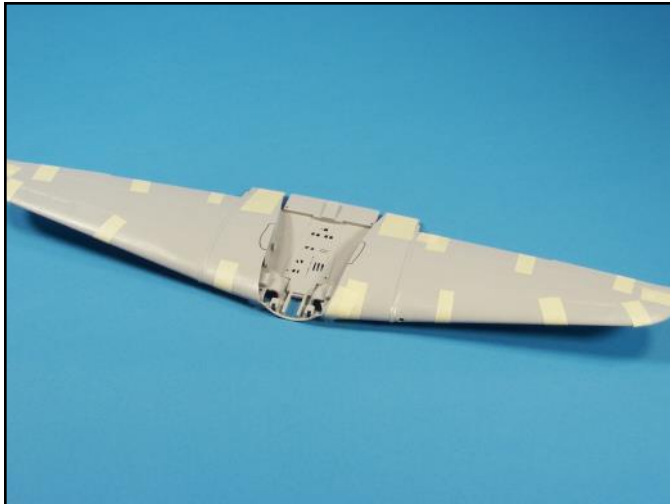
The wing halves were tightly masked together and super glue was run along the seam lines with a thin wire applicator. The seams were then scraped and sanded smooth.

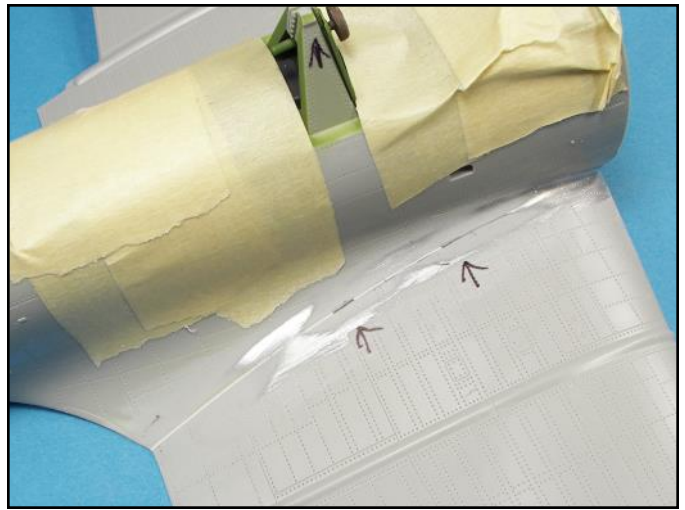
The super glue was applied and then the area was sanded smooth. The silver paint also acts as an indicator for when the super glue is sanded smooth.

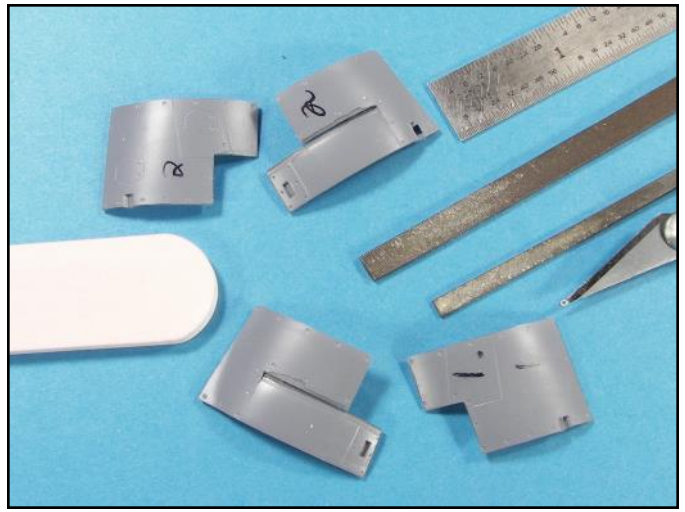
With the access panels separated it is time to thin the edges to make them appear to have a scale thickness.

The edges were carefully scraped with a sharp number 11 X-Acto blade.

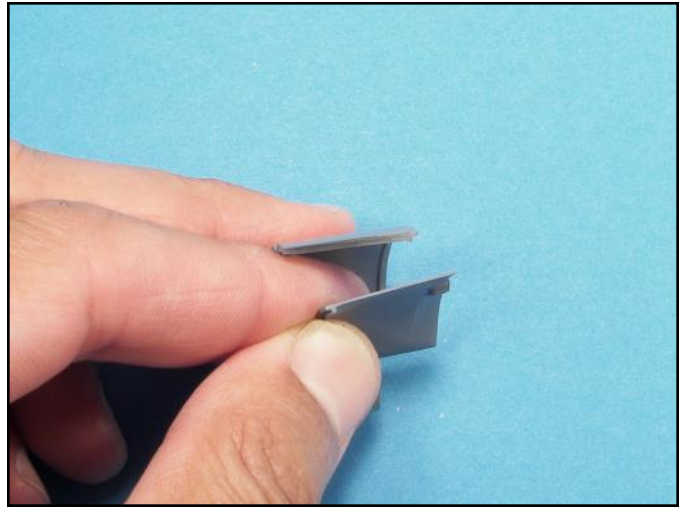
The difference in the thickness of the two access panel parts is very apparent. The lower part is complete and more scale in appearance.

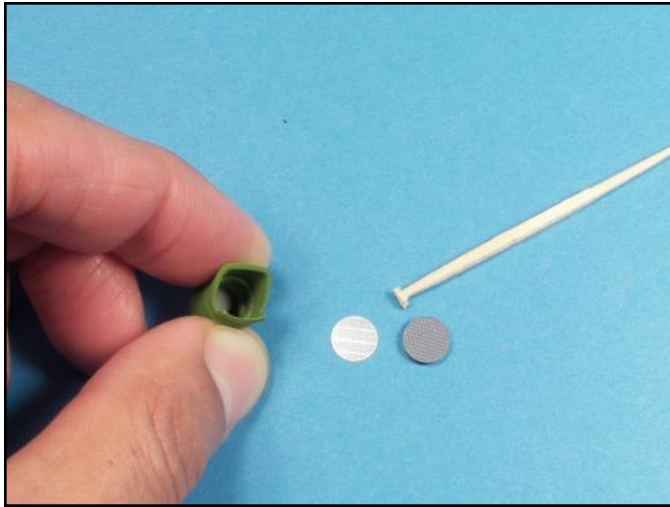
The plastic air intake screen was replaced with the Eduard photoetch part.

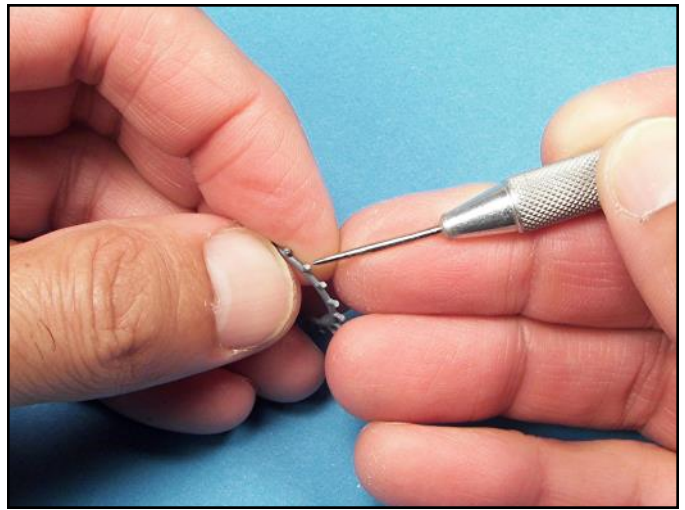
The first step in drilling out the spark plug wire locations on the collector ring was to indent the surfaces for drilling.

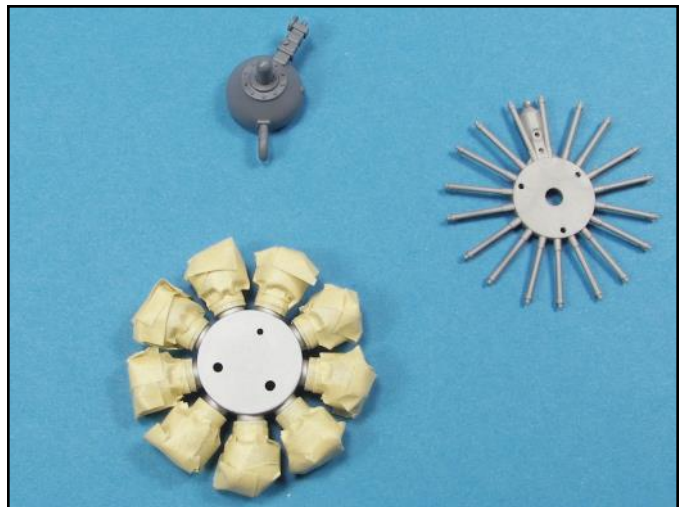
The spark plug wire locations were then carefully drilled out so that brass wire could be inserted into the holes and glued into place.

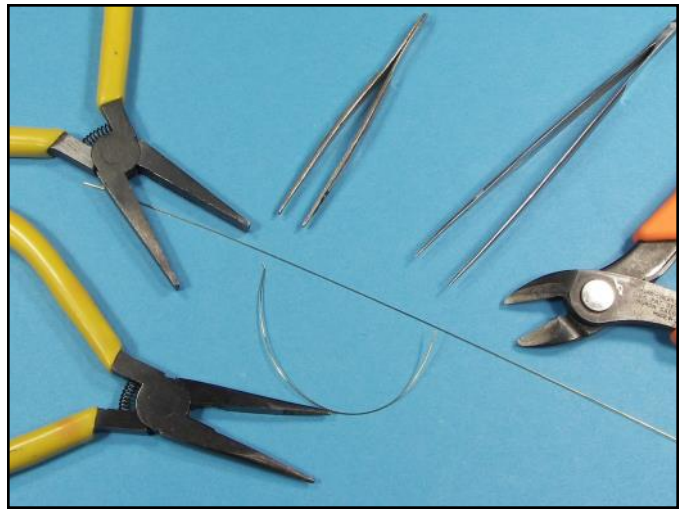
Lengths of brass beading wire was stretched straight to represent the spark plug wiring shielding.

The lengths of brass beading wire were cut and bent into shape and then form fitted into place. Each cylinder gets two plug wires, one in the front and one in the back.

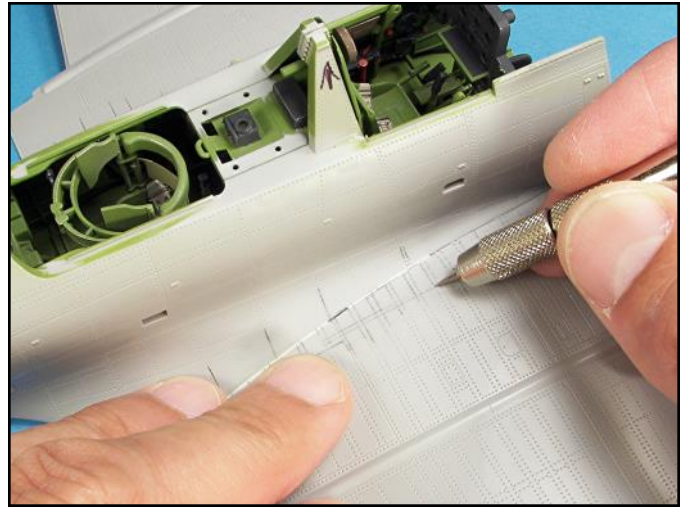
After the panel lines were completed, the rivet detail needed to be restored. The tip of the scribing needle was used to restore each rivet. Pushing down on the needle creates a slight upward dimple around each rivet location.

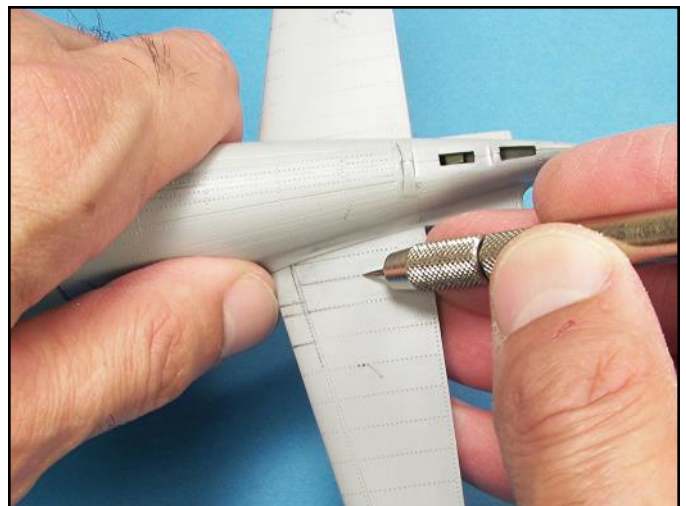
To remove the ridges along scribed lines and the dimples around new rivet detail, smooth the plastic surface with 0000 steel wool.

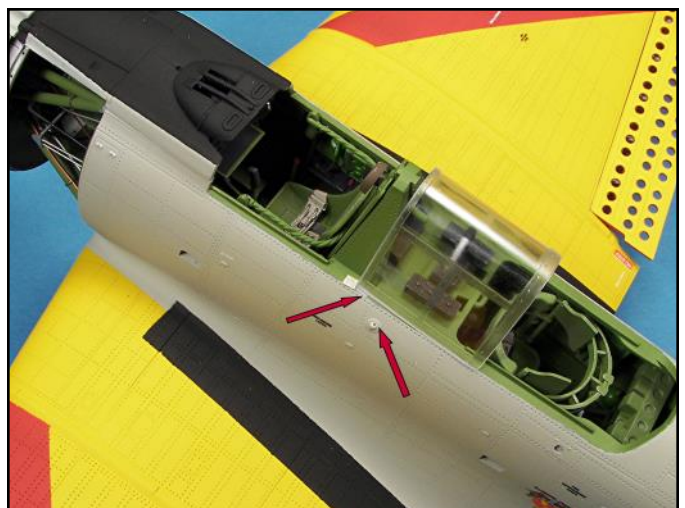
The rear canopy was slightly warped inward and had to be corrected.
